**PRELIMINARY
GEOTECHNICAL
AND FAULT RUPTURE HAZARD
INVESTIGATION**

**GROVE PARK
APN 380-250-003
SW CLINTON KEITH RD & YAMAS DR
WILDOMAR, CALIFORNIA**

**REVISED FEBRUARY 24, 2015
MARCH 24, 2014
PROJECT NO. T2539-22-02A**

Subject: PRELIMINARY GEOTECHNICAL AND
FAULT RUPTURE HAZARD INVESTIGATION
GROVE PARK, APN 380-250-003
SW CLINTON KEITH RD & YAMAS DR
WILDOMAR, CALIFORNIA

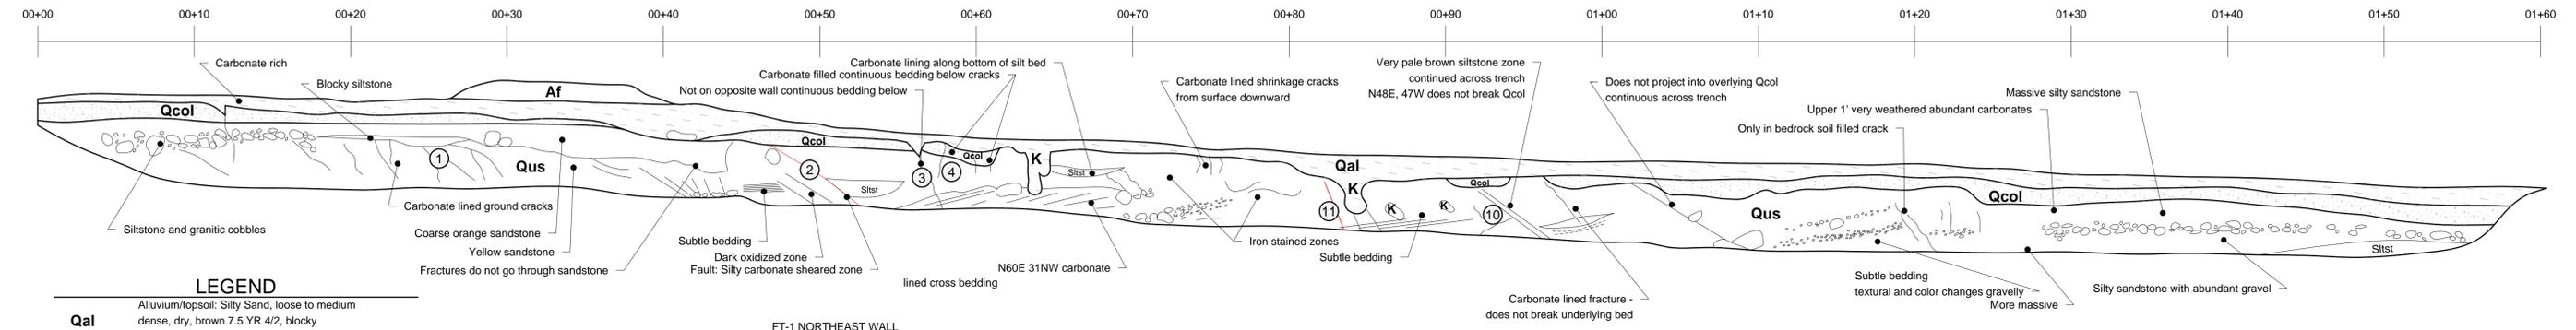
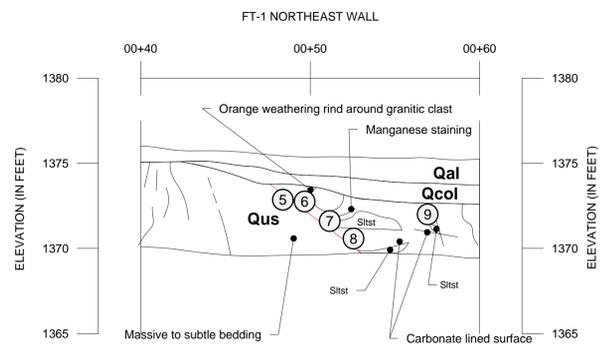
FT-1
N37°E
SOUTHWEST WALL

Based on our exploration as described above we did not observe active faulting within either site. Older faulting was observed within the Unnamed Sandstone (very early Pleistocene approximately 1.6 million years old) on the northern site. However, no faulting was observed within the Pauba Sandstone (early Pleistocene approximately 1 million years old) on either site. We have included the fault location as dotted (buried) on the Geologic Map. We are not recommending building setback zones on either site based on this evidence.

- ① fracture: N30W, SW - continues on opposite wall discoloration along crack
- ② Fault: N75W, 28S, continuous on surface N65W across trench
- ③ fracture: N20E, 50S
- ④ fracture: N20W, 80S carbonate filled
- ⑤ through ⑧ Fault Zone: Average N63W, 33SW
- ⑨ fracture: N68E, 80S, fracture/ground crack
- ⑩ fracture: N20E, 26W ground crack
- ⑪ Fault: EW, S continues across trench does not disrupt underlying bedding
