Brown House Property Condition Assessment Study

PROPERTY CONDITION ASSESSMENT

The Brown House
Baxter Road and Central Avenue
Wildomar, California 92595

Hillmann Project Number C3-6561

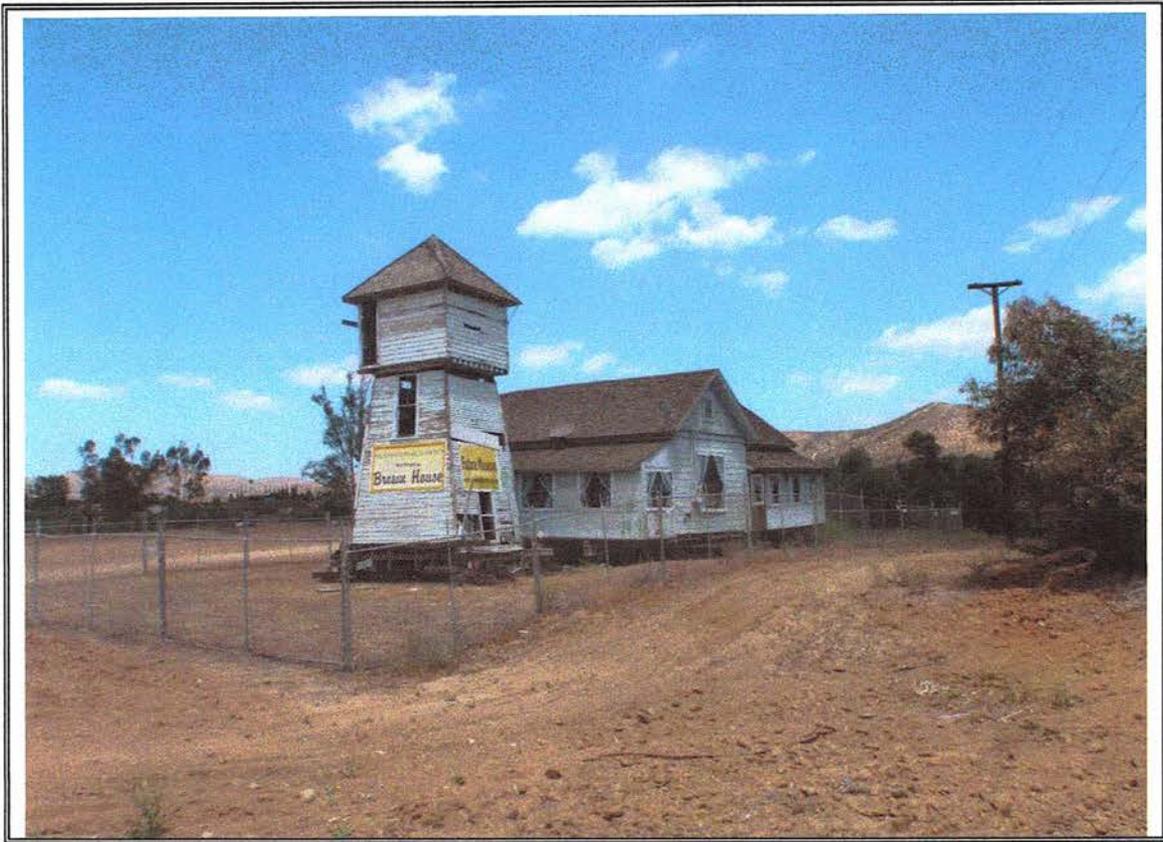
1. Western elevation

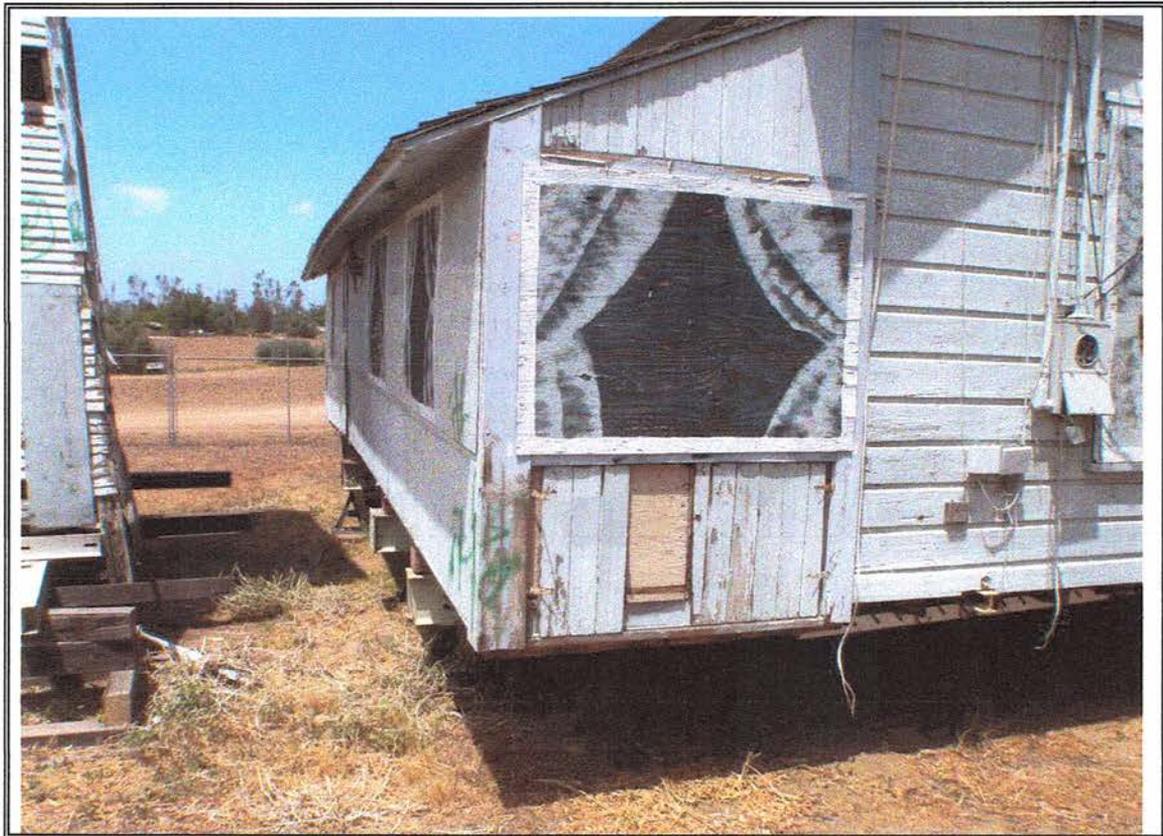
2. Western and partial southern elevation

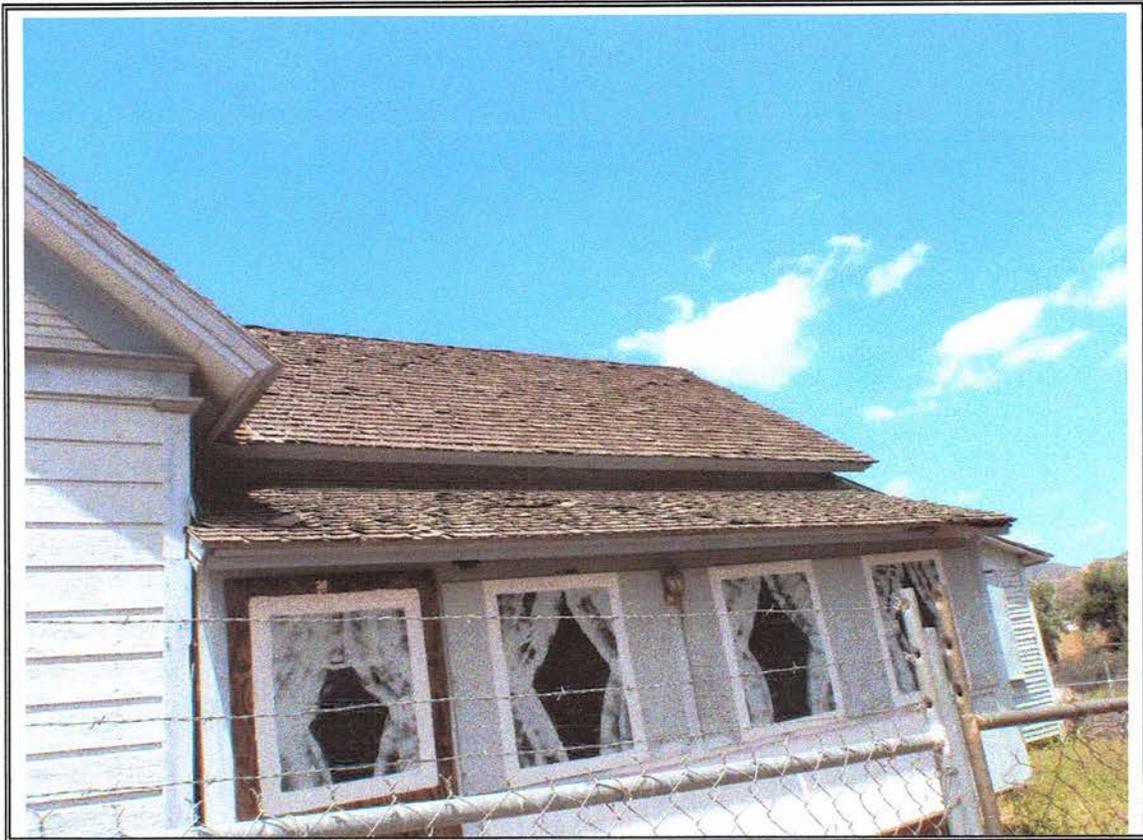
3. Partial southern elevation

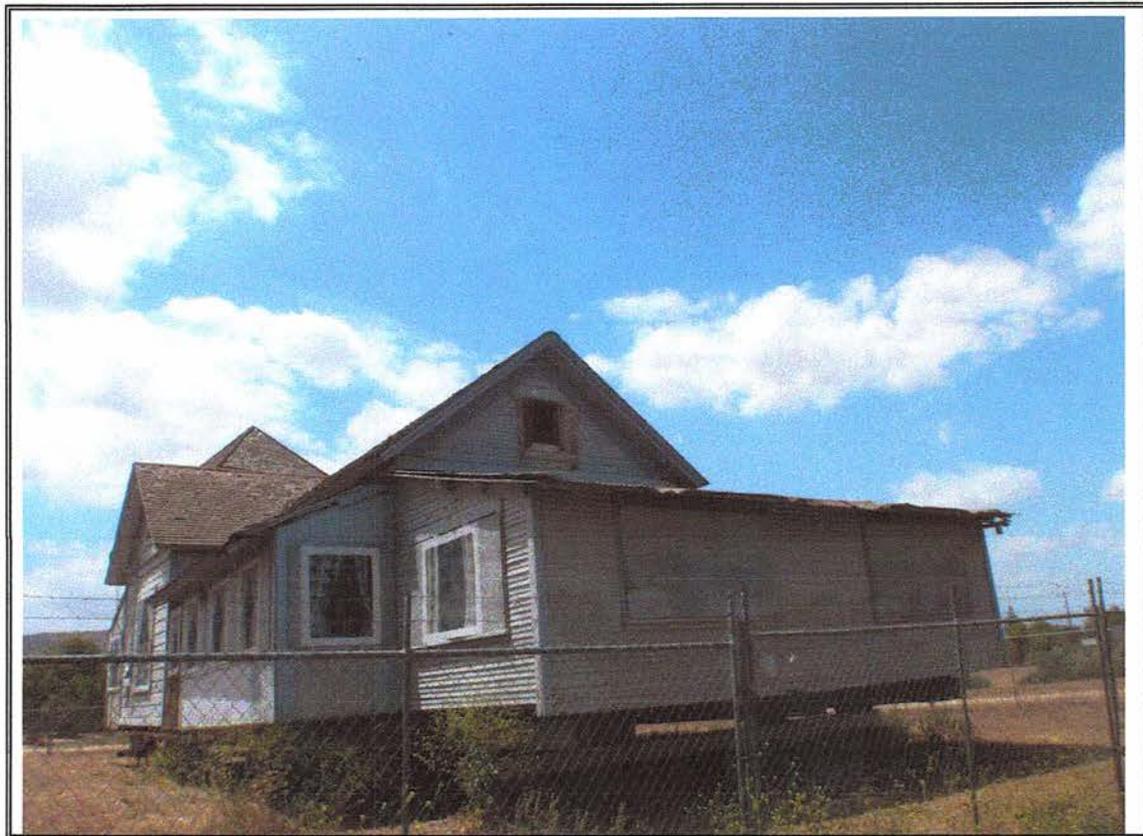
4. Eastern elevation

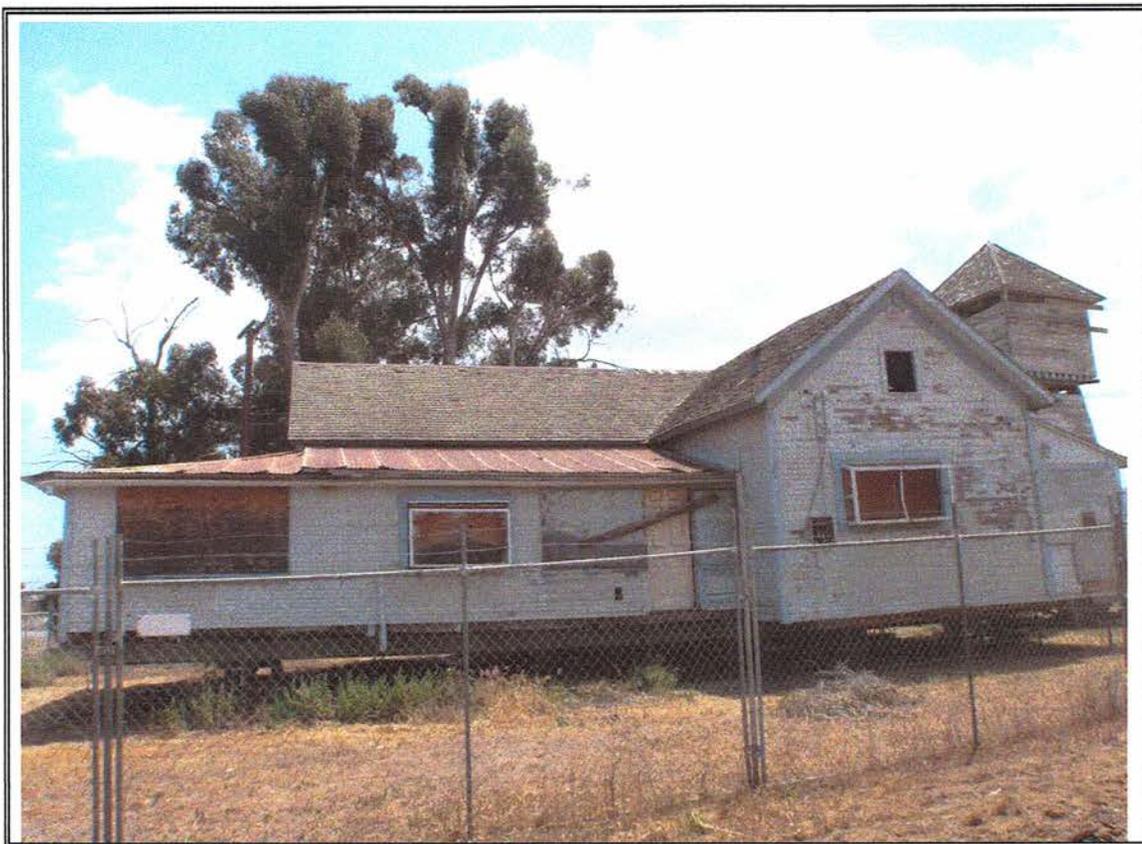
5. Northern elevation

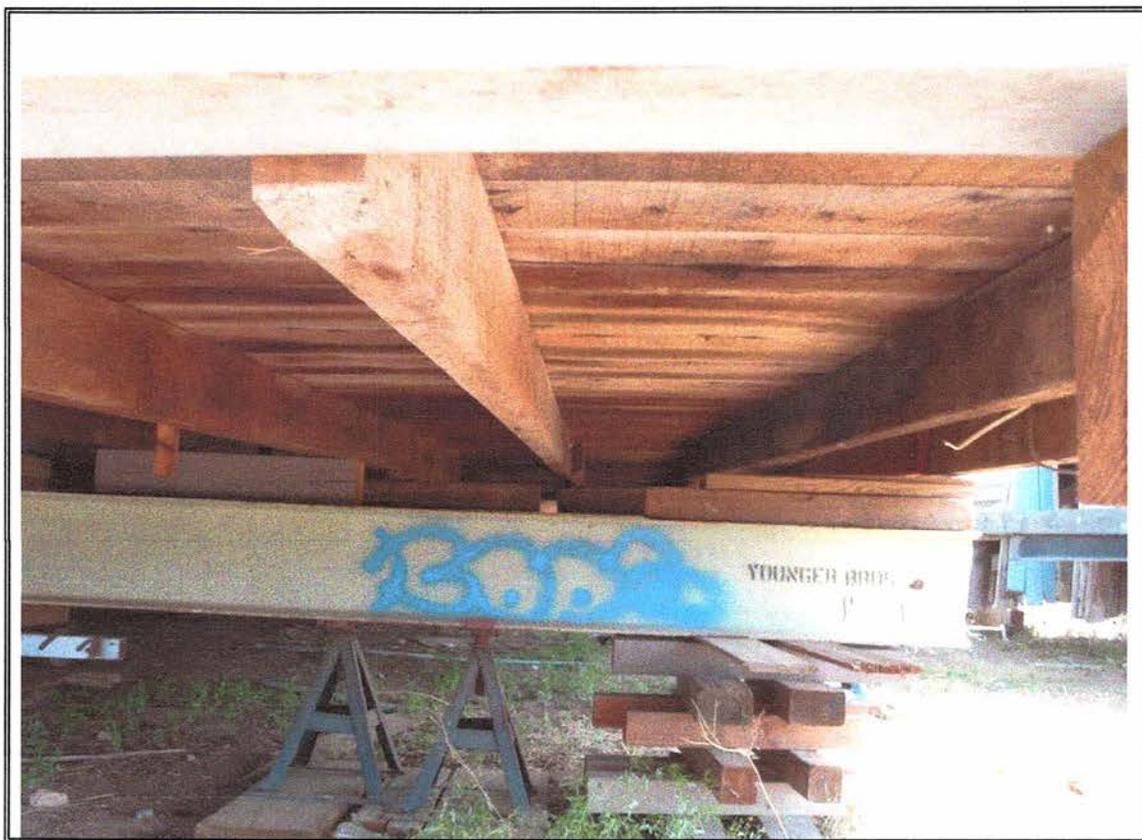
6. Floor structure

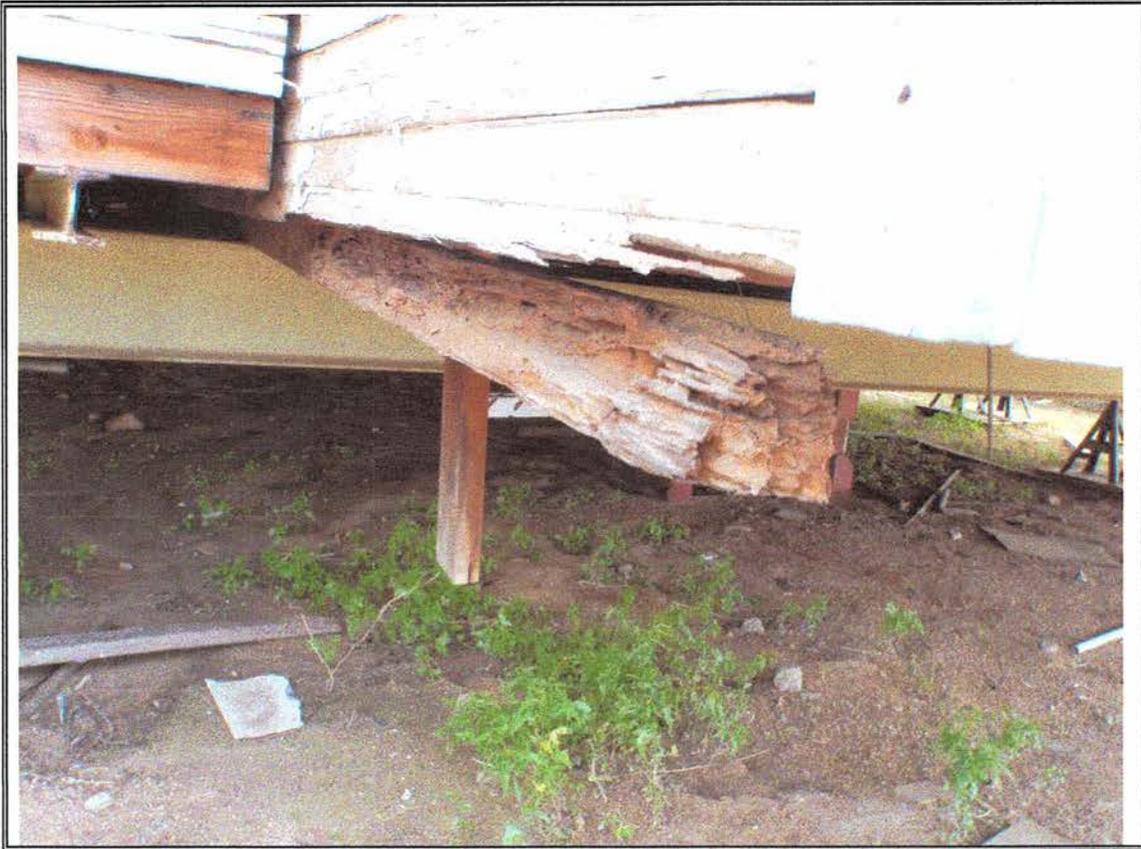
The superstructure and flooring were observed where possible. Based on the areas viewed, the superstructure and flooring of the Subject Buildings are in poor overall condition. Significant areas of dry rot and deteriorating wood beams were observed. The wood structure will require a sizable amount of retrofit to maintain the integrity of the building. Probable costs to complete the required demolition are included within Table 1.

7. Decomposing floor trusses

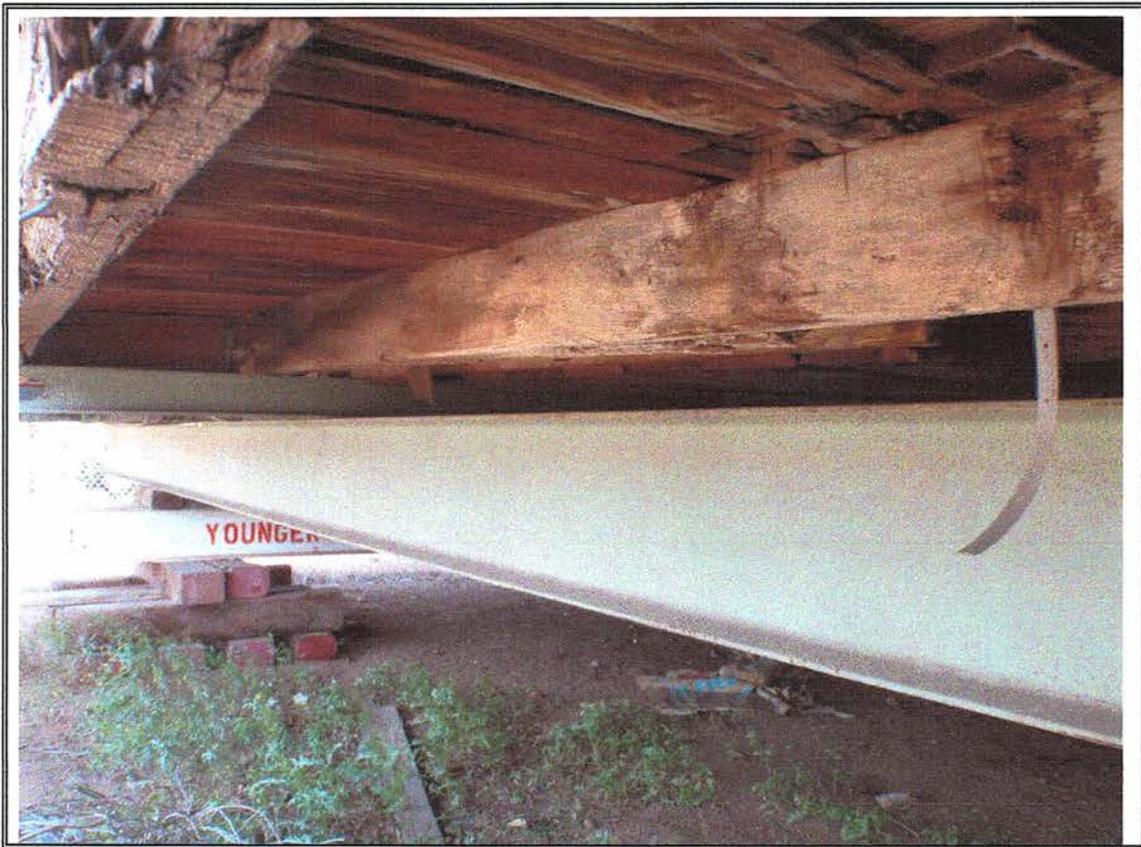
8. Decomposing floor trusses

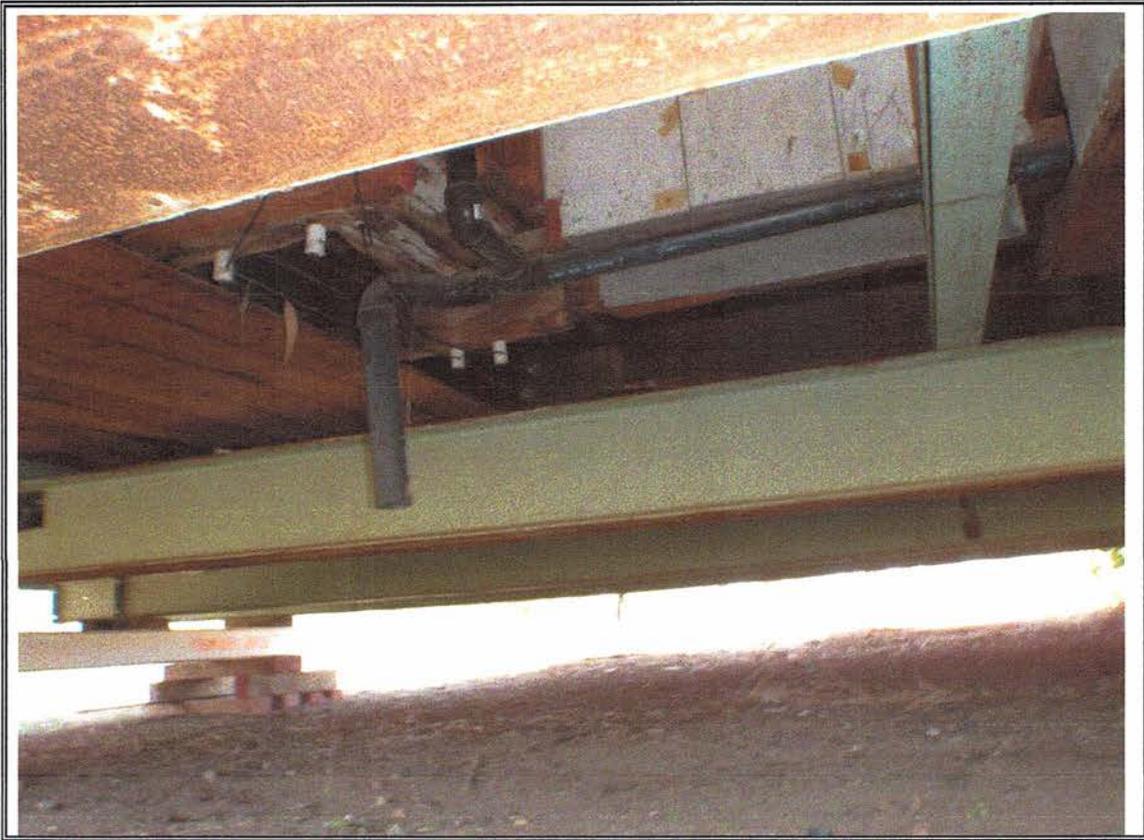
9. Renovated waste and knob and tube electrical system

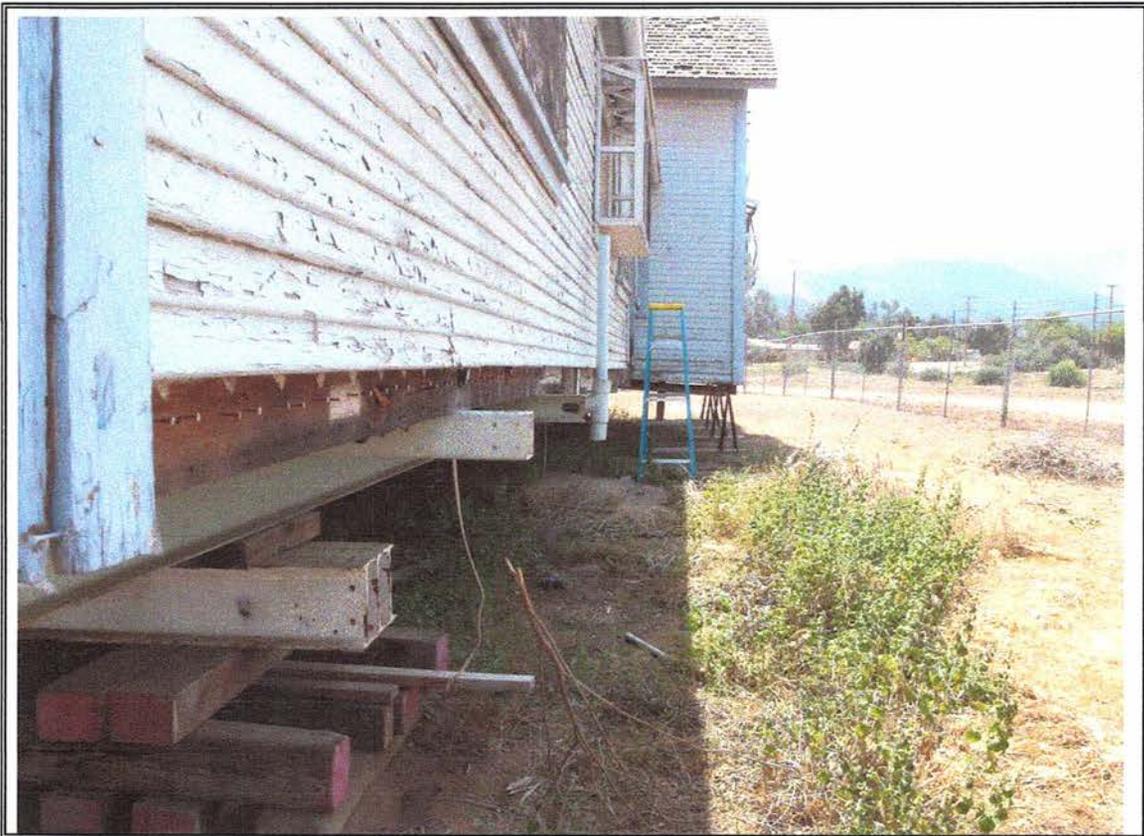
10. Rim joist

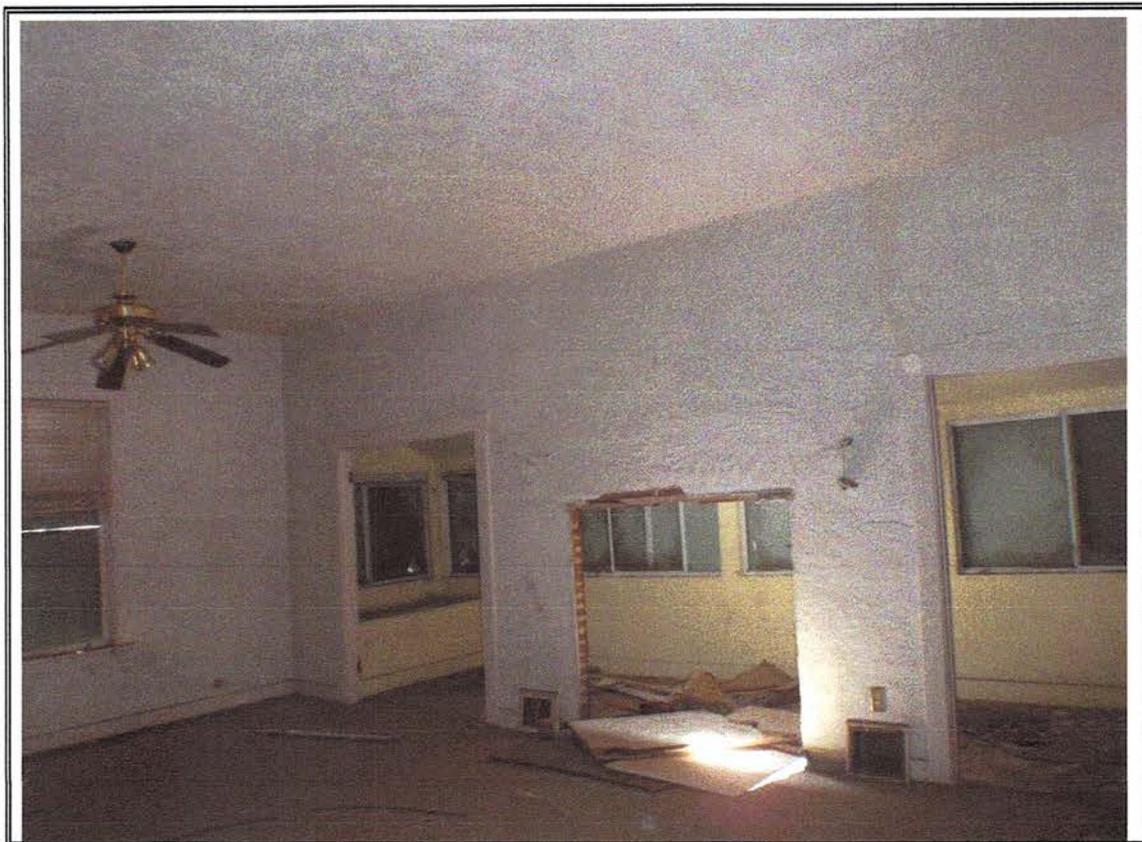
11. Living room

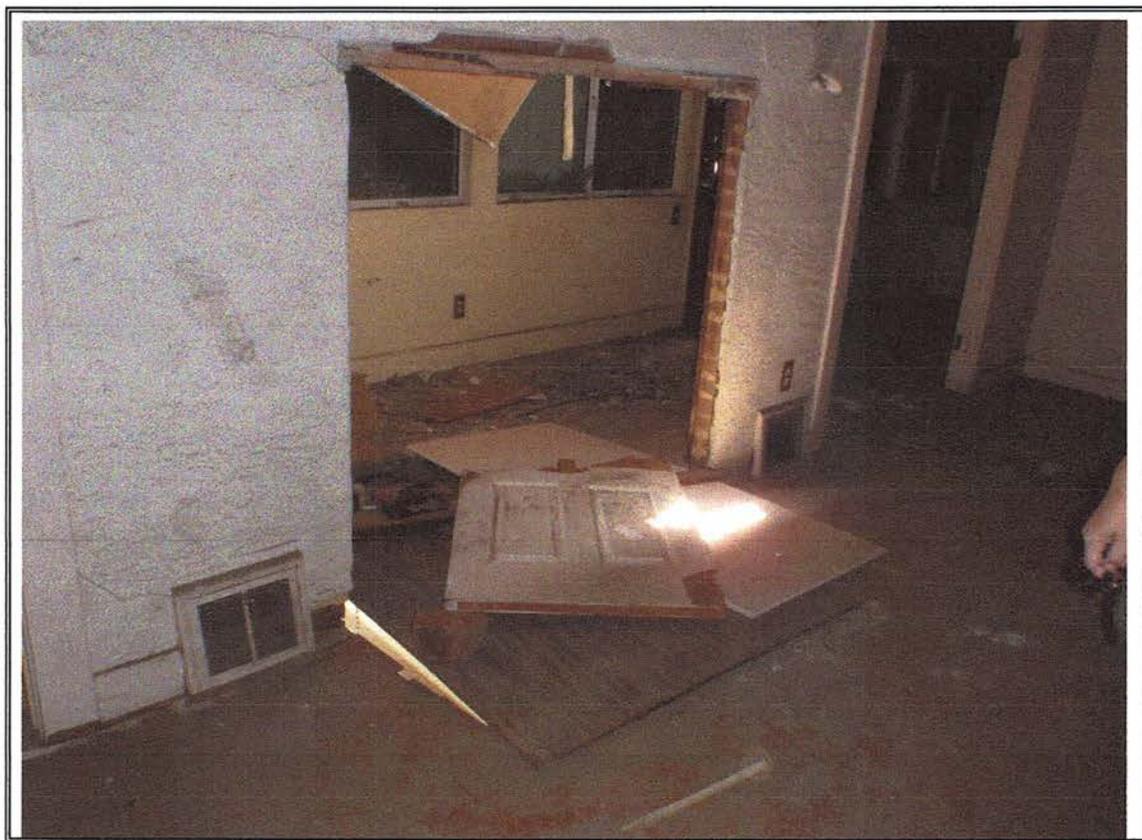
12. Former fireplace opening

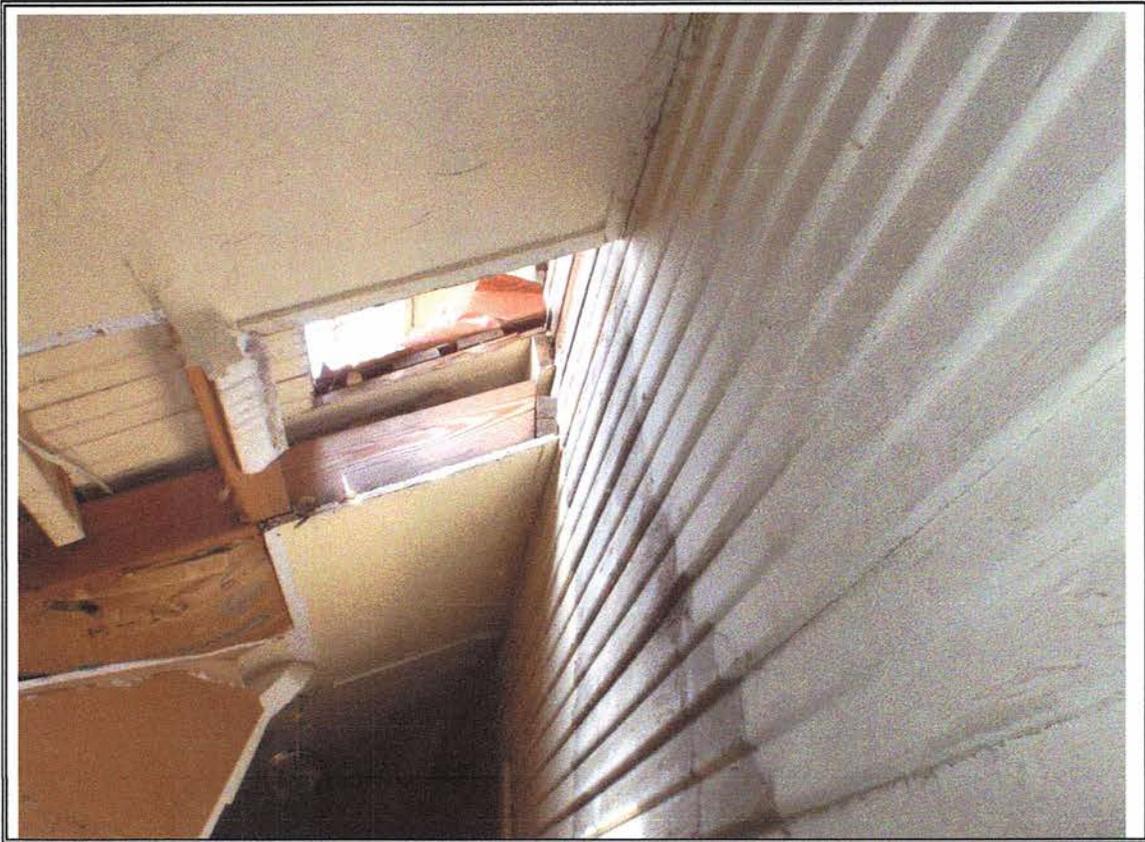
13. Former chimney flue

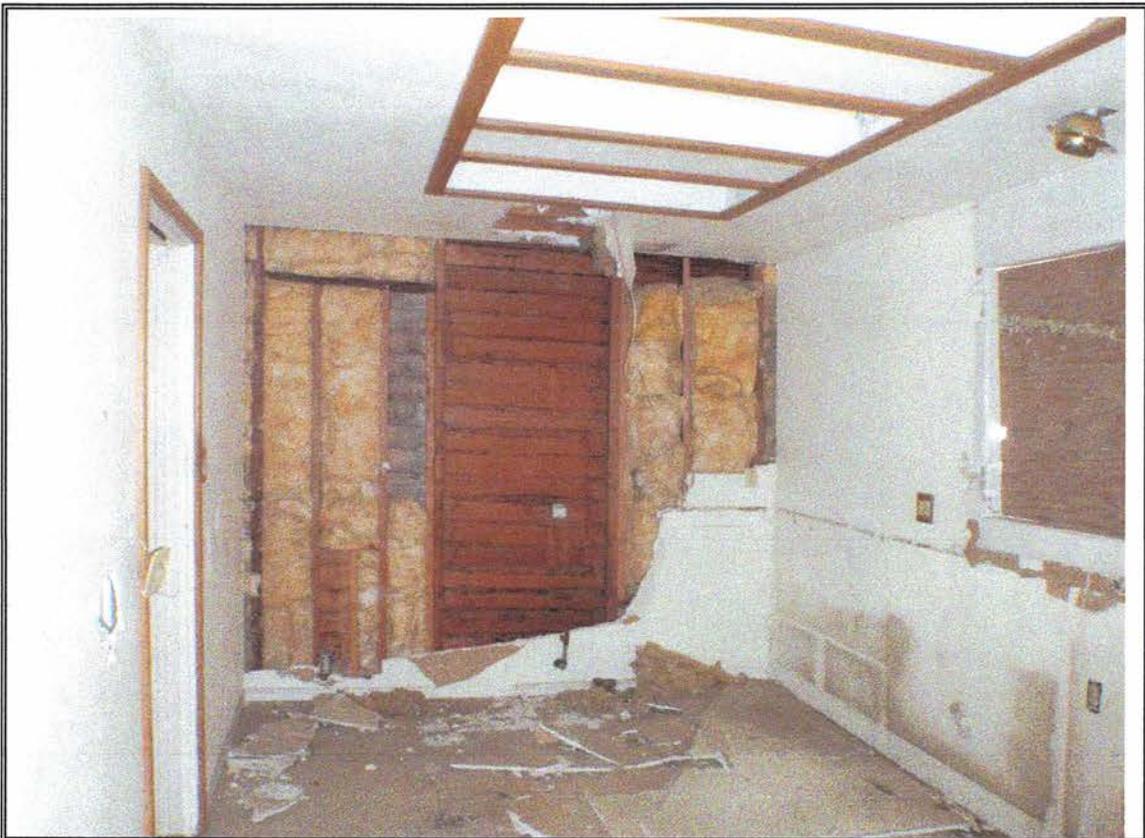
14. Kitchen

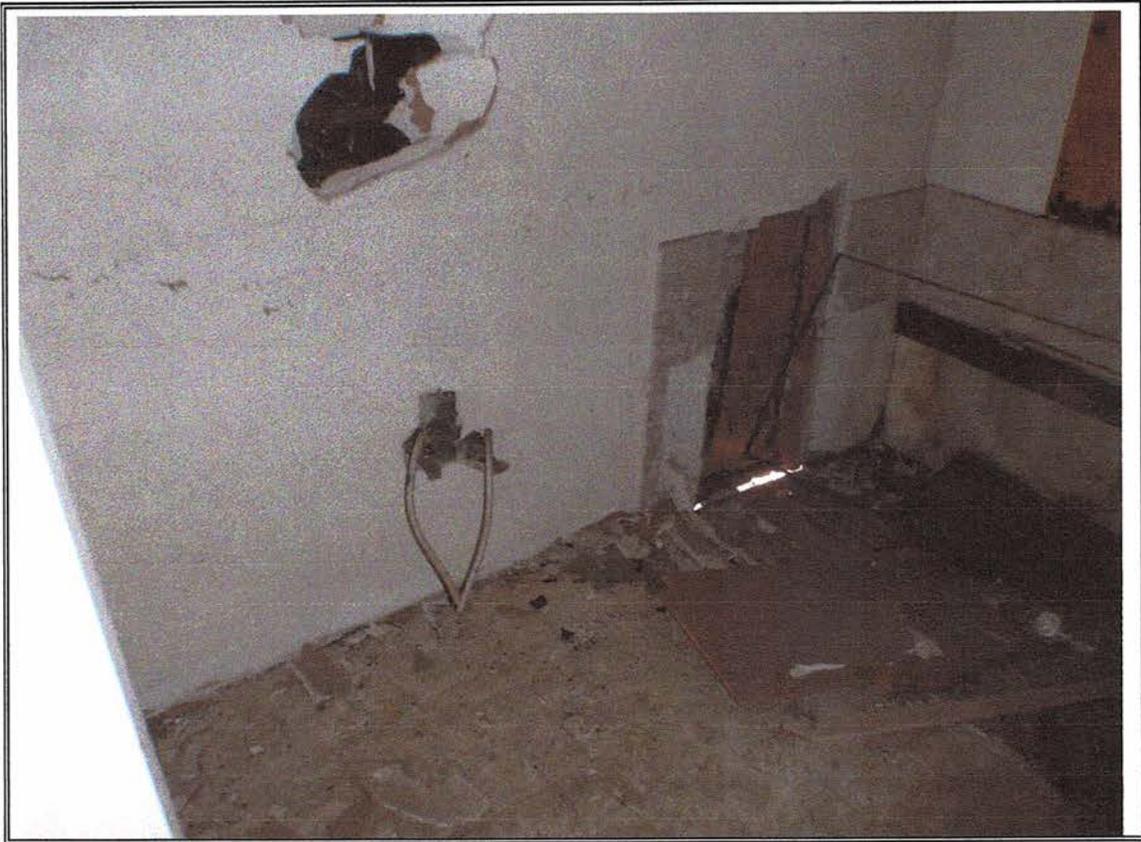
15. Bathroom

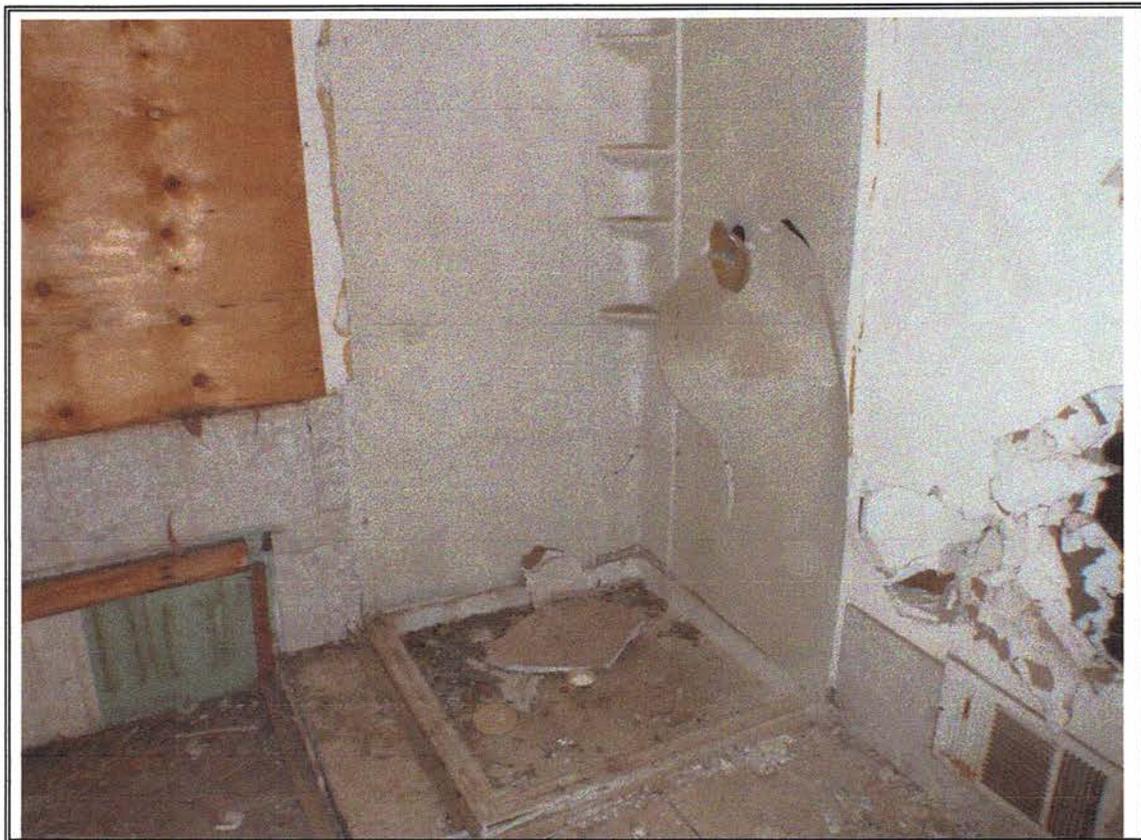
16. Bathroom

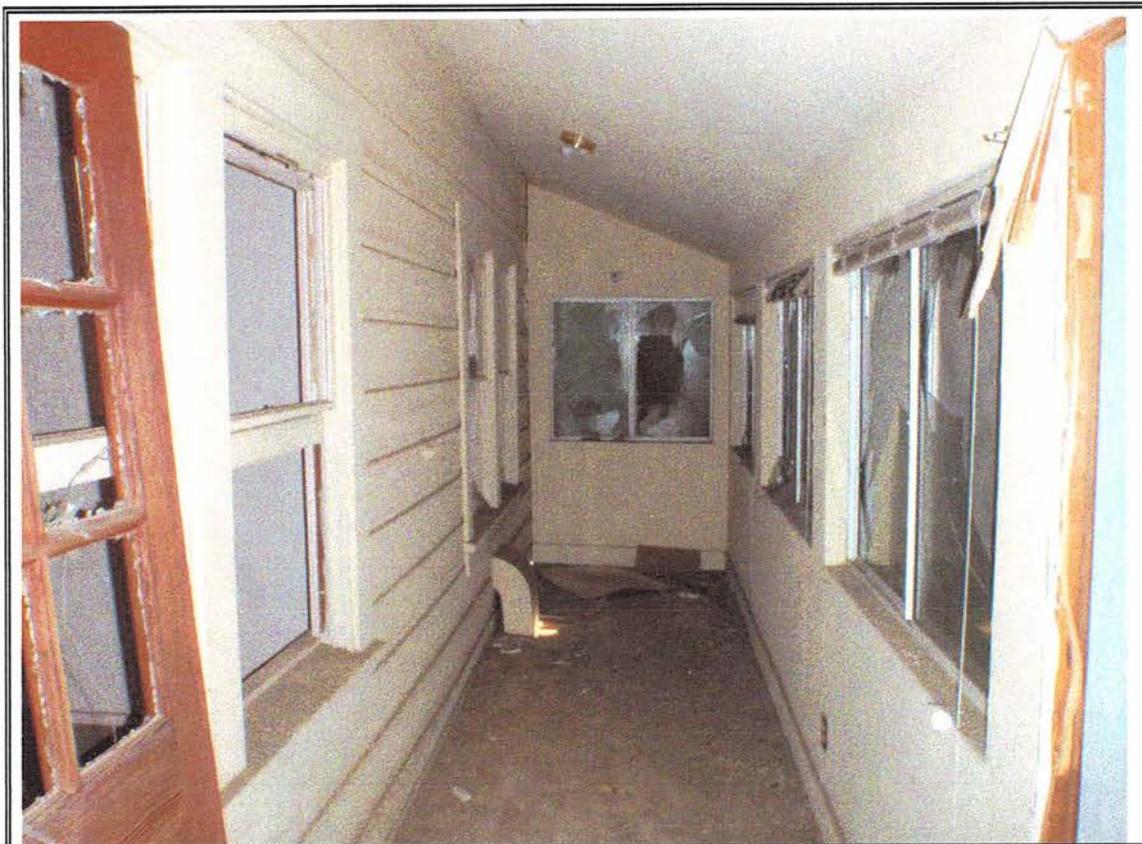
Balconies or porches exist at the western and southern elevations of the building. The porches have been enclosed with wood framing and aluminum windows. There are currently no stairs providing access to the building.

17. Typical enclosed porch

Enclosed porches should be removed and restored to original condition including railings and stairs. Probable costs are included within Table 1

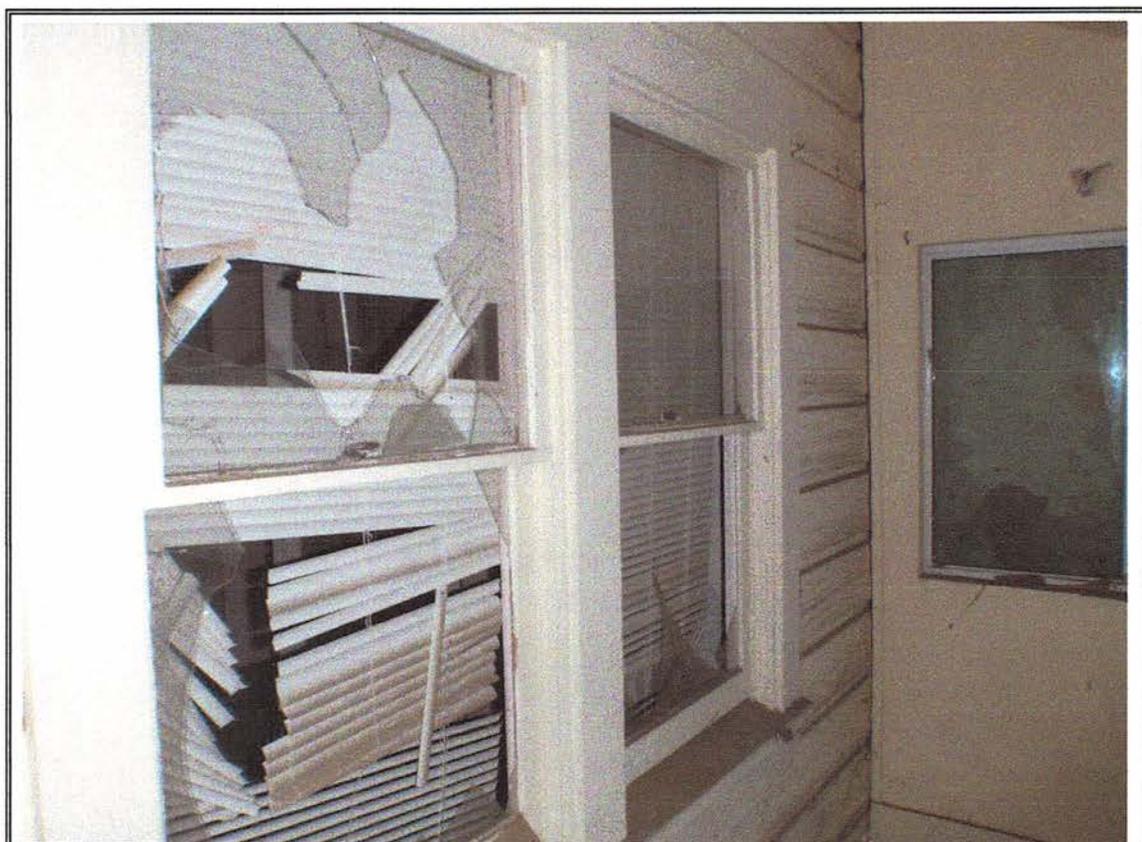
Exterior windows were observed to be in overall poor condition. Approximately 70% of the windows are broken, however, the wood frames appear to be in fair condition. Window renovation will be required, including glass replacement and sash cord counterweight replacement.

18. Windows

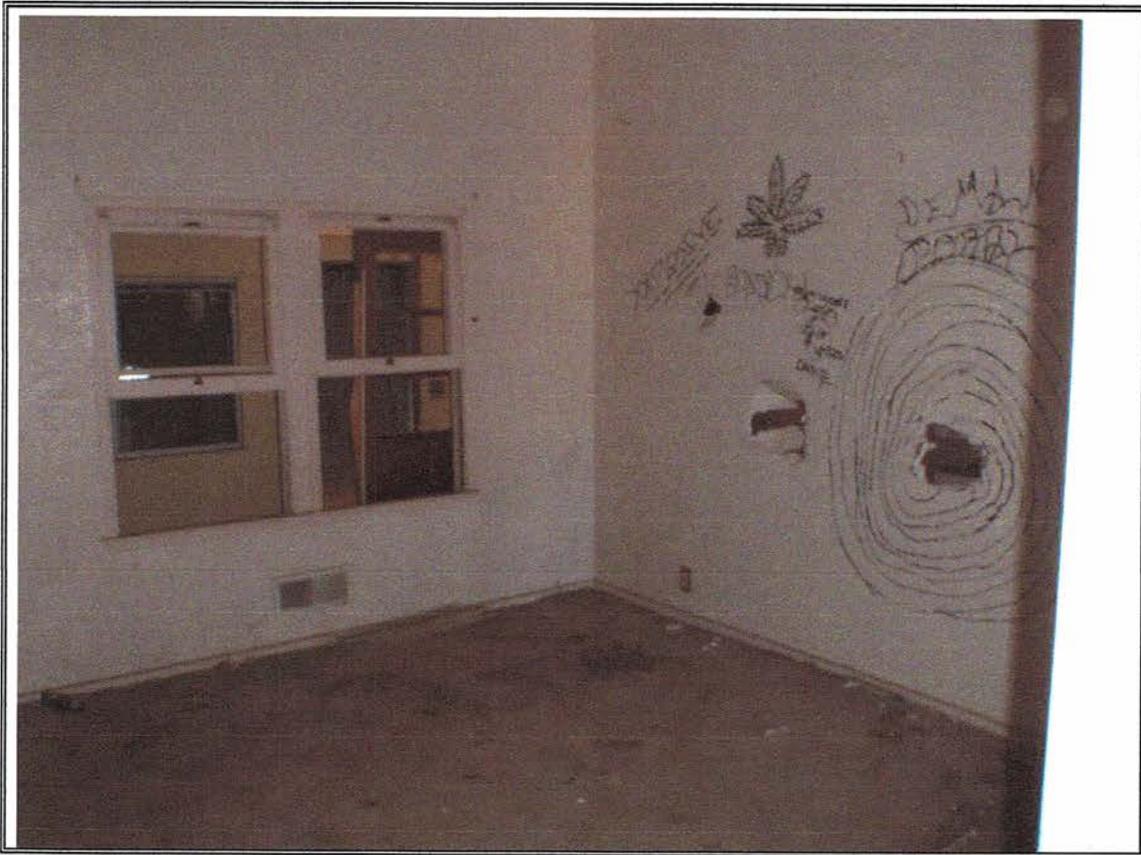
19. Small bedroom

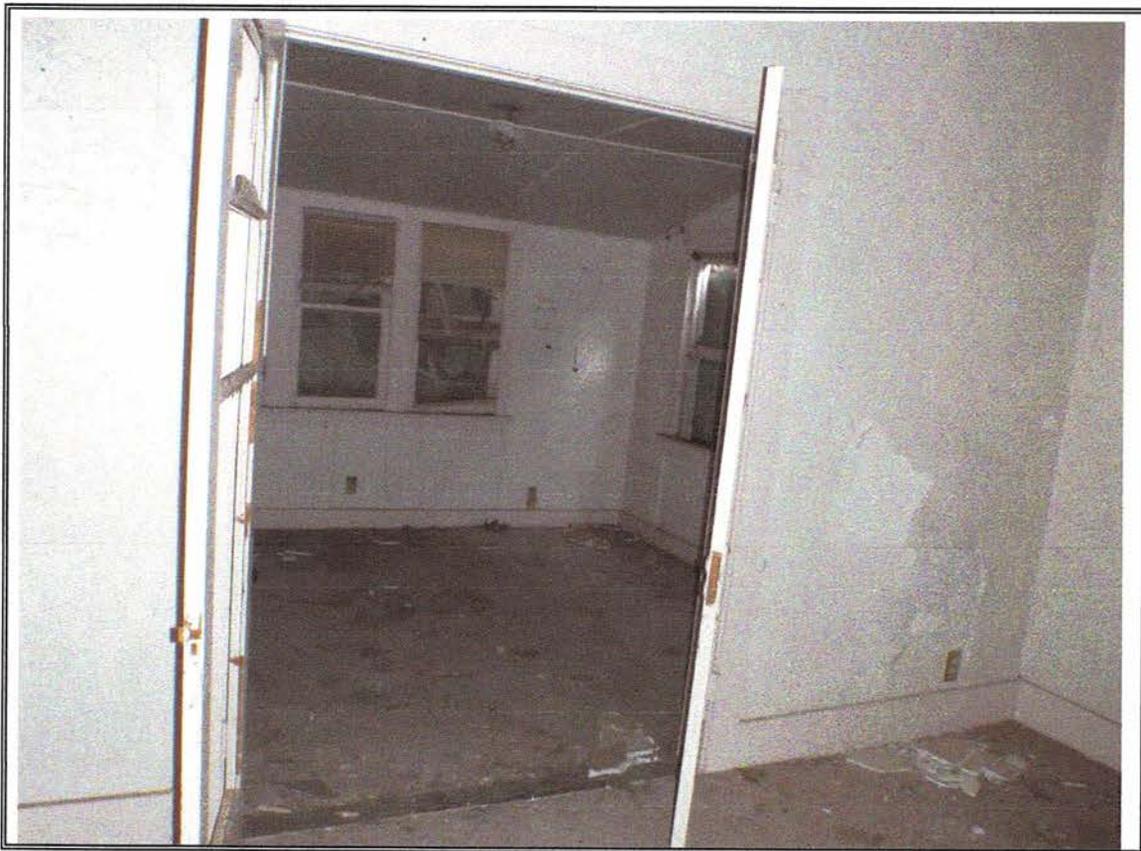
20. Master bedroom

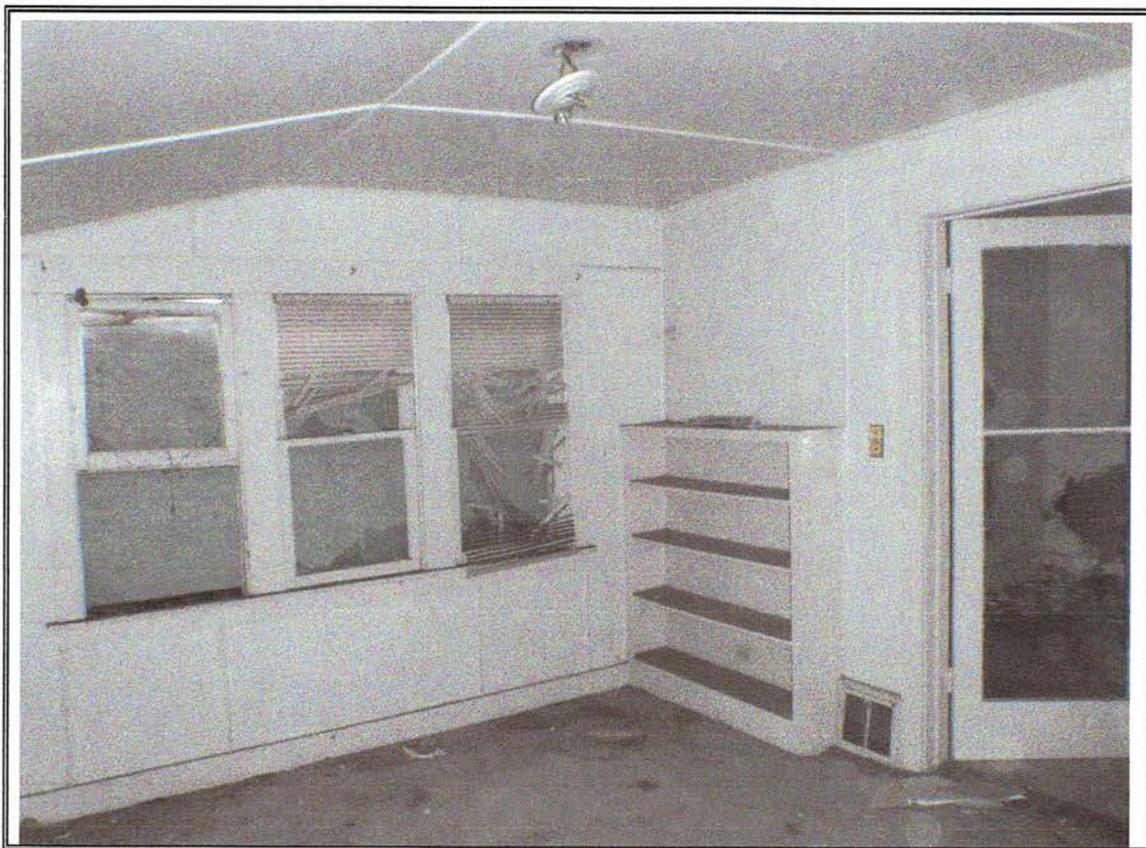
21. Master bedroom

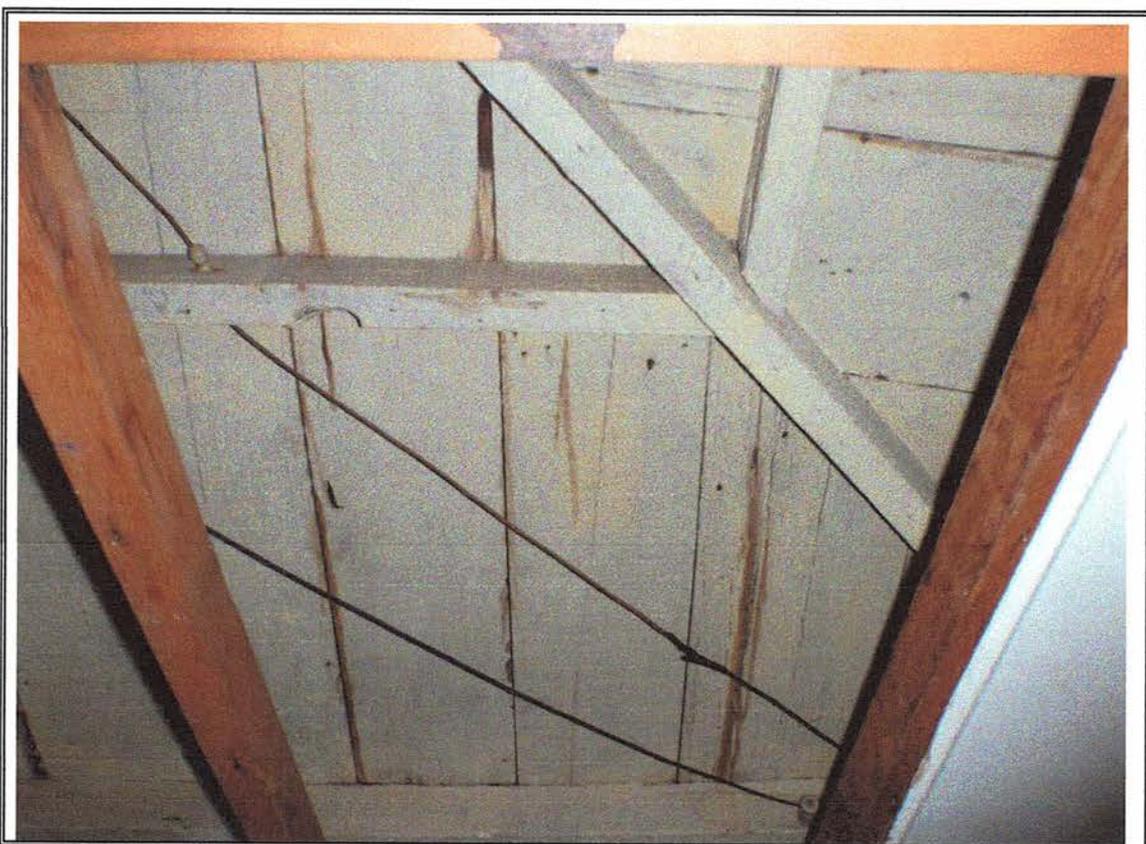
22. Shed roof framing

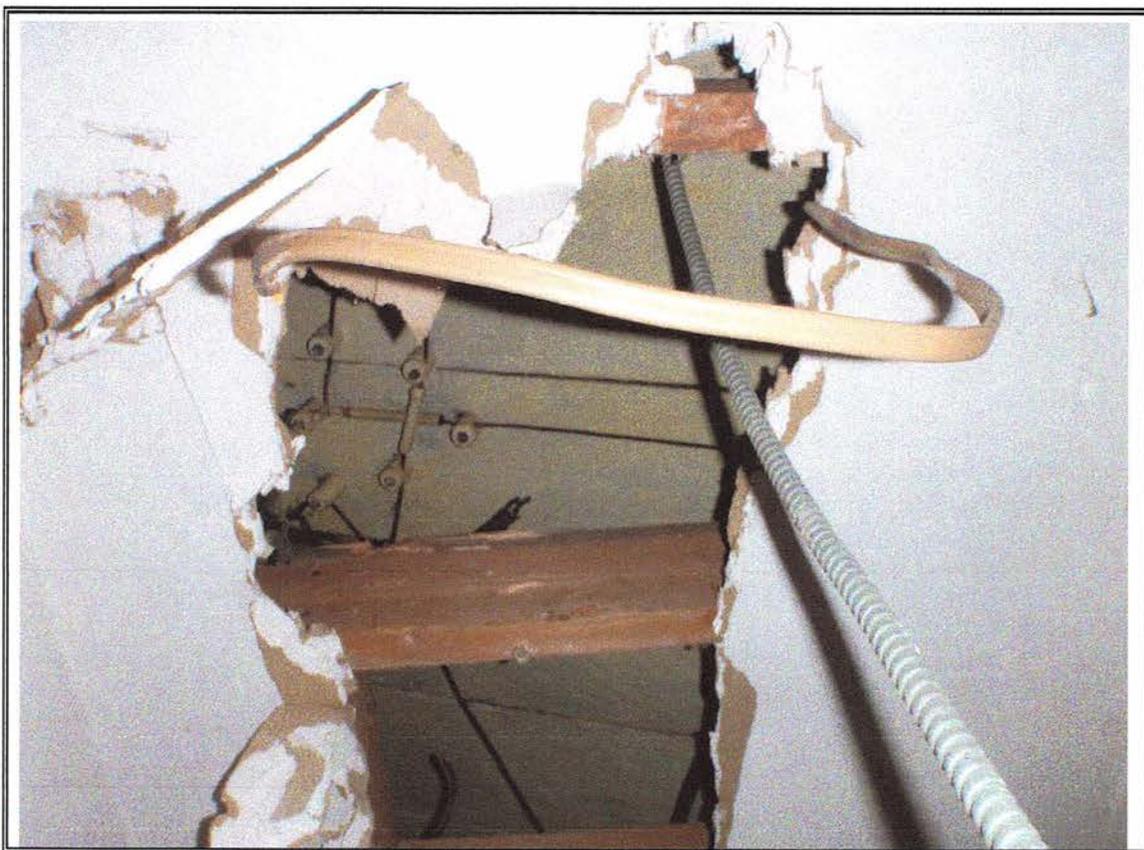
The current electrical system is a knob and tube system utilized around the turn-of-the-century. The system should remain in place, however not energized and a new system should be installed and engineered to fit the current needs of the building.

23. Knob and tube electrical wiring
