Brown House Property Condition Assessment Study

PROPERTY CONDITION ASSESSMENT

The Brown House
Baxter Road and Central Avenue
Wildomar, California 92595

Hillmann Project Number C3-6561

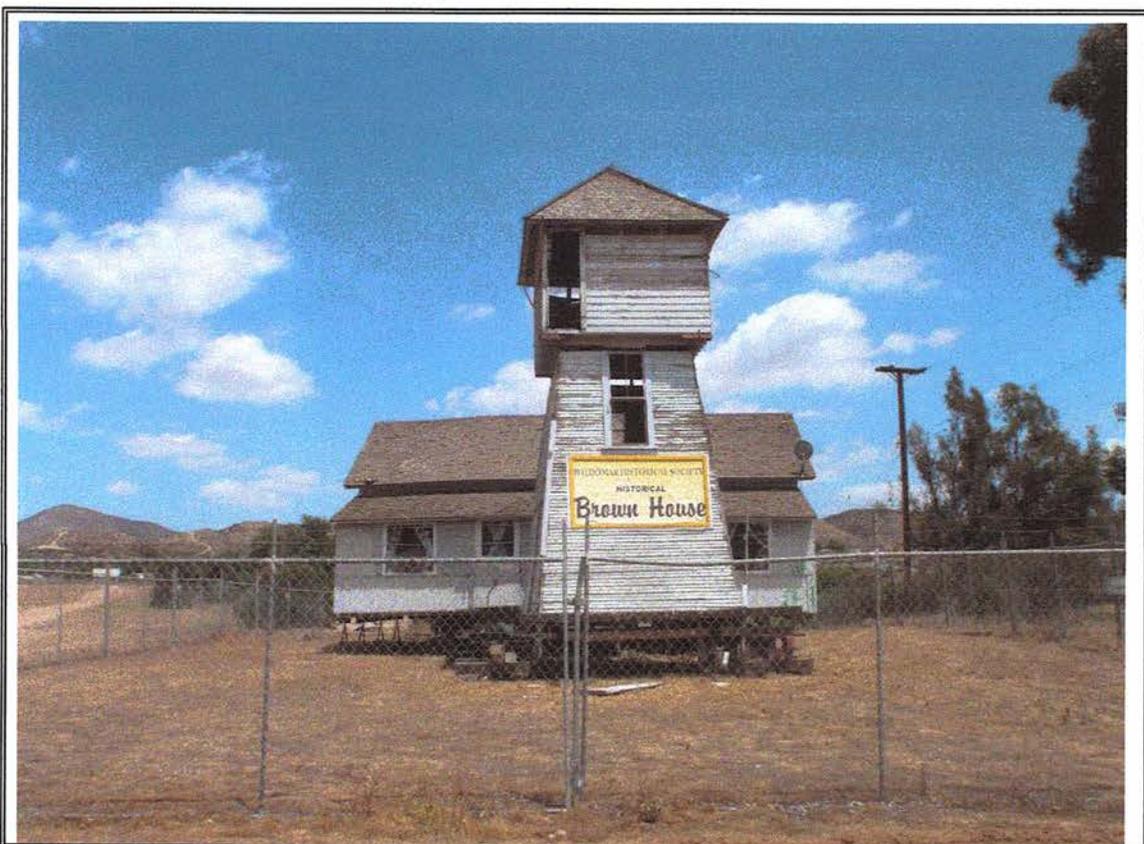
24. Western elevation of the water tower

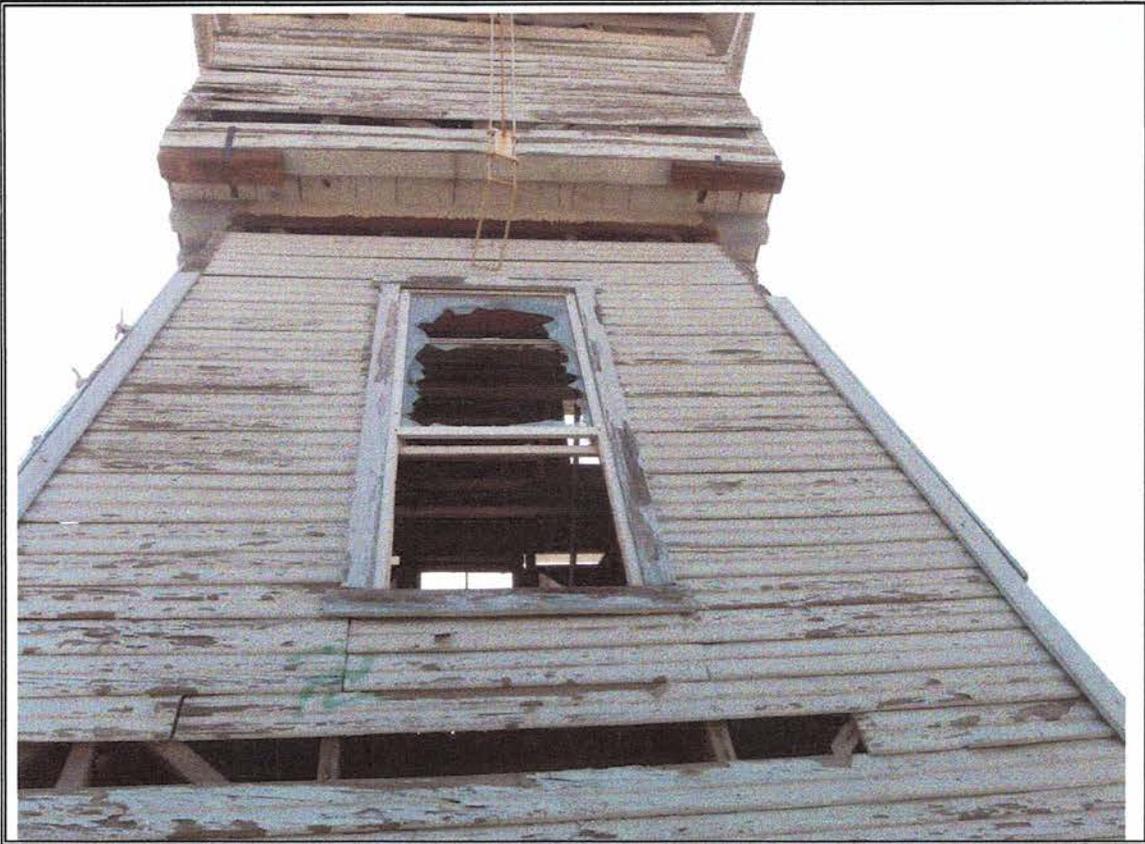
25. Water tower siding

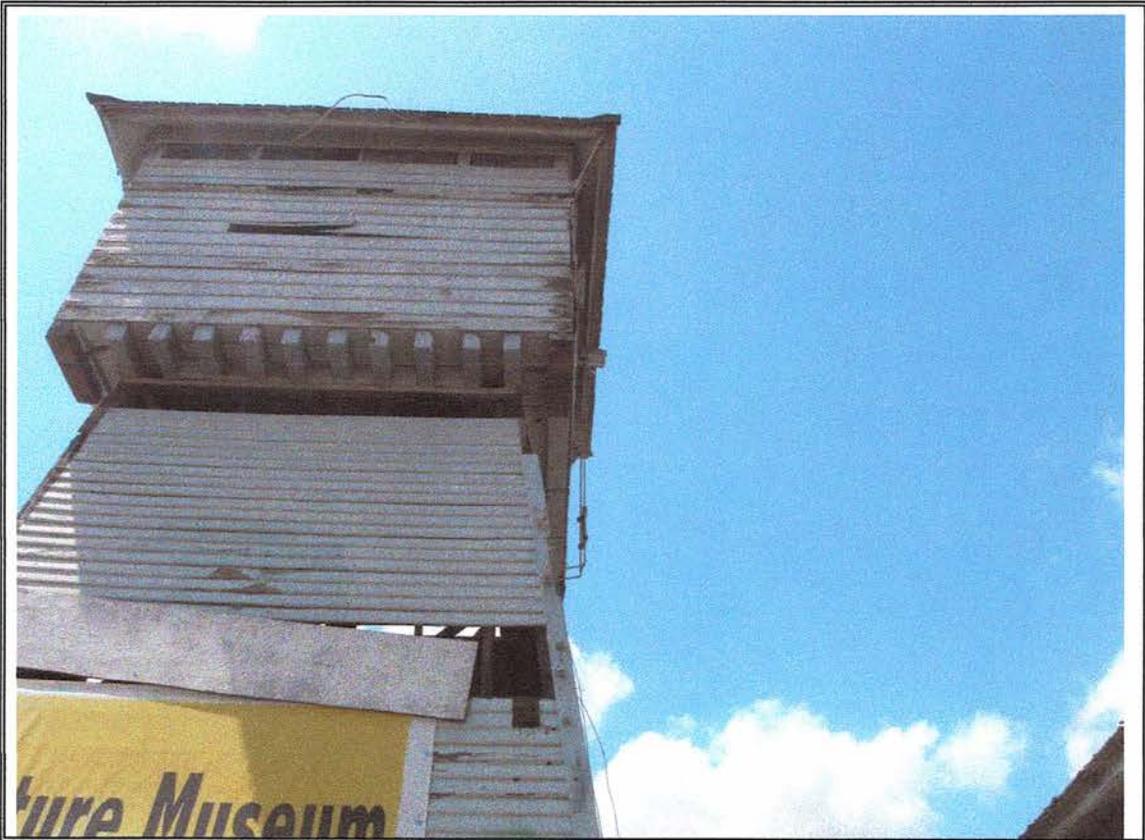
26. Water tower

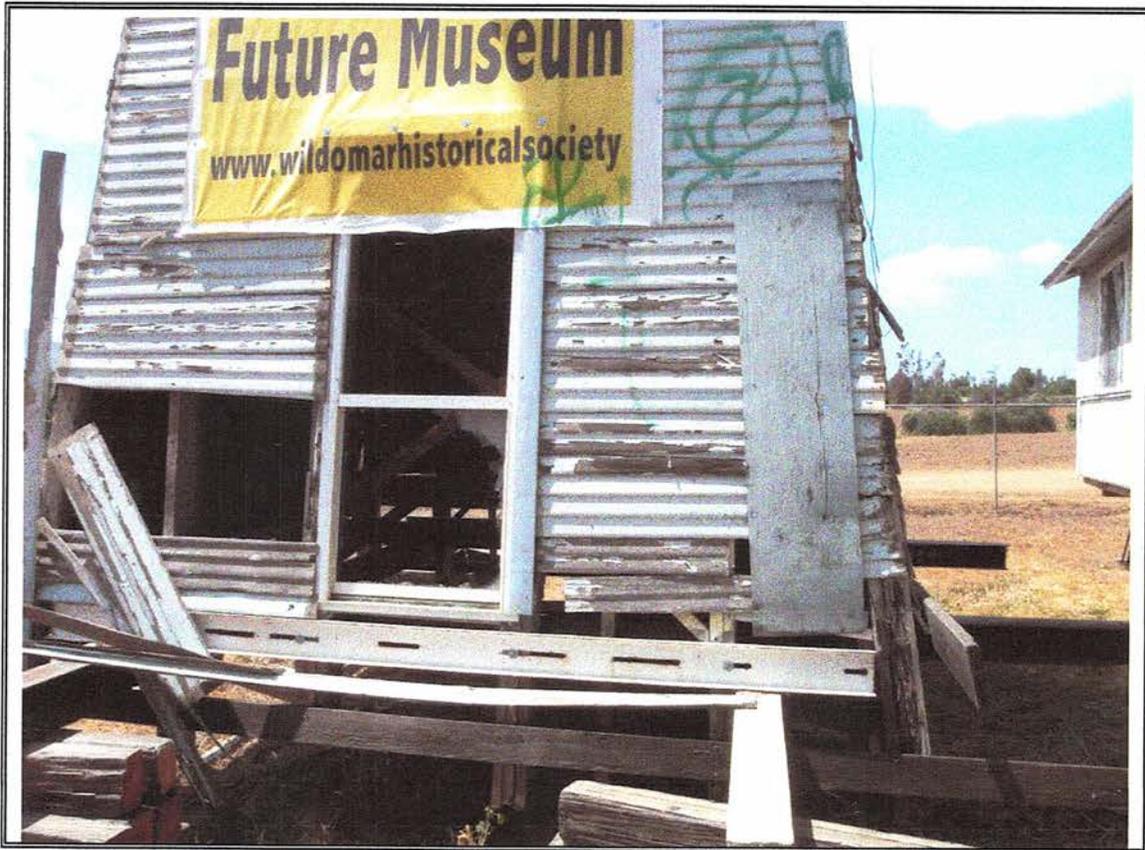
27. Water tower

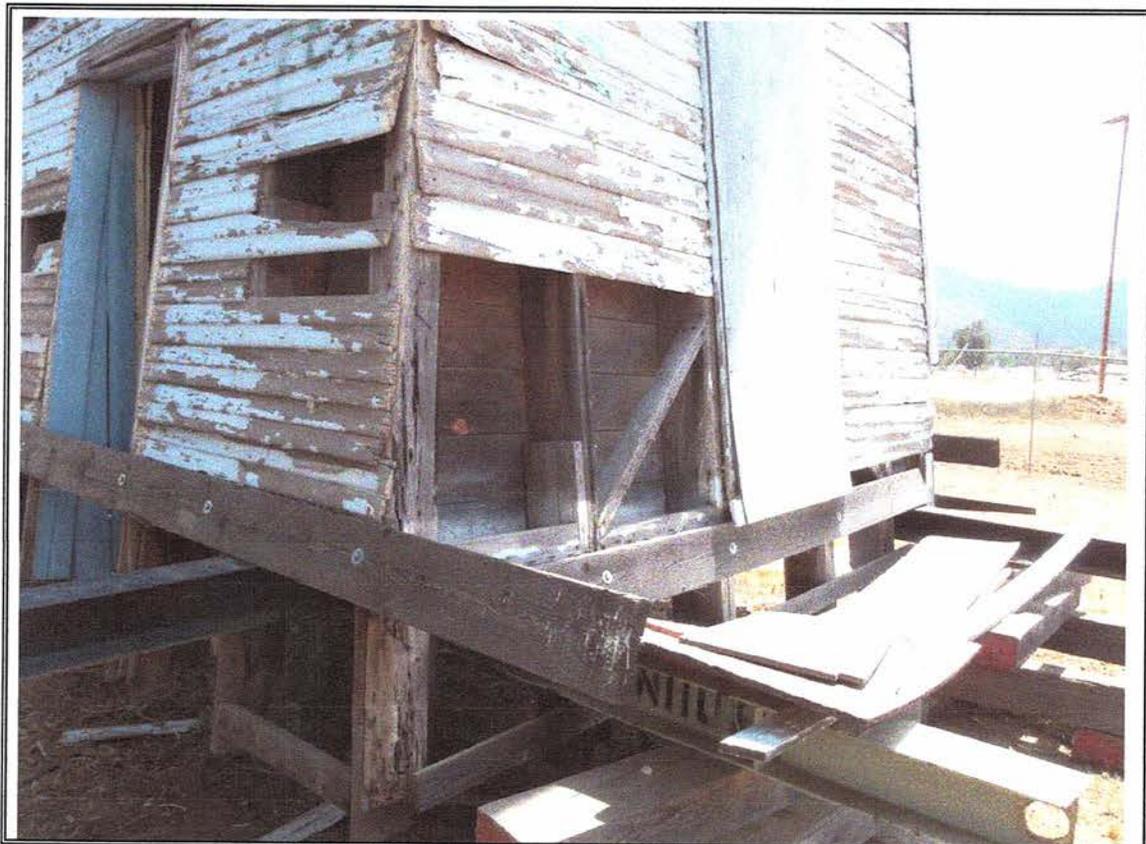
28. Water tower structural framing

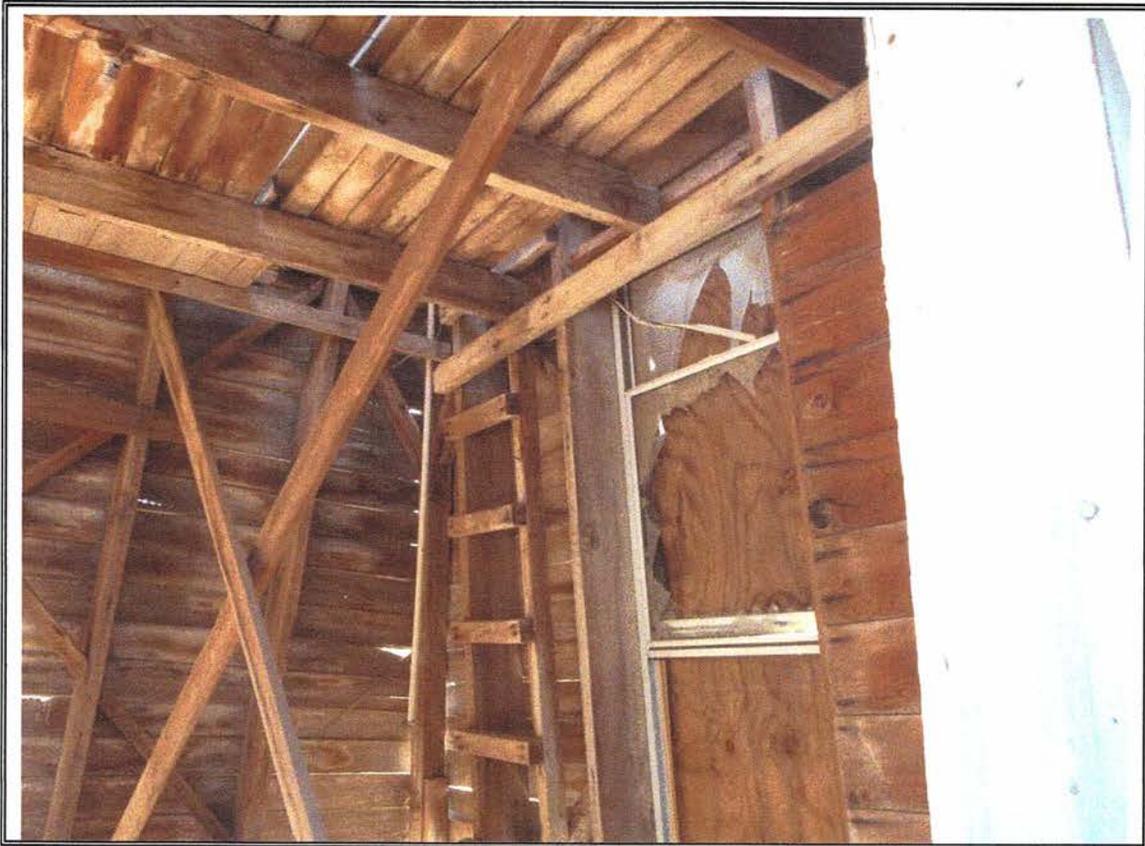
29. Water tower structural framing

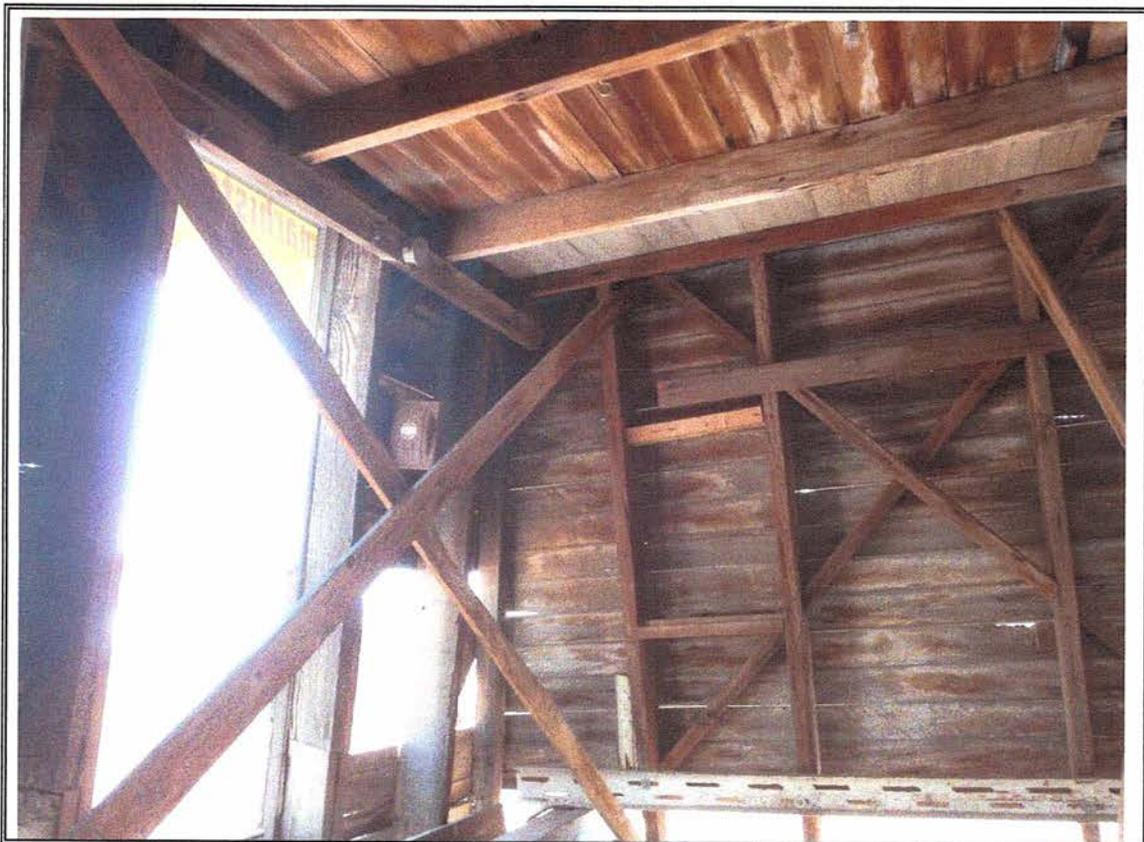
30. Water tower structural framing
