**PRELIMINARY
GEOTECHNICAL
AND FAULT RUPTURE HAZARD
INVESTIGATION**

**APN 380-250-023
NW OF PRIELIPP RD & ELIZABETH LN
WILDOMAR, CALIFORNIA**

**STRATAEQUITY GROUP, INC.
SAN DIEGO, CALIFORNIA**

**MARCH 24, 2014
PROJECT NO. T2539-22-02B**

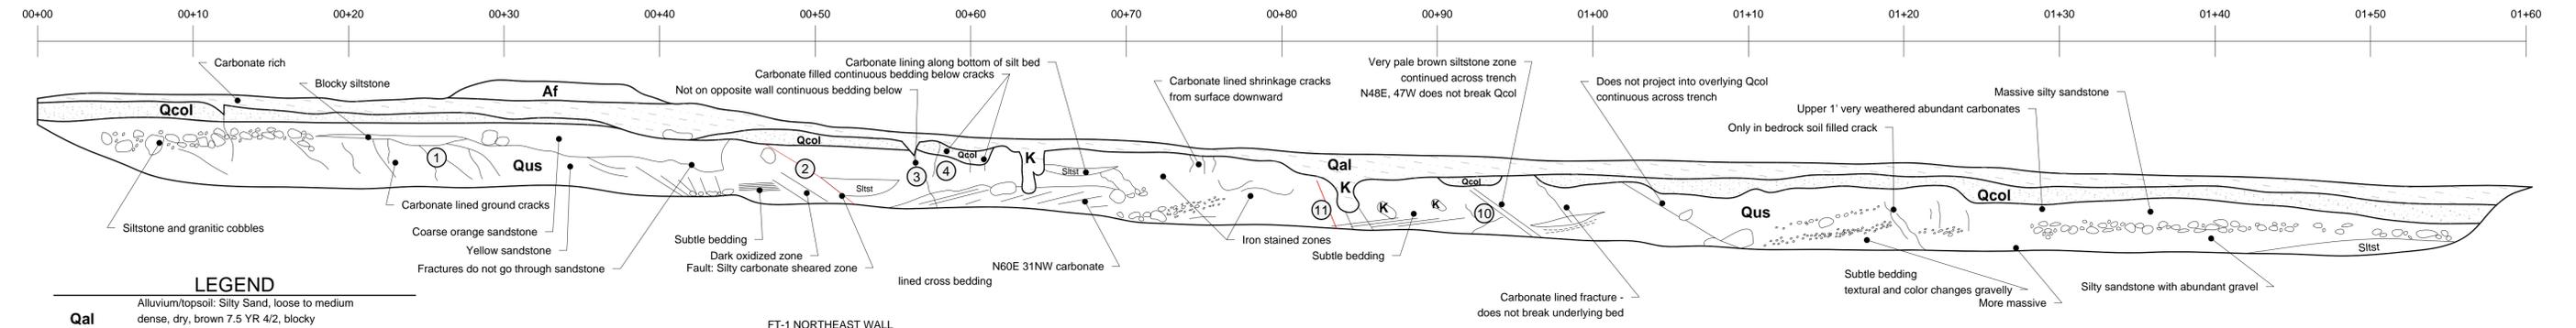
FT-1
N37°E
SOUTHWEST WALL

Based on our exploration as described above we did not observe active faulting within in either site. Older faulting was observed within the Unnamed Sandstone (very early Pleistocene approximately 1.6 million years old) on the northern site. However, no faulting was observed within the Pauba Sandstone (early Pleistocene approximately 1 million years old) on either site. We have included the fault location as dotted (buried) on the Geologic Map. We are not recommending building setback zones on either site based on this evidence.

- ① fracture: N30W, SW - continues on opposite wall discoloration along crack
- ② Fault: N75W, 28S, continuous on surface N65W across trench
- ③ fracture: N20E, 50S
- ④ fracture: N20W, 80S carbonate filled
- ⑤ through ⑧ Fault Zone: Average N63W, 33SW
- ⑨ fracture: N68E, 80S, fracture/ground crack
- ⑩ fracture: N20E, 26W ground crack
- ⑪ Fault: EW, S continues across trench does not disrupt underlying bedding

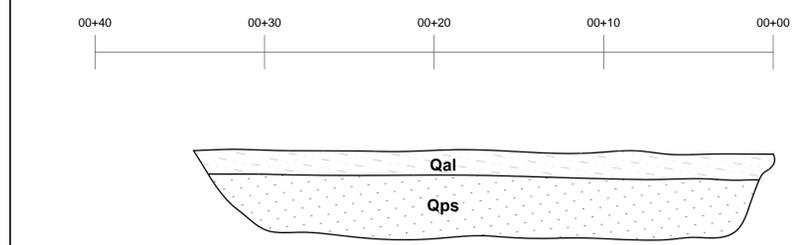
FT-2
N20°E
NORTHWEST WALL

The site is not within a currently established Alquist-Priolo Earthquake Fault Zone for surface fault rupture hazards. However, Riverside County depicts a mapped fault trending northwest across APN 380-250-023. The mapped fault is based on Kennedy and Morton's mapping. The fault is mapped trending approximately N32W near the center of the site, see Figure 2. A fault rupture hazard investigation was performed by LGC on an adjacent property located between the APNs 380-250-003 and 380-250-023; however, the report was inconclusive with respect to the location and activity of the faulting. As a result, Geocon performed a fault hazard investigation by excavating trenches approximately perpendicular to the mapped fault trace within APN 380-250-003 (FT-1 and FT-2) and APN 380-250-023 (FT-3). We did encounter faulting within the Unnamed sandstone (FT-1) however, we did not observe evidence of faulting within the Pauba Sandstone (FT-2 and FT-3). Therefore, the faulting likely occurred prior to the

deposition of the Pauba Sandstone and the potential for surface rupture due to faulting occurring beneath the site during the design life of the proposed development is considered low. A detailed discussion of the subsurface fault hazard investigation is provided in Appendix C.
