GEOLOGICAL FAULT HAZARD INVESTIGATION,
PROPOSED ±5-ACRE PARCEL, APN 362-250-003, WILDOMAR,
RIVERSIDE COUNTY, CALIFORNIA

September 19, 2005

Project No. 601027-002

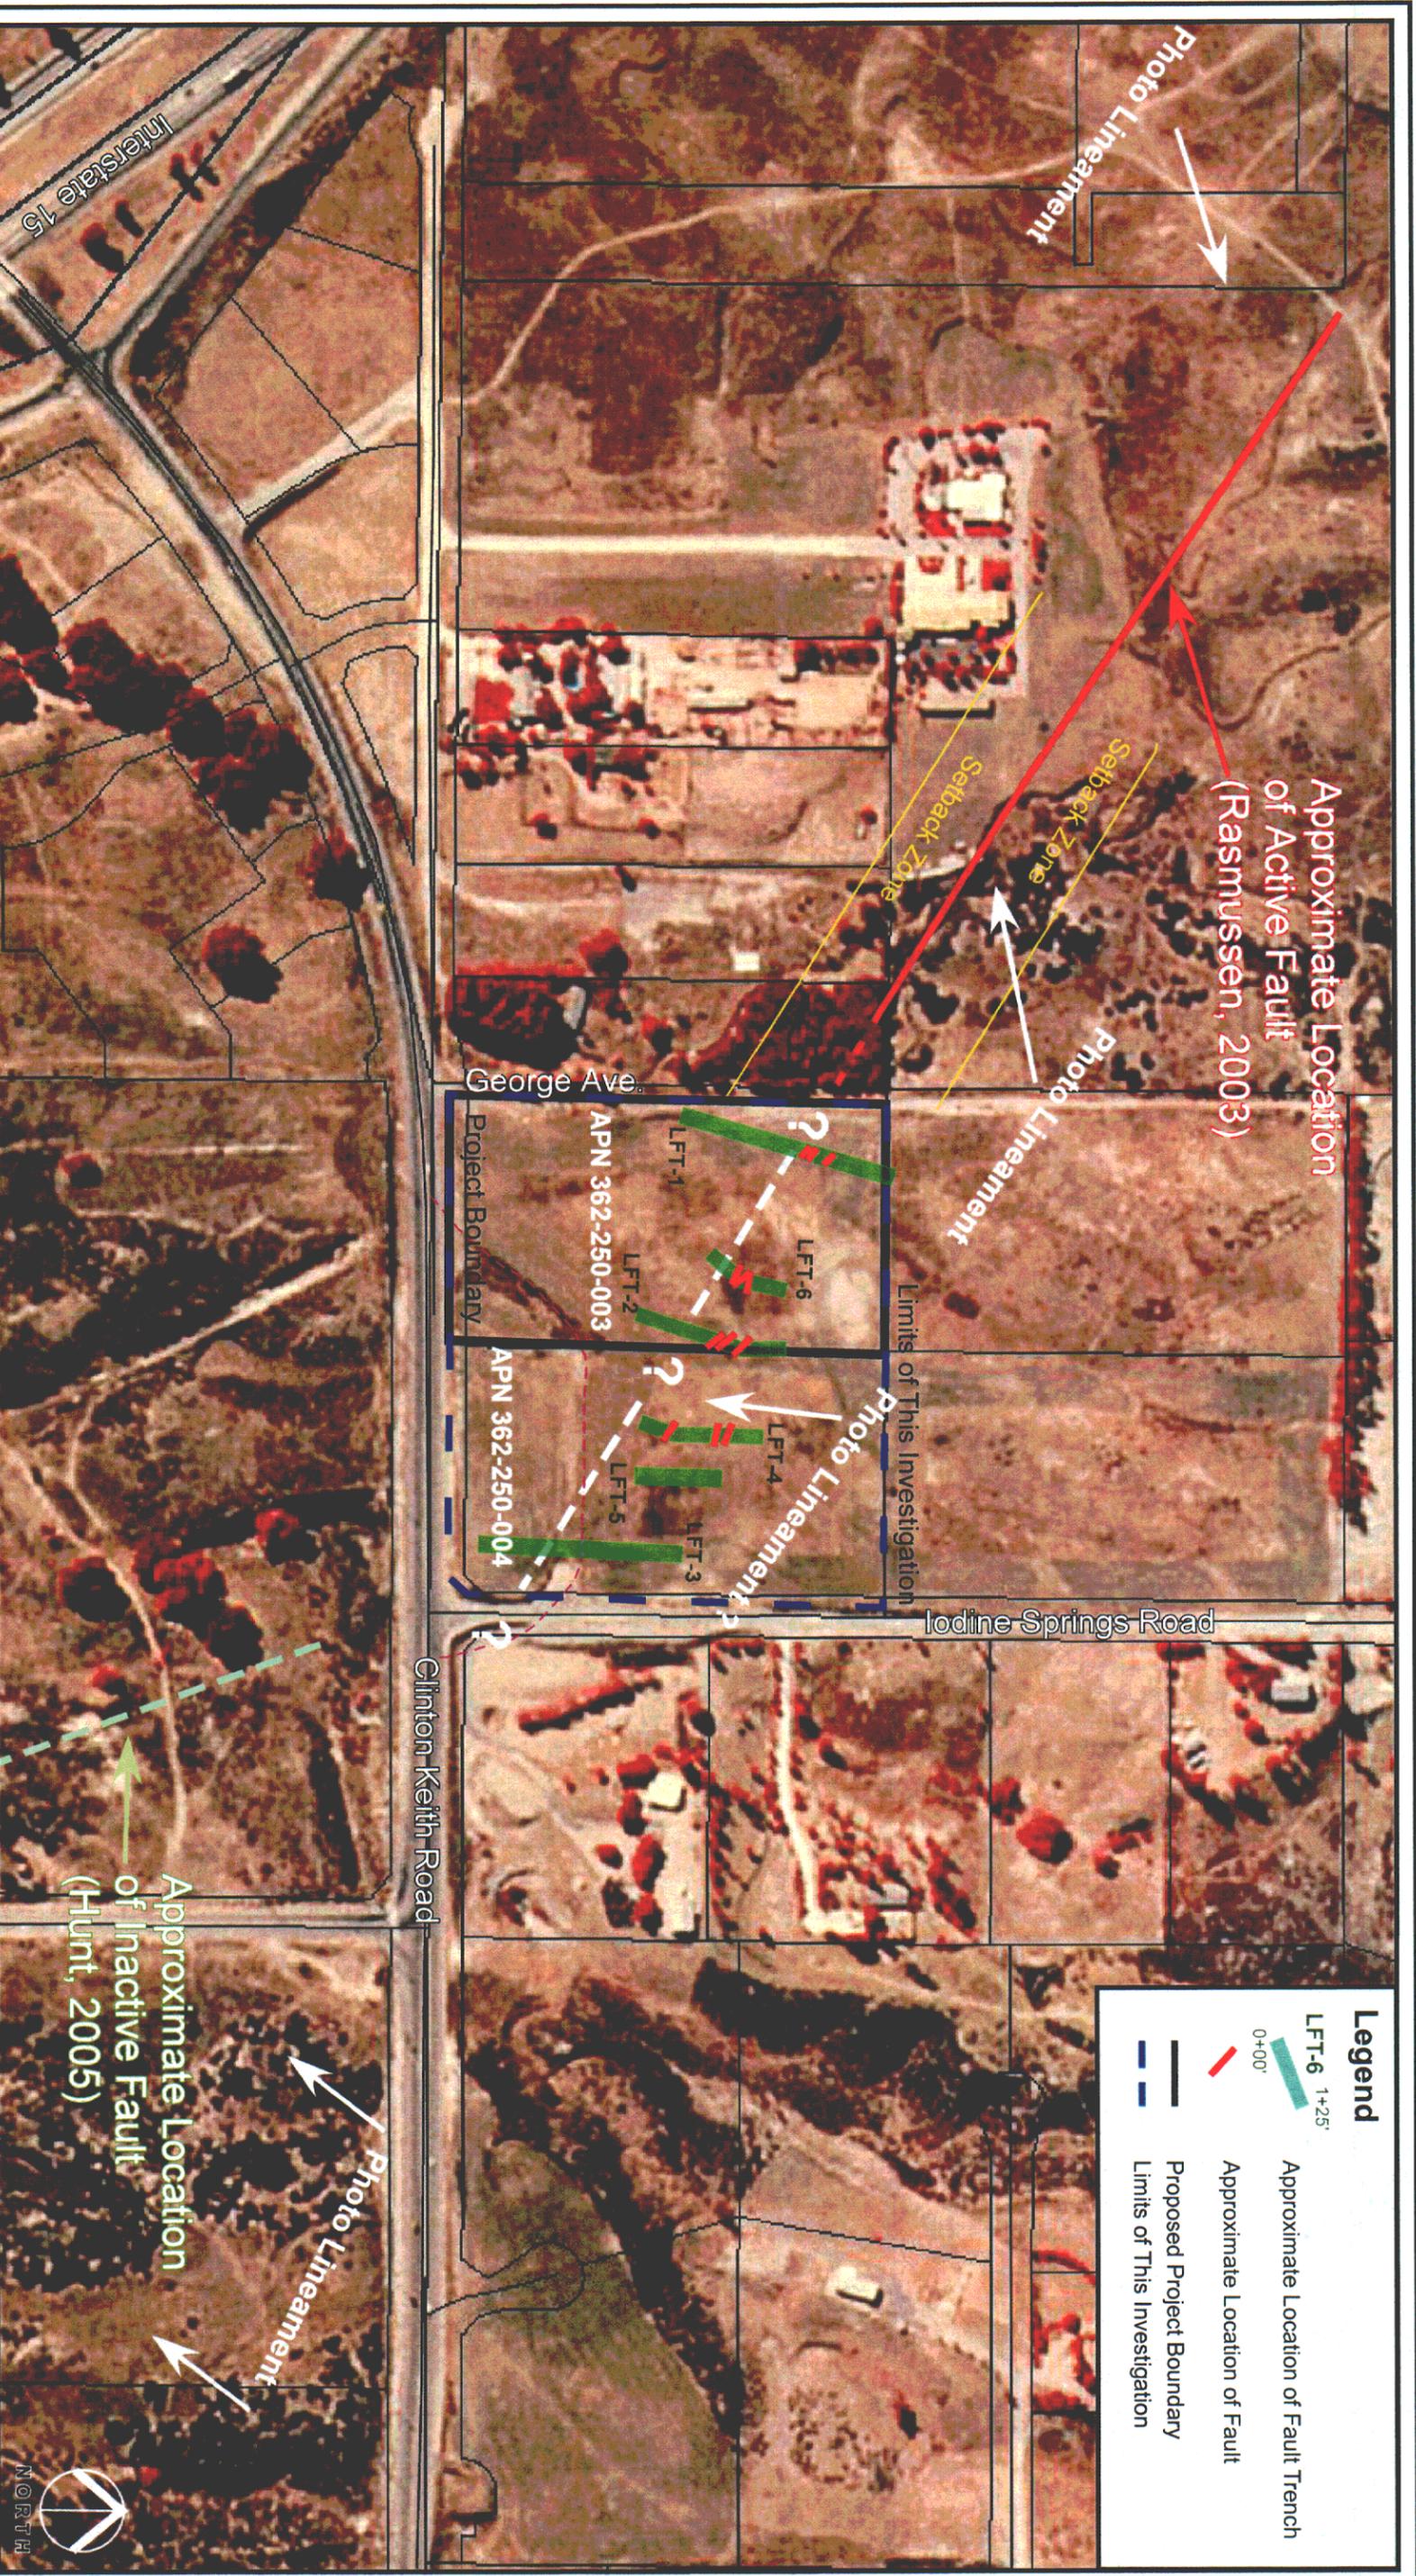
Figure No. 2

Additional northwest-trending lineaments and associated potential faults were investigated to the immediate south of the subject site (Hunt, 2005). The faults exposed during that investigation were reported as “bedrock” faults of pre-Holocene age and therefore considered inactive. A suspect fault trace southeast of the site was documented as inactive based on soil chrono-stratigraphic relationships (Hunt, 2005). For reference, that fault trace is depicted on Figure 2- *Fault Trench Location Map*.

The locations of the surface projection and limits of onsite active faults exposed in our trenches have been staked in the field and are shown on the accompanying Figure 2 - *Fault Location Map*. The fault locations should be surveyed by the project civil engineer and a 25 to 50 foot structural setback zone as indicated on the fault zone map should be established beyond the southern side of fault zone. A 50-foot wide structural setback zone as indicated on our map should be established beyond the northern side of fault zone. This fault setback zone is recommended for structures intended for human occupancy of 2000 hours/year or more. The limits of the recommended structural setbacks included in this report are for planing purposes only and do not take into account possible future grading design configurations. Leighton Consulting should review grading design plans prior to their finalization and site development.

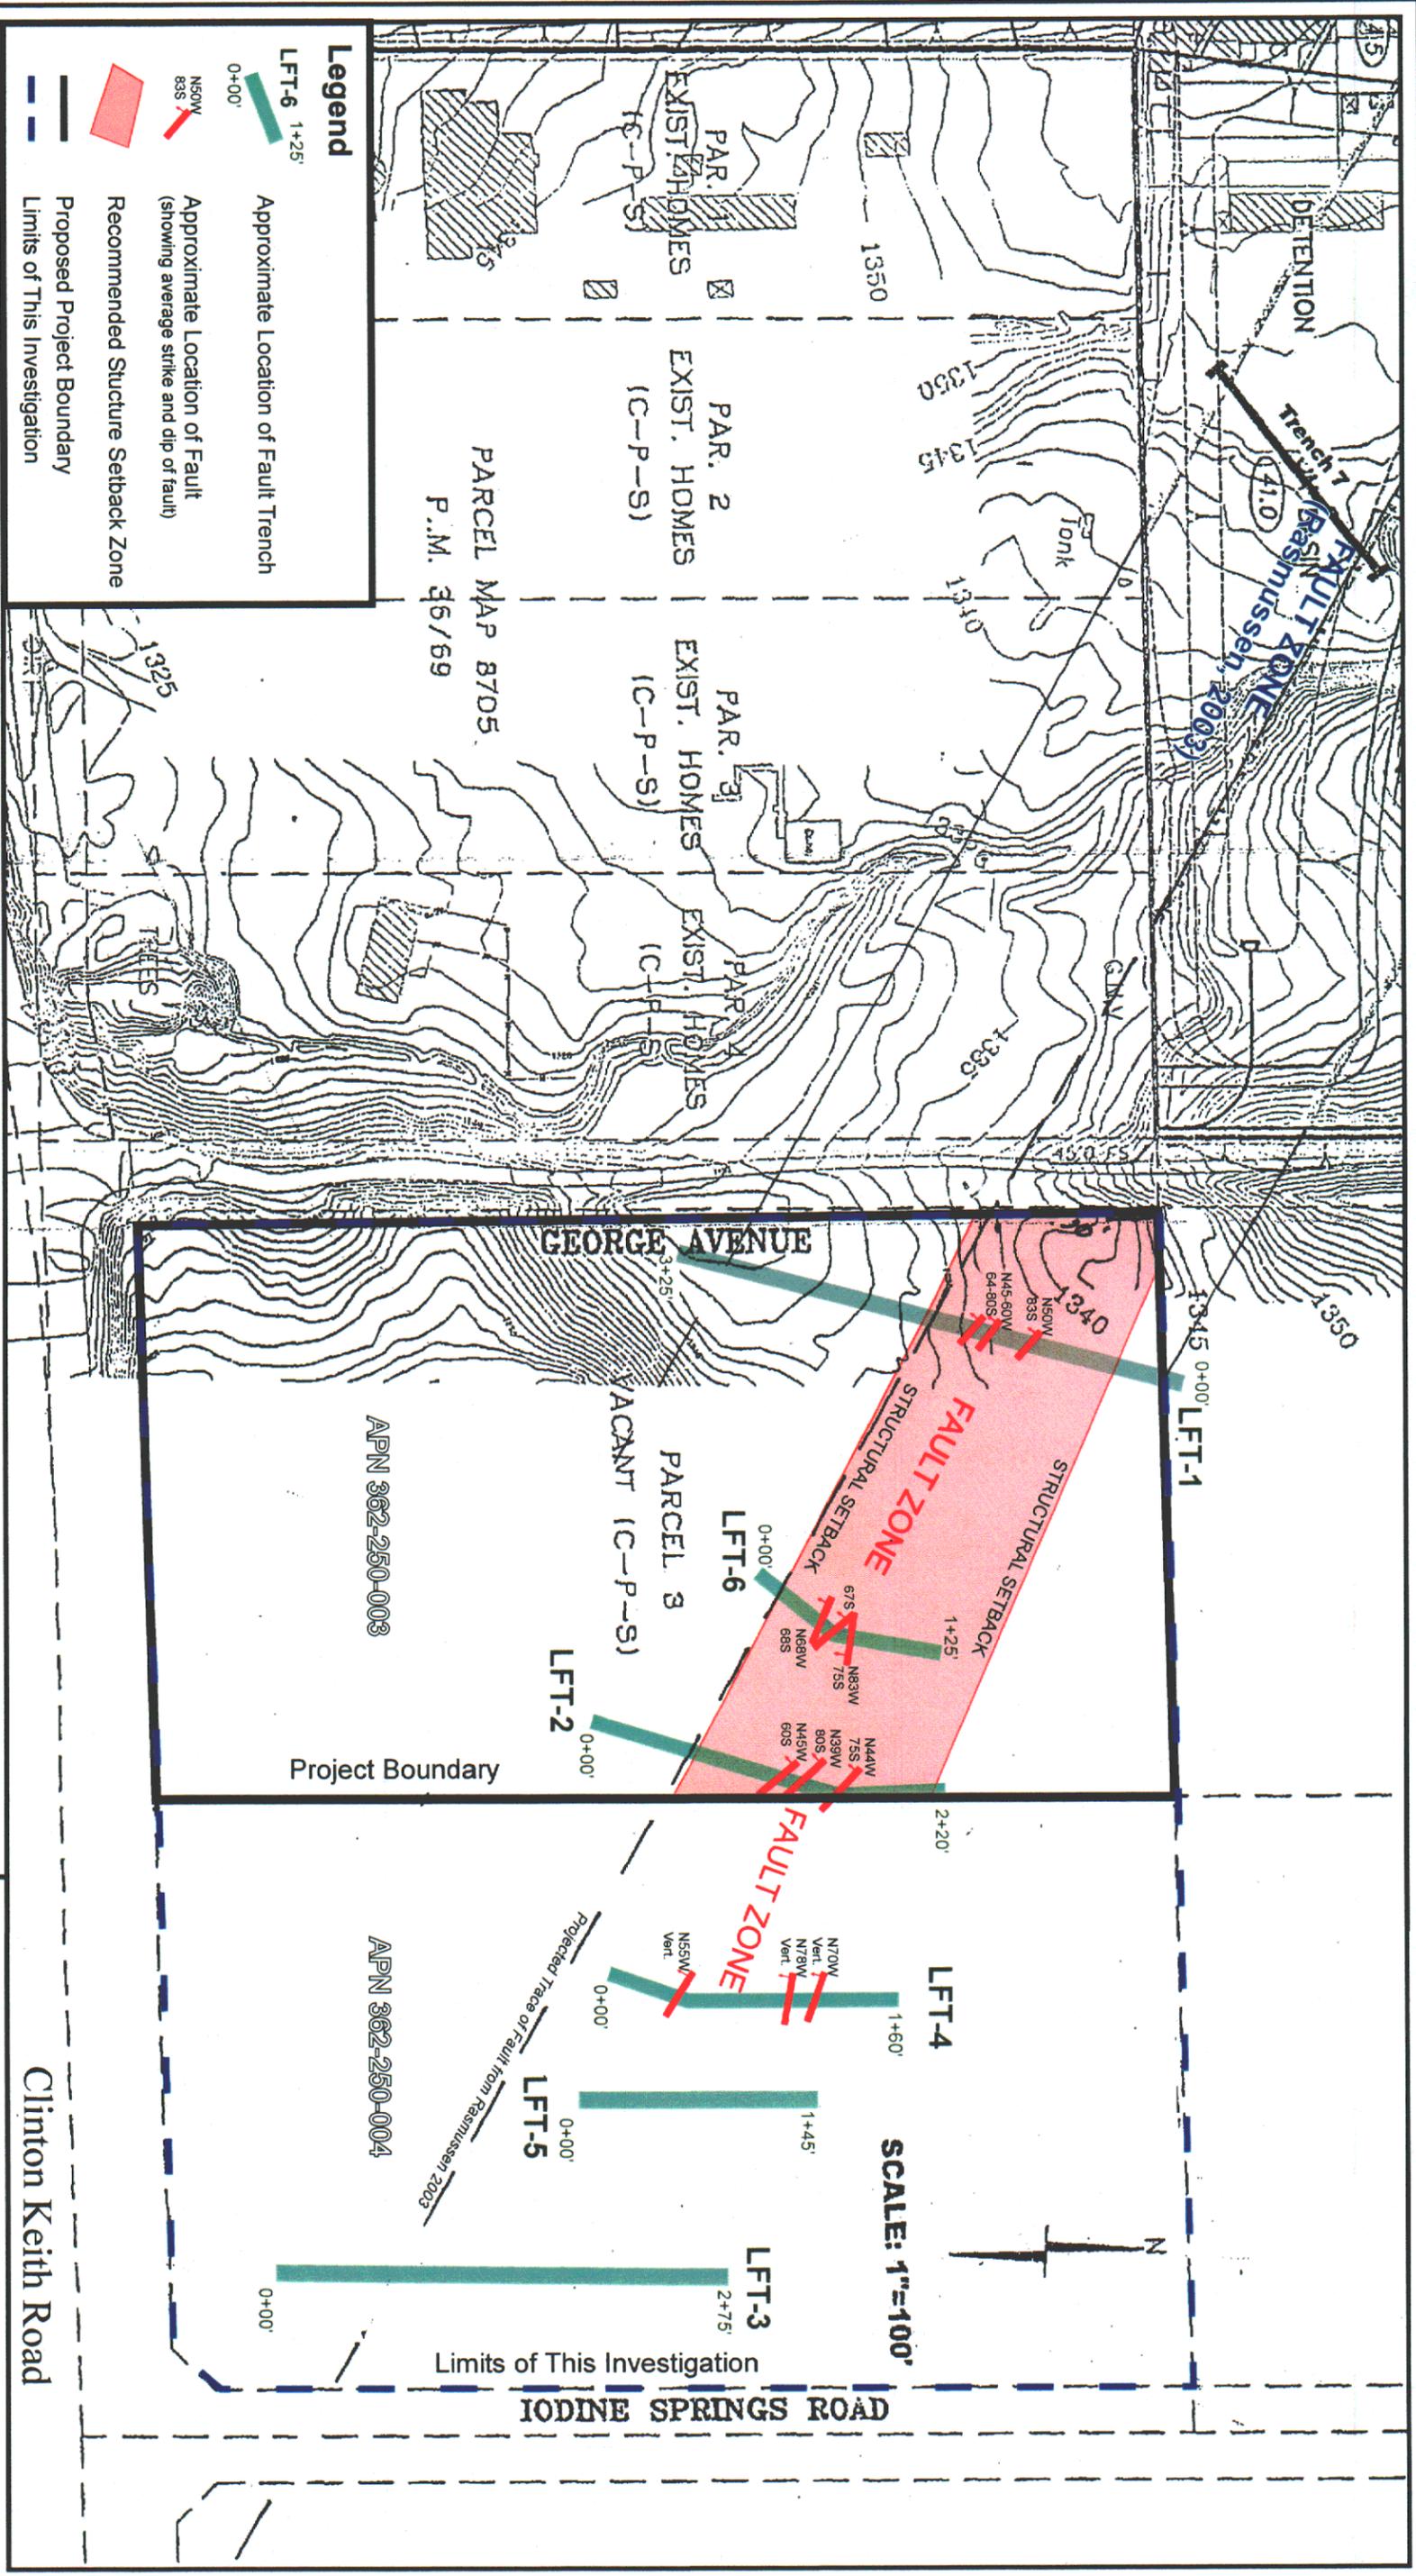
FAULT LOCATION MAP

- Specific structural (restricted use) setback provisions have been prepared. The limits of the recommended structural setback are presented on the accompanying Fault Location Map (Figure 3). Structures intended for human occupancy should **not** be located within the structural setback zone. California Code of Regulations, Section 3601 states, "A structure for human occupancy is any structure used or intended for supporting or sheltering any use of occupancy, which is expected to have a human occupancy rate of more than 2,000 person-hours per year" (CDMG, 1997).

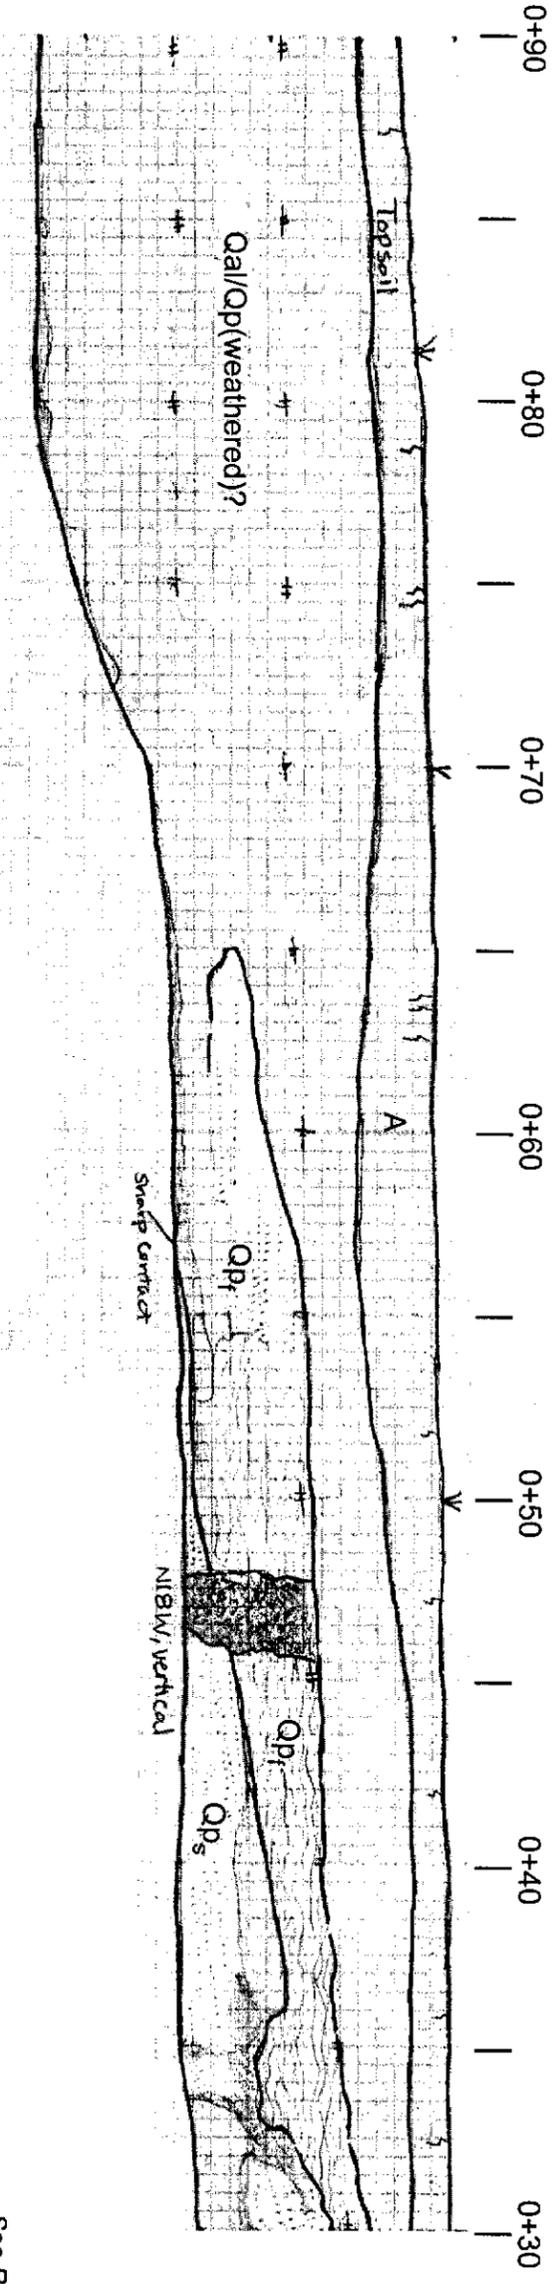
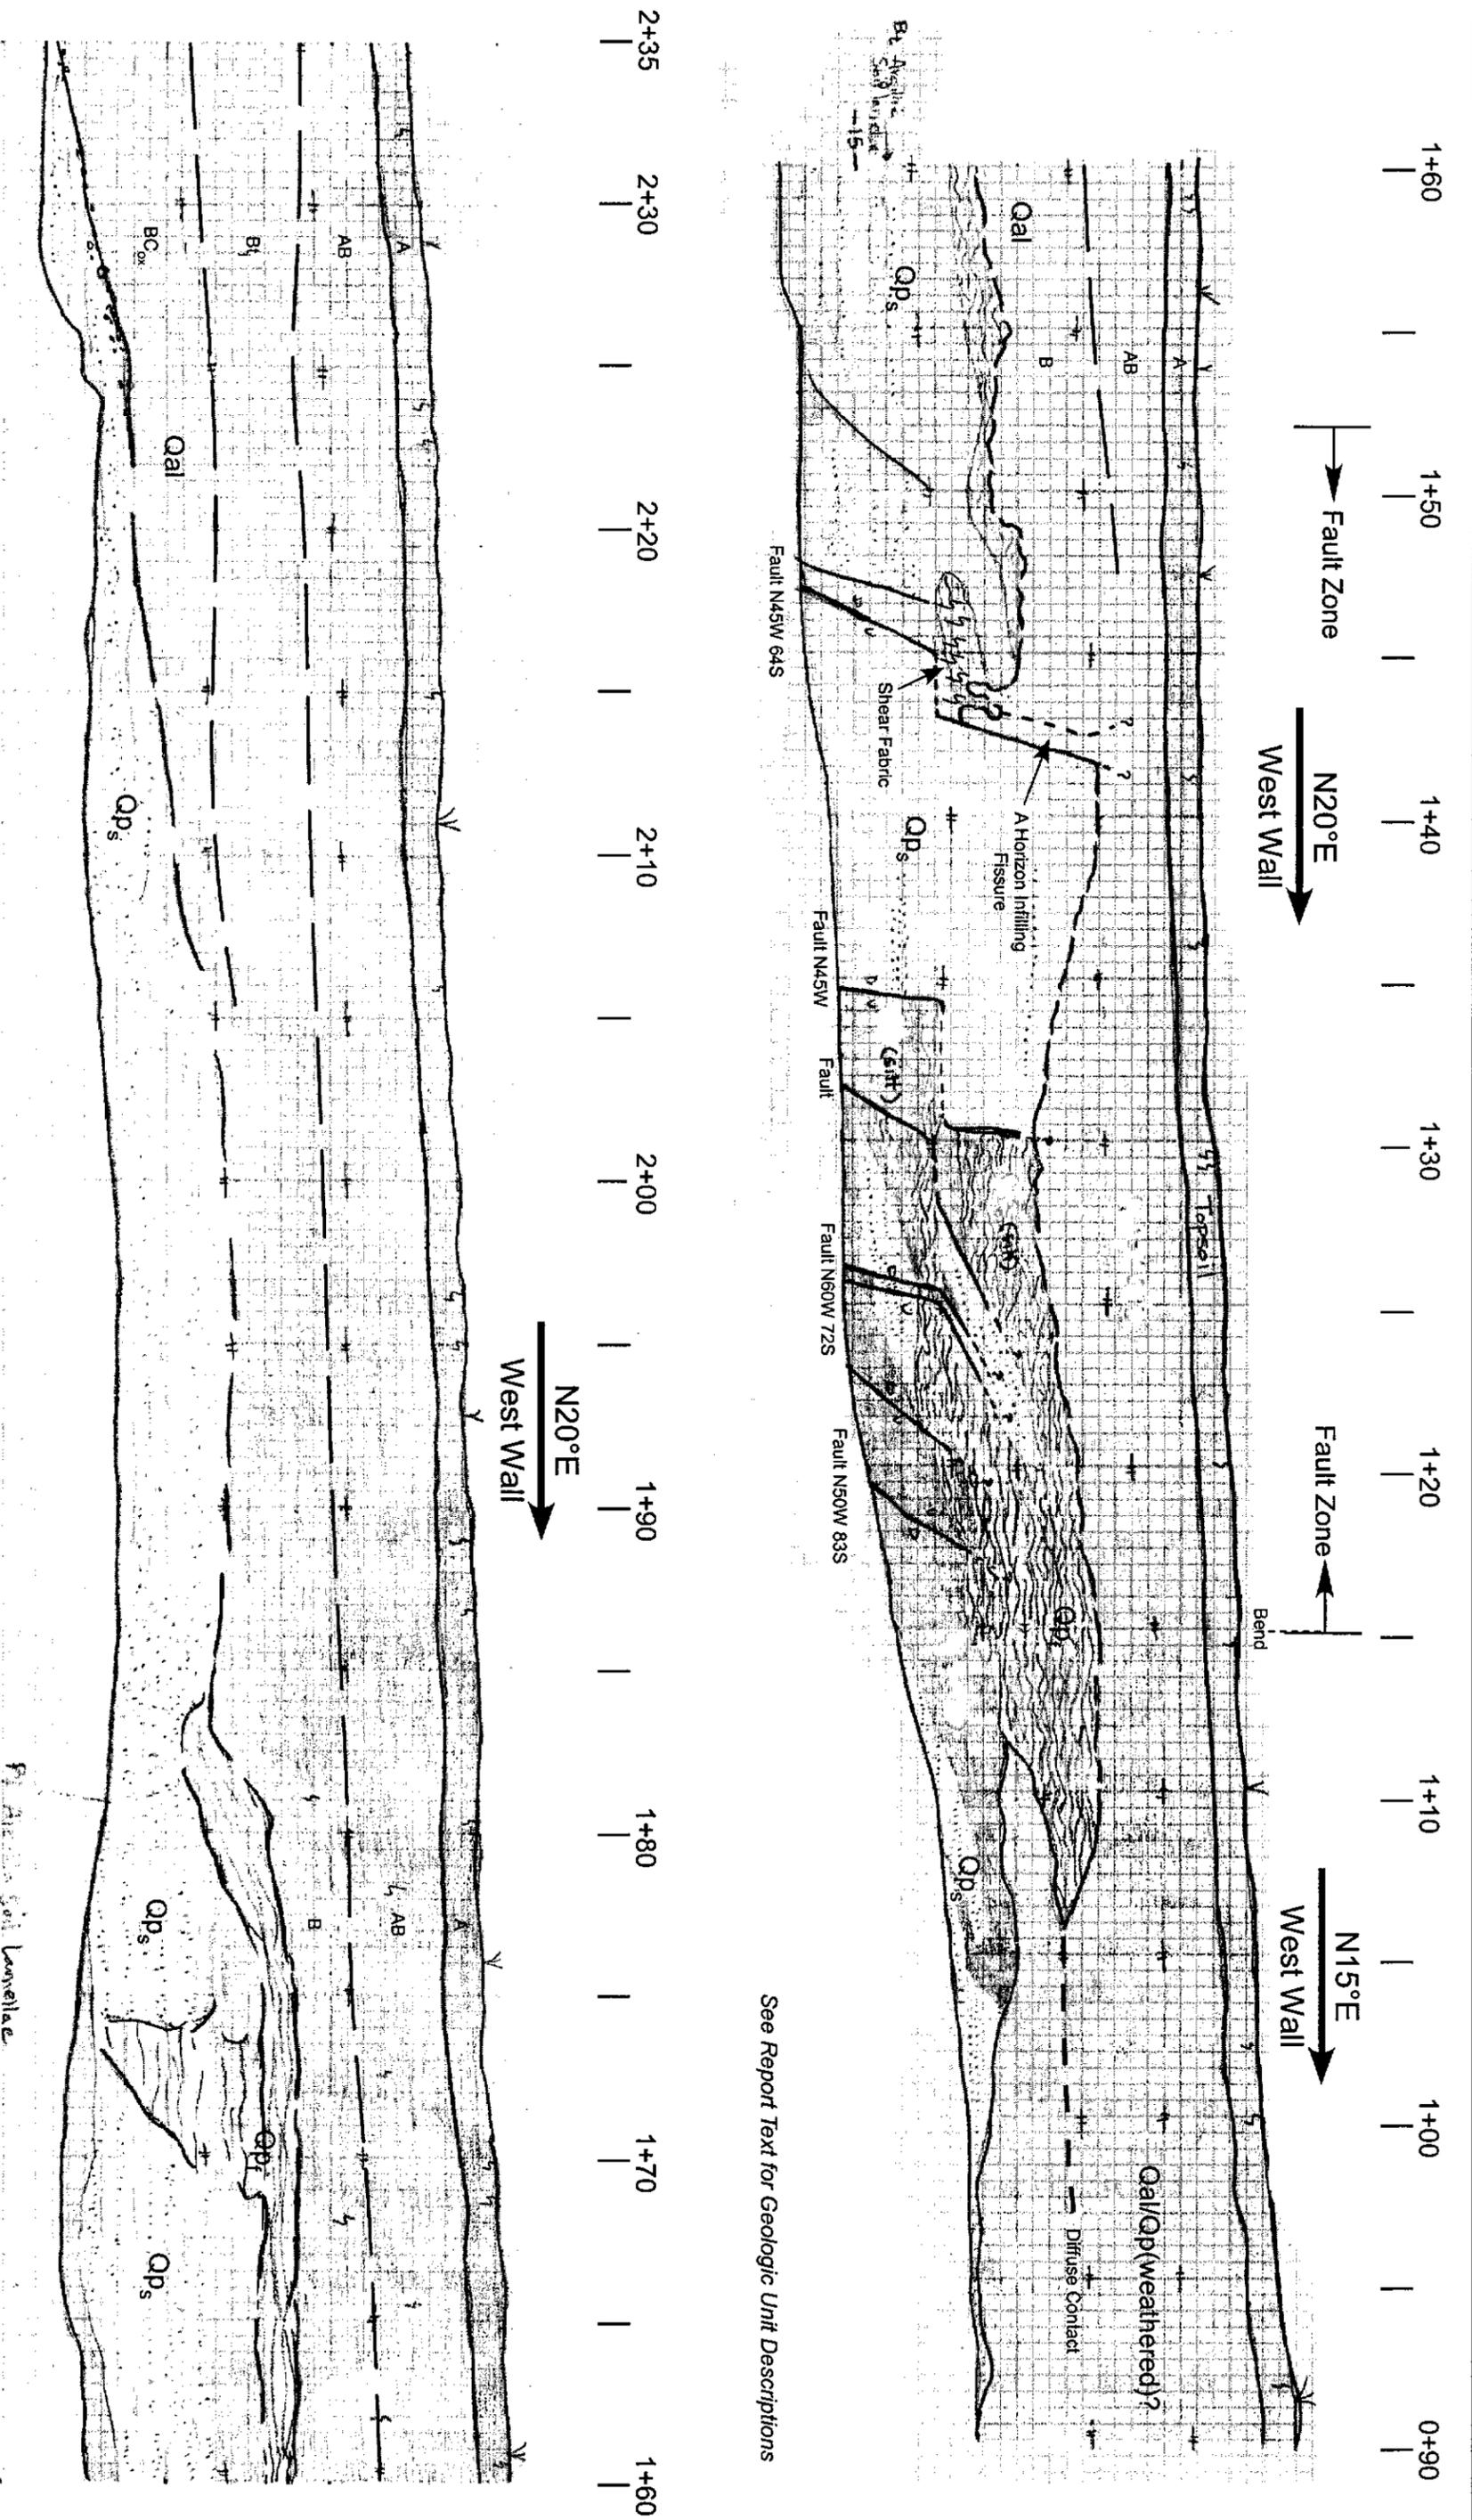
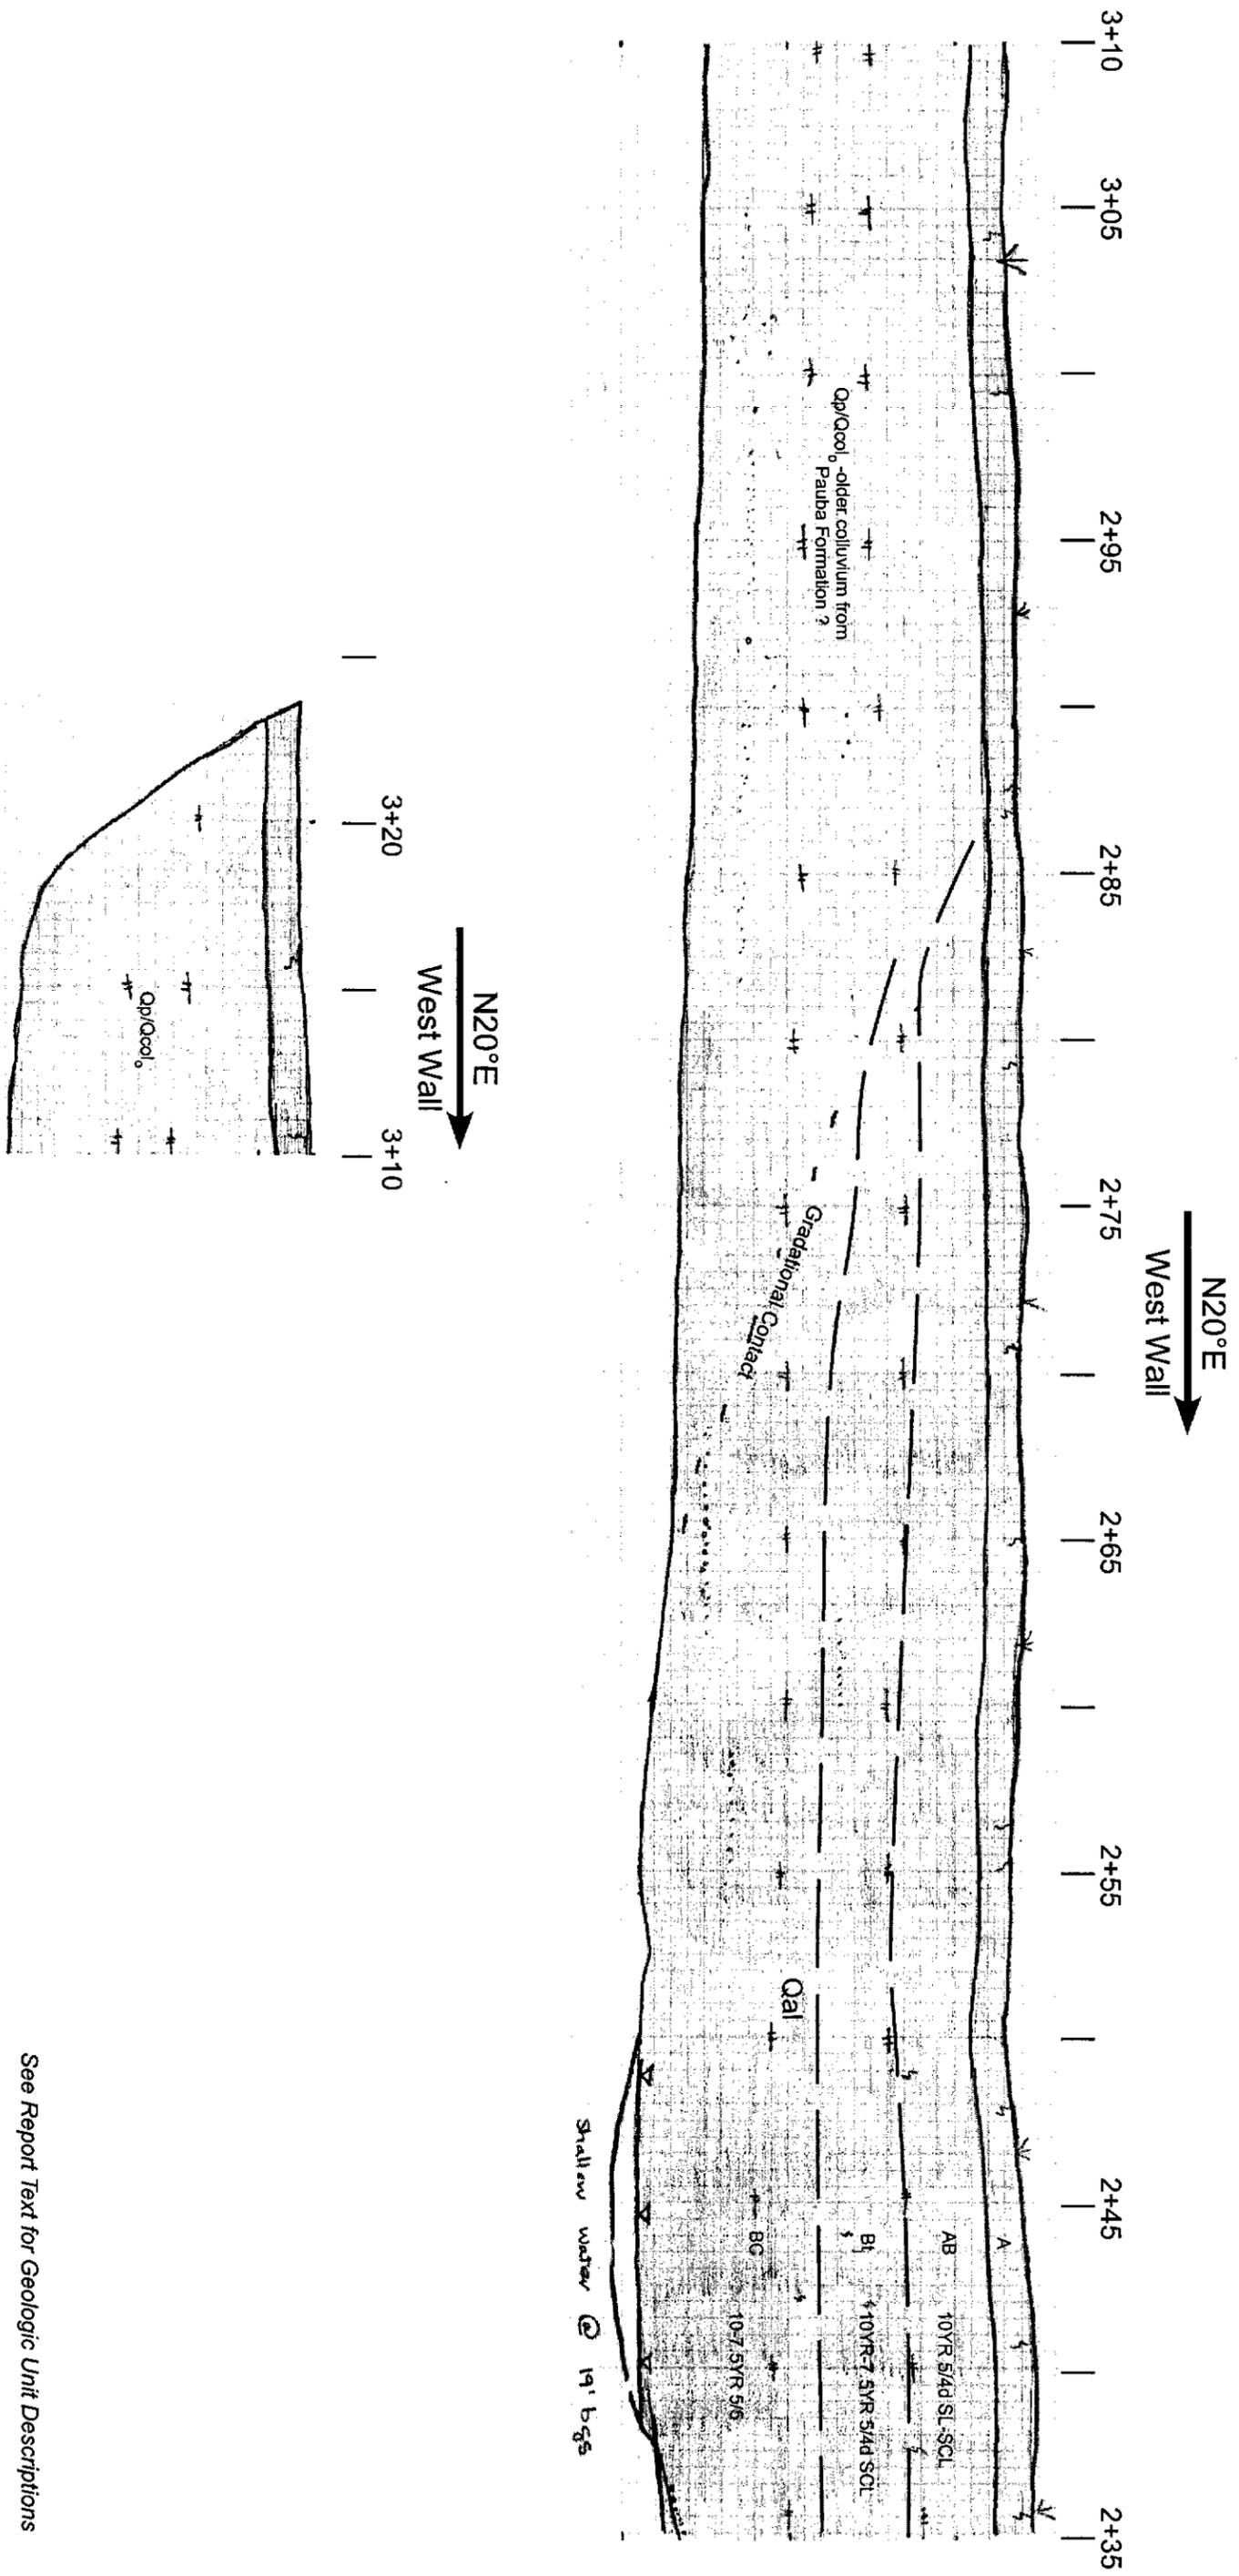
FAULT TRENCH LOG LFT-1
Assessor Parcel Numbers 362-250-003 & 362-250-004
 Wildomar, California

Fault Trench 1 (Map Symbol LFT-1) - Fault Trench 1 was excavated to a maximum depth of 14 feet below ground surface (bgs), and a length of approximately 325 feet. FT-1 was located in the northwestern portion of the property across the width of the projected fault zone and recommended setbacks that were identified in the report for the adjacent site by Rasmussen (2003). Evidence of past seismic activity was readily apparent as an approximately 40-foot wide zone of offset deposits, associated shears, and in-filled fractures within the Pauba Formation, Quaternary alluvium, and near-surface soils. The location of the faults generally coincides with the southeastern projection of the fault zone from the previous investigation to the northwest. The orientation and character of faulting at this location is best described as a series of en echelon northwest-striking (N30-60°W), steeply southwest dipping fault planes and discrete shear zones that displace the bedrock and overlying alluvium downward to the southwest. Total offsets of deposits were indeterminate given the limits of the trenching for this investigation, however, maximum down-dip separation of bedrock units observed within the trench were on the order of 2.5 to 6 feet.

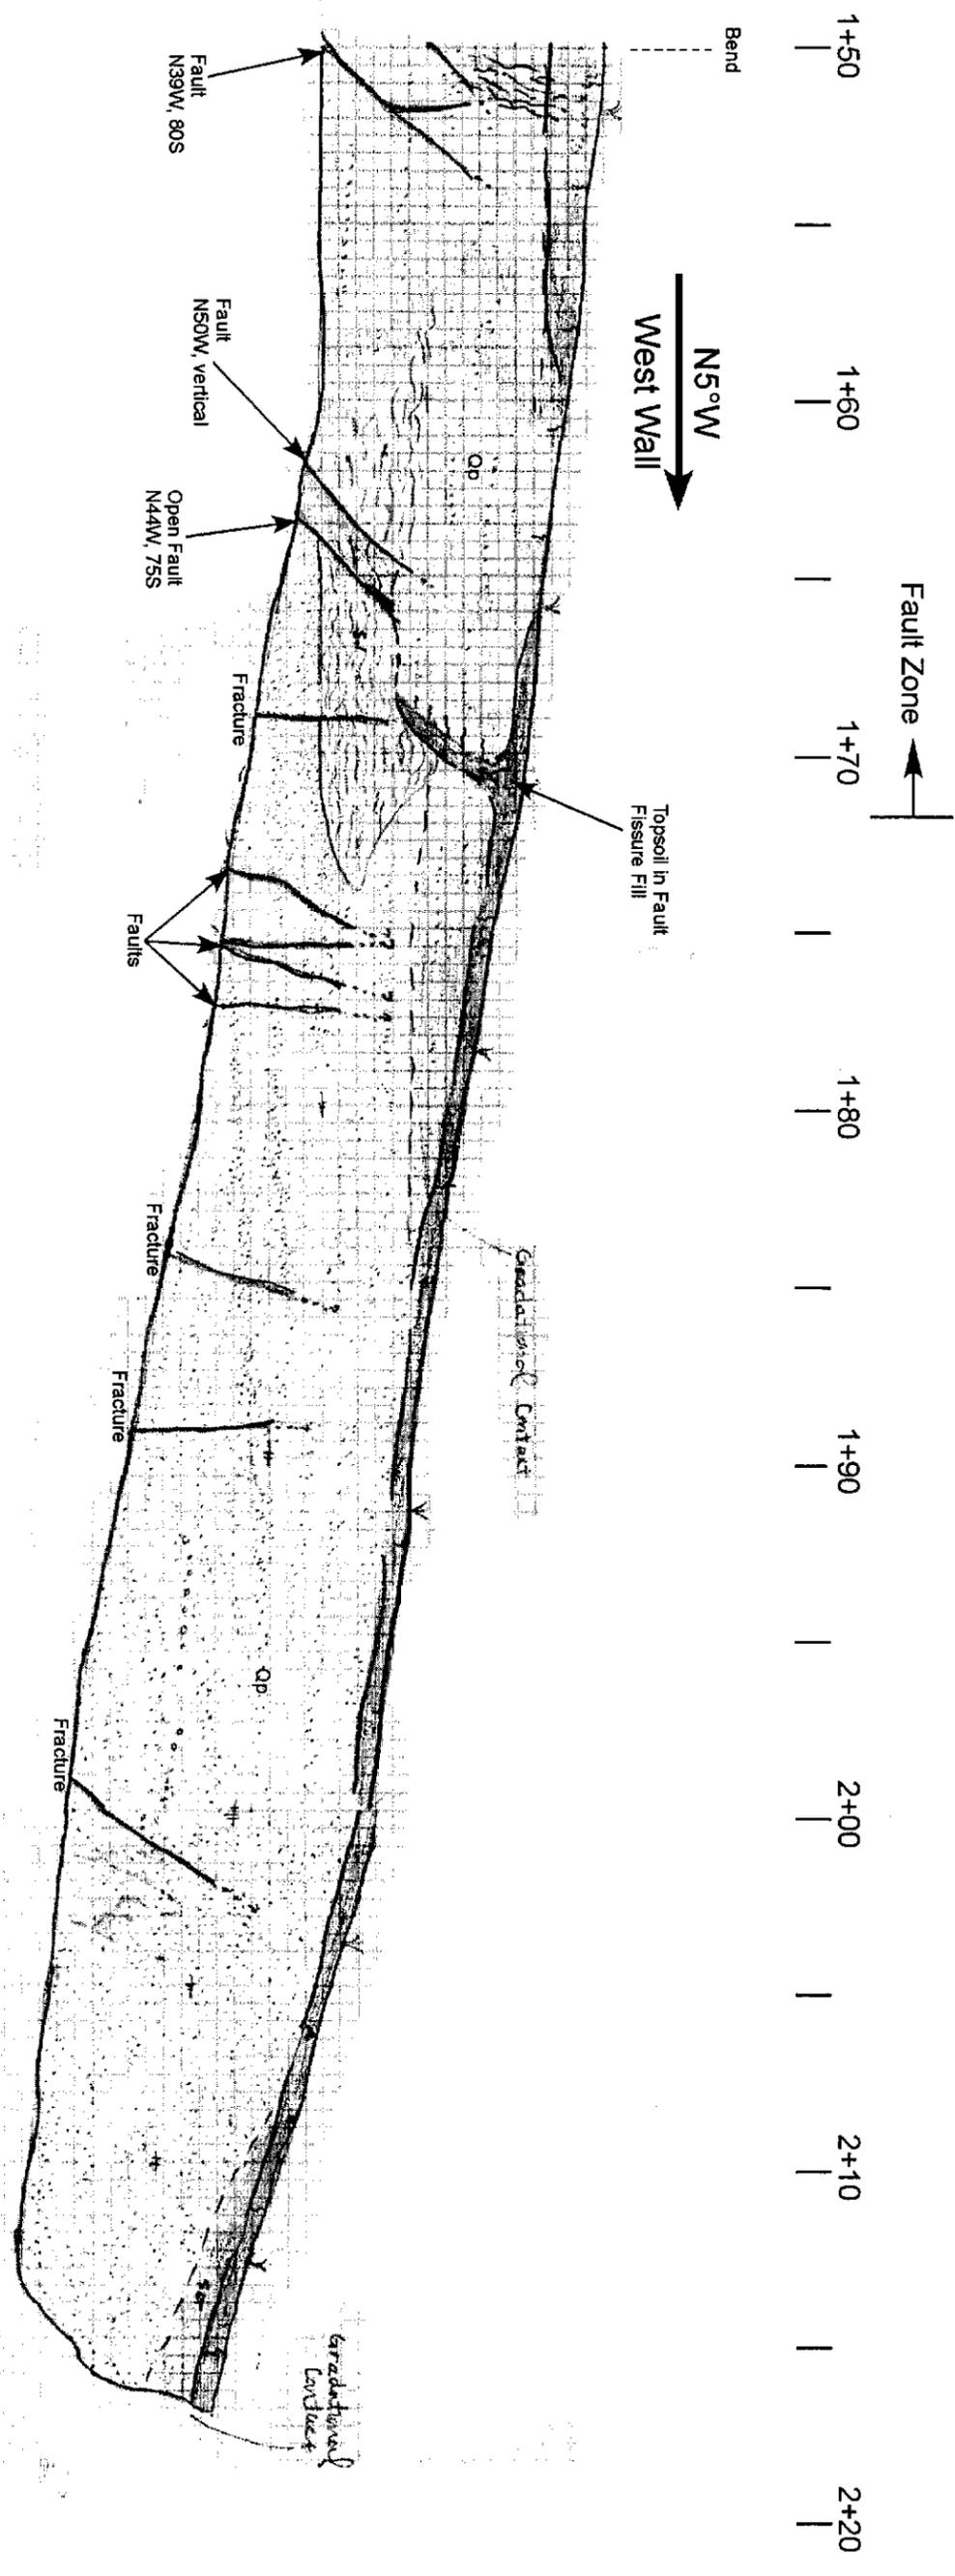
FAULT TRENCH LOG LFT-2
Geologic Fault Investigation
 Assessor Parcel Numbers 362-250-003 & 362-250-004, Wildomar, California

Fault Trench 2 (Map Symbol LFT-2) - Fault Trench 2 was located along the eastern margin of the 362-250-003 parcel boundary (the central portion of the overall area

of investigation). The trench was located across the projected alignment of the faulting reported from the site to the northwest and the faults observed in FT-1 (Figure 2). FT-2 was excavated to a maximum depth of 9 feet bgs, and a length of approximately 220 feet. An approximately 40-foot wide zone of active faults were identified within the central portion of the trench. The faults within this zone have an average trend approximately 45 degrees to the west of north (N45°W) and dip steeply to the southwest. The trench exposed bedrock of the Pauba Formation with a well-developed "Pleistocene" soil profile mantled by a horizon of topsoil at the surface. Approximately 1 foot of apparent vertical separation of the top of Pleistocene soil was observed across the fault(s) in this trench.
