GEOLOGICAL FAULT HAZARD INVESTIGATION,
PROPOSED ±5-ACRE PARCEL, APN 362-250-003, WILDOMAR,
RIVERSIDE COUNTY, CALIFORNIA

September 19, 2005

Project No. 601027-002

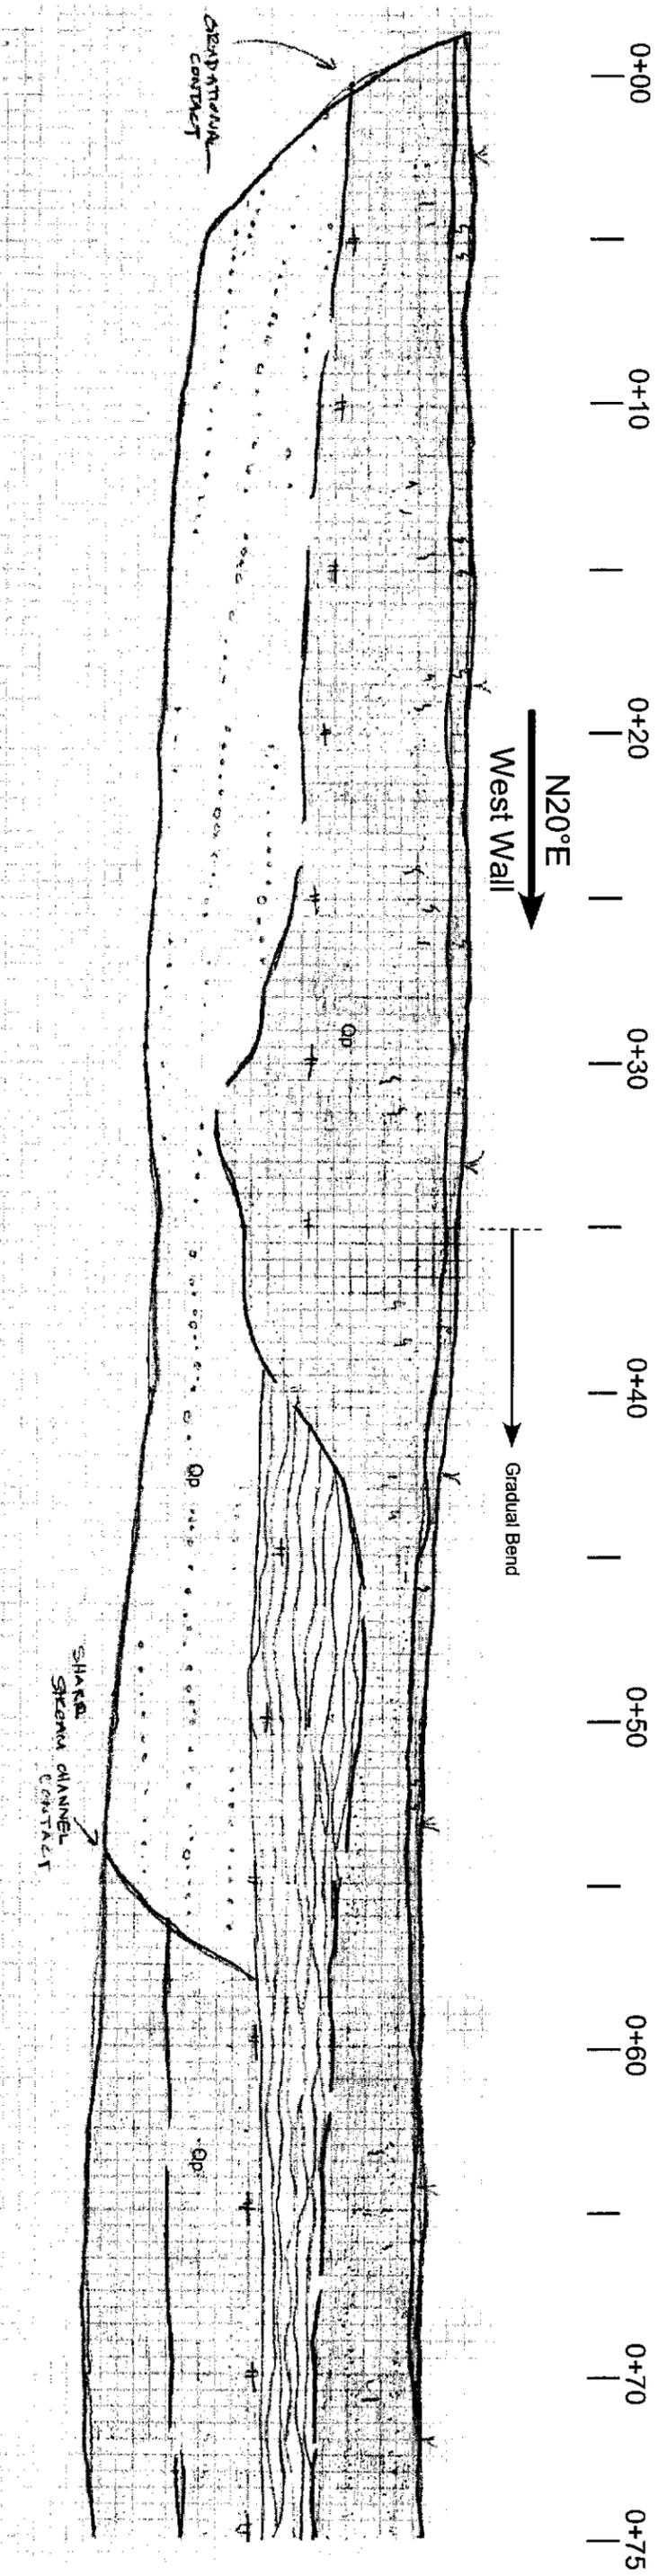
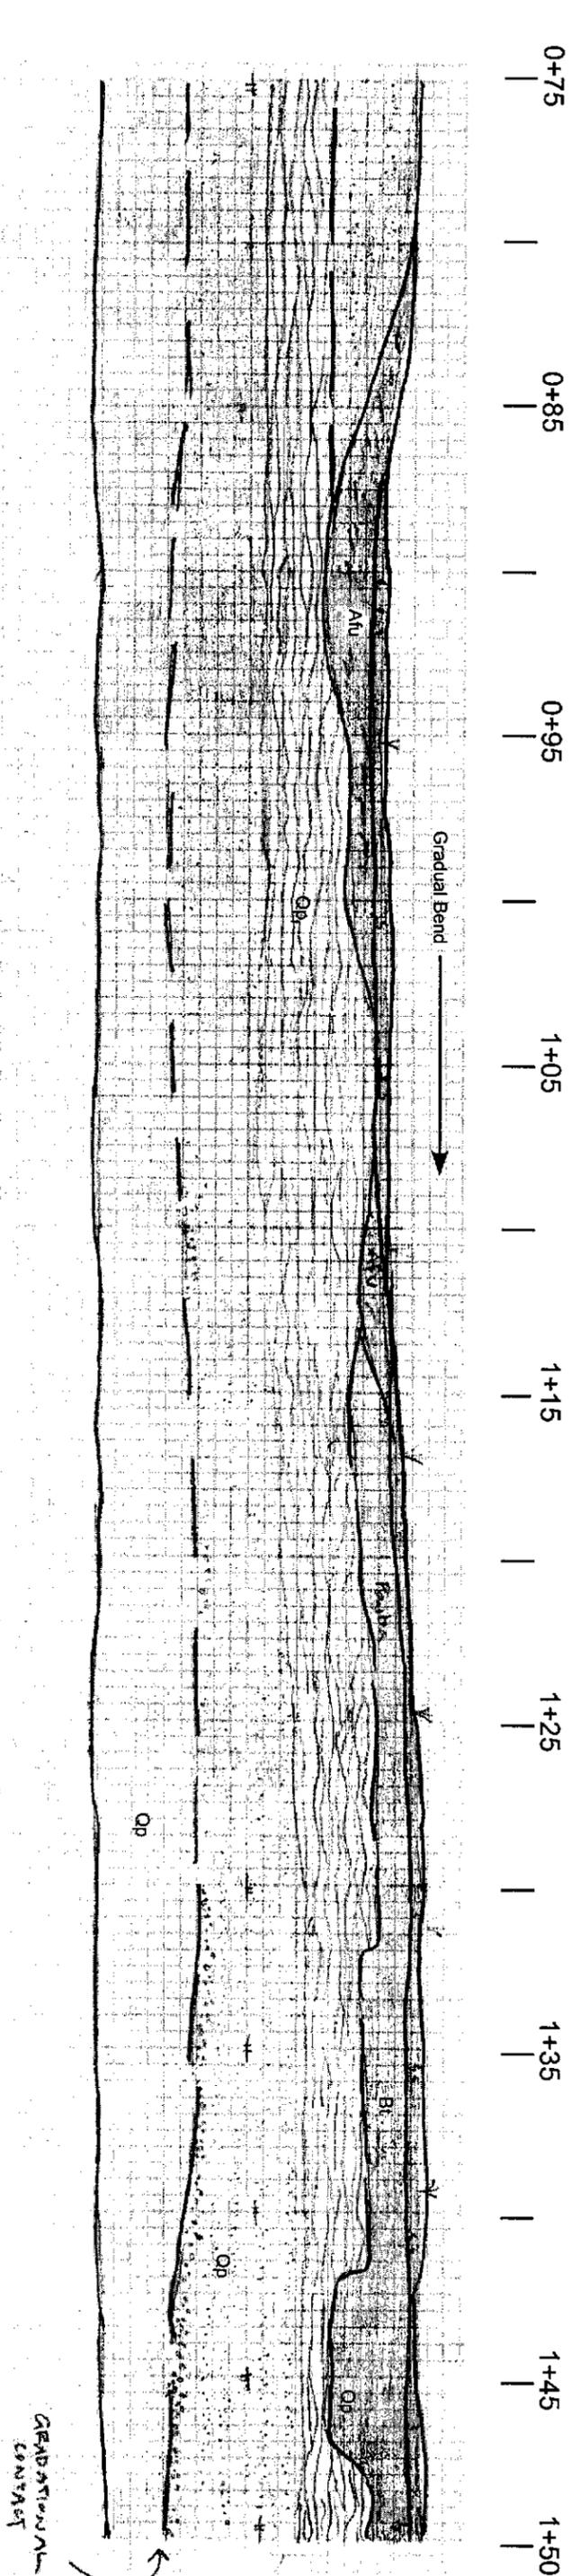
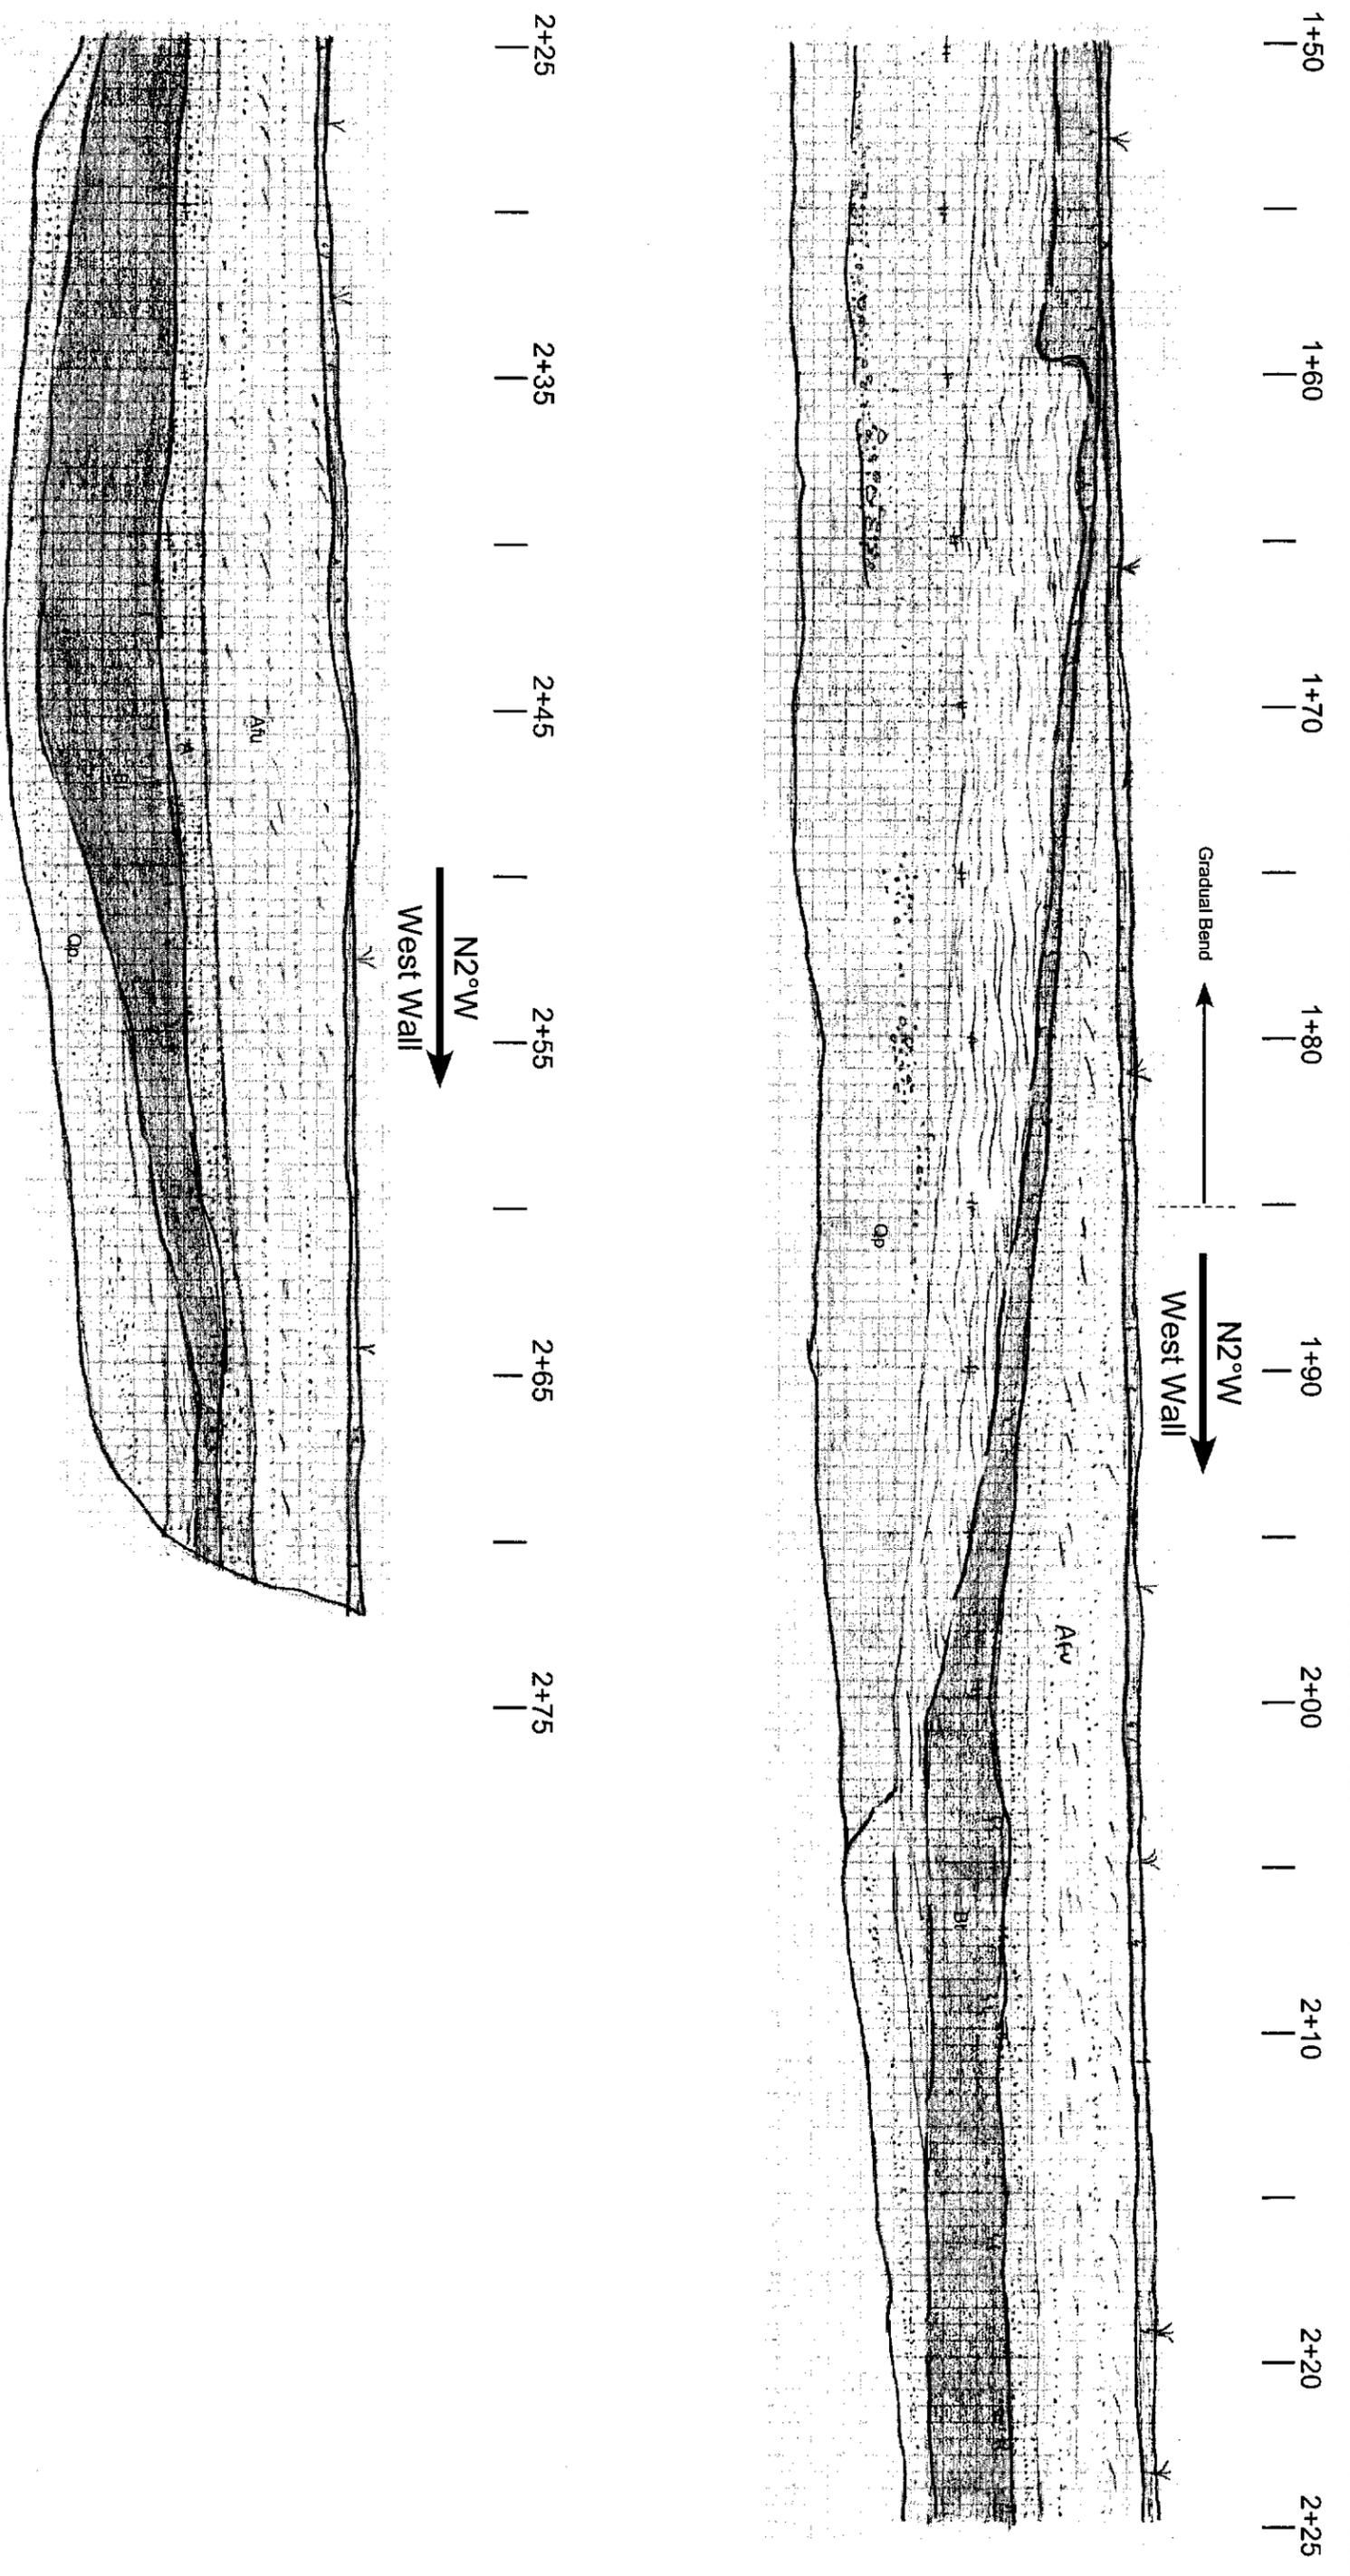
FAULT TRENCH LOG LFT-3
Geologic Fault Investigation
 Assessor Parcel Numbers 362-250-003 & 362-250-004, Wildomar, California

Fault Trench 3 (Map Symbol LFT-3) - Fault Trench 3 was located in the southeastern limits of the area of this investigation (along the eastern margin of parcel 362-250-004). Trench LFT-3 was excavated to a maximum depth of 10 feet bgs, and a length of approximately 270 feet. The trench exposed a discontinuous surface layer of artificial fill of variable thickness underlain by bedrock of the Pauba Formation with a well-developed "Pleistocene" soil profile. The ground surface prior to placement of the fill was indicated by the presence of a buried horizon of topsoil at the base of the fill. No evidence of past seismic activity was identified, within this trench. Stratigraphic marker units and contacts within the bedrock deposits and soils appeared to be unbroken within the limits of the trench.

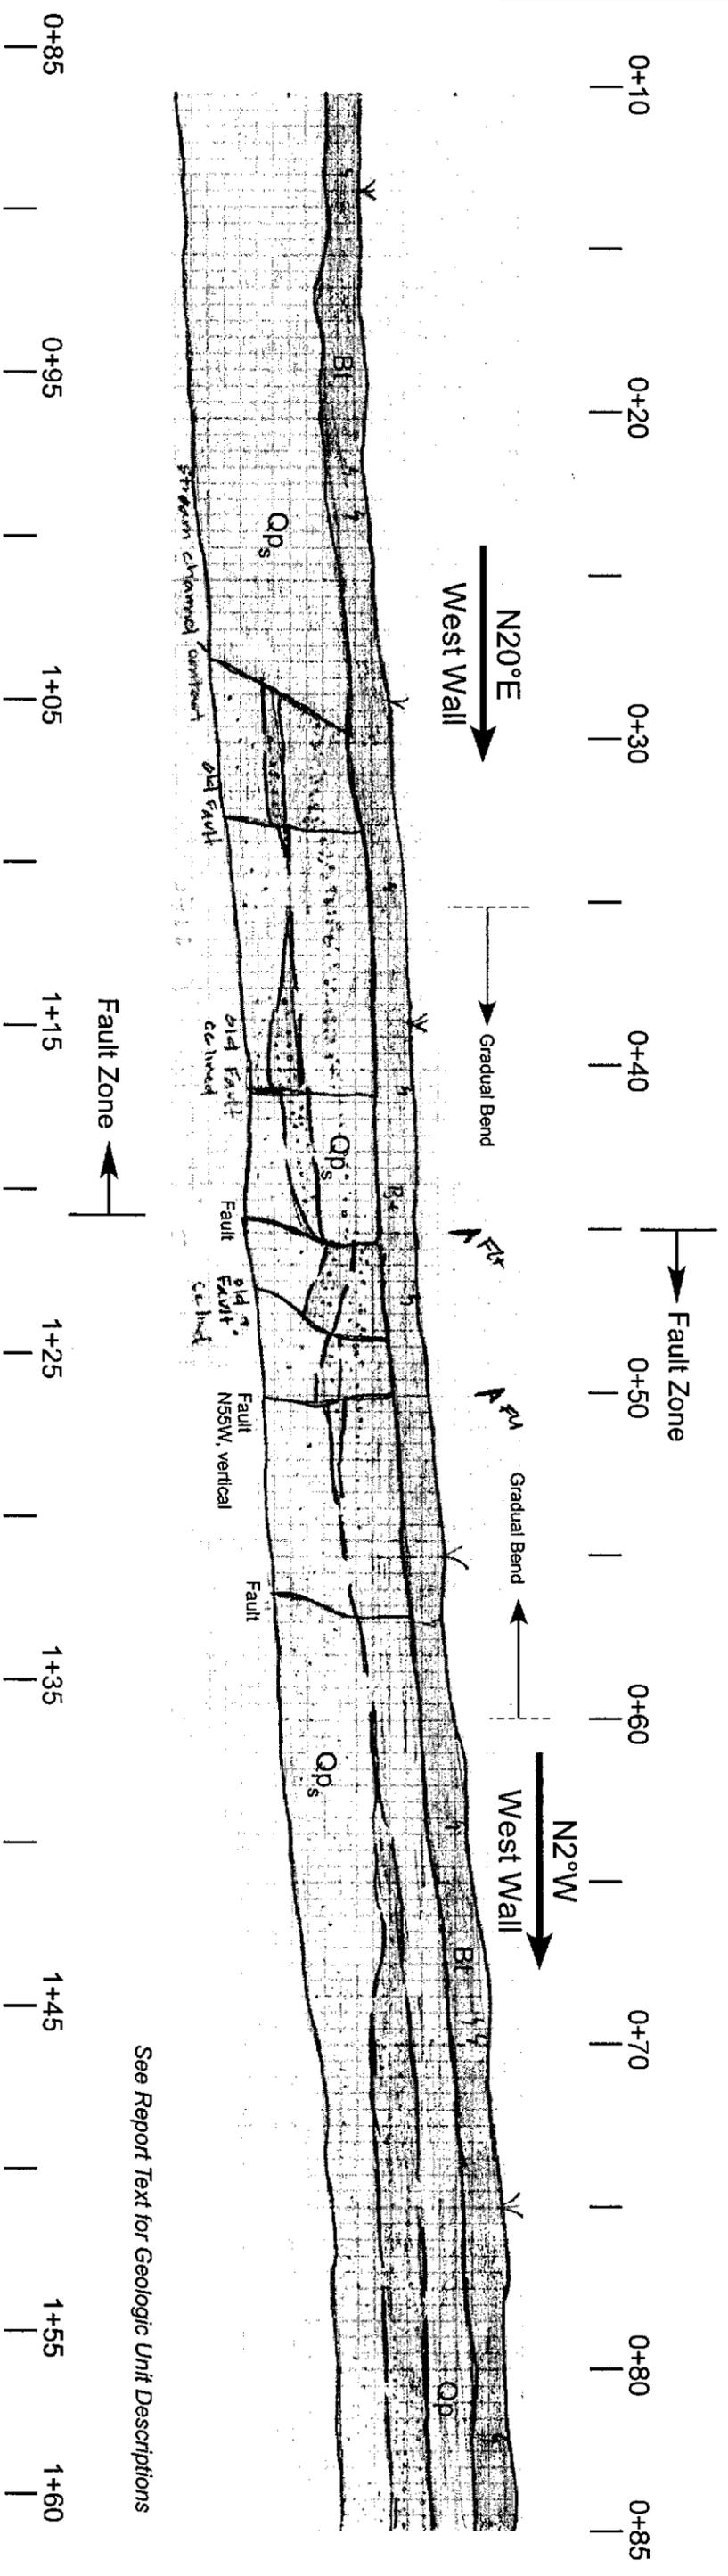
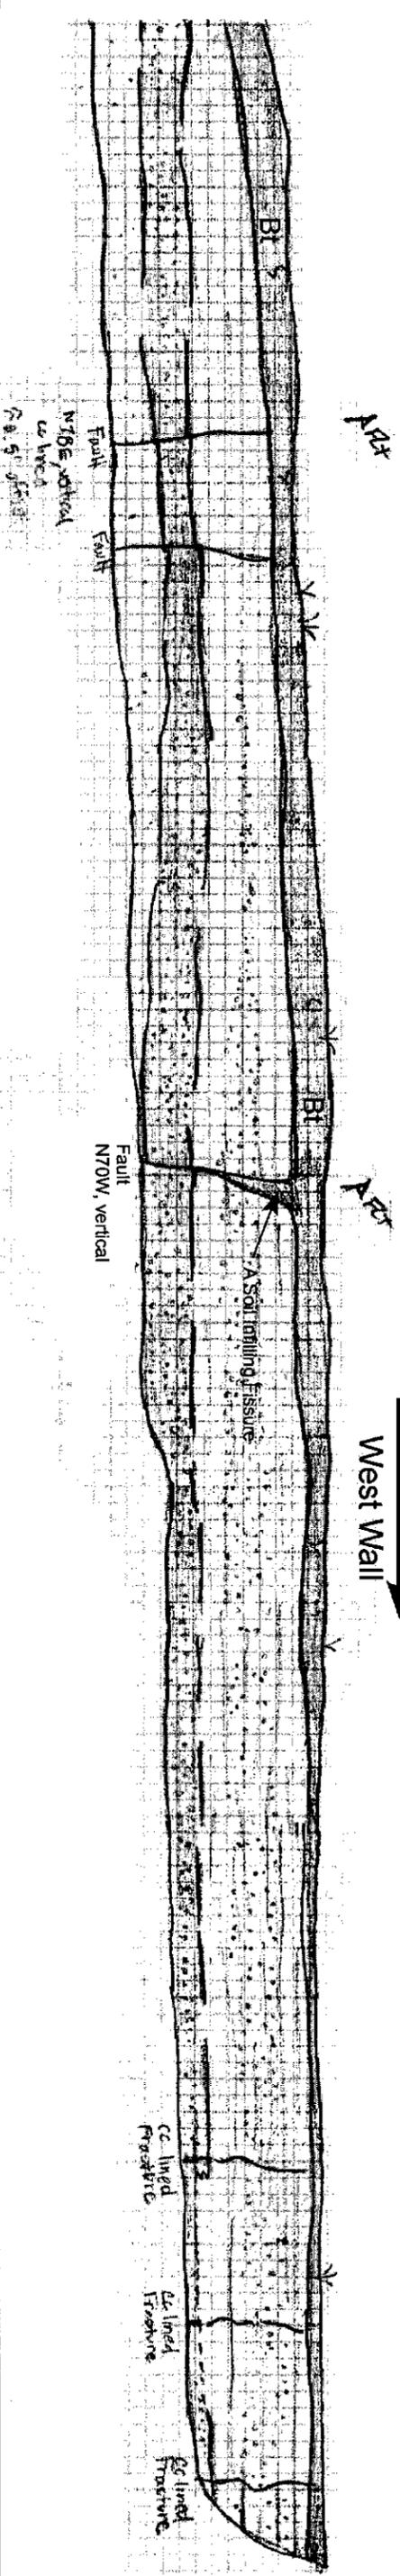
FAULT TRENCH LOG LFT-4
Geologic Fault Investigation
 Assessor Parcel Numbers 362-250-003 & 362-250-004, Wildomar, California

Fault Trench 4 (Map Symbol LFT-4) - Fault Trench 4 was located approximately midway (~150 feet) between trenches LFT-2 and LFT-3 to determine the location and limits of faulting within the overall area of the investigation. The trench measured approximately 6 feet in depth by 160 feet long. Geologic units and soils present within the trench were similar to those exposed in LFT-2. An approximately 75 foot wide zone of faults were observed that offset bedding contacts within the Pauba Formation and broke upward into the argillic horizon of the overlying soil profile. A maximum of 2 to 3 inches of vertical separation were apparent within the upper portions of the faulted soil profile at this location.

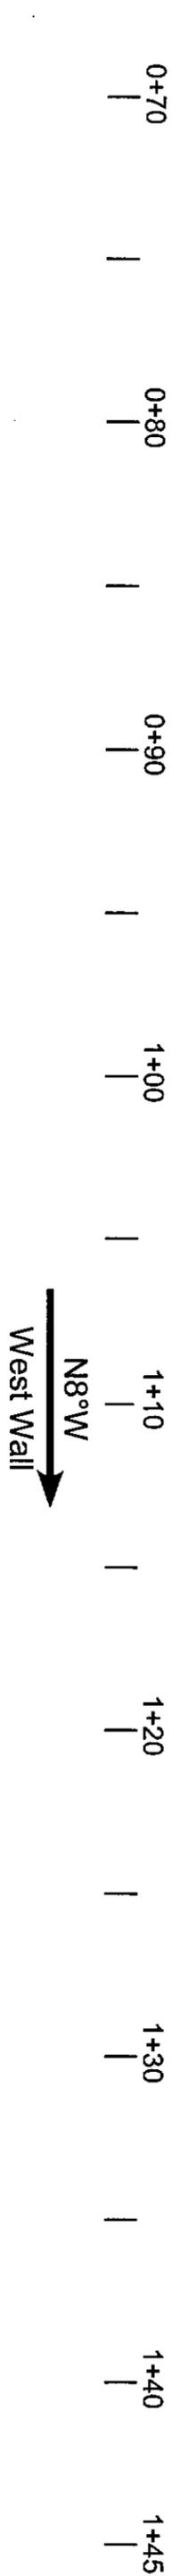
FAULT TRENCH LOG LFT-5
 Geologic Fault Investigation
 Assessor Parcel Numbers 362-250-003 & 362-250-004, Wildomar, California

Fault Trench 5 (Map Symbol LFT-5) - Fault Trench 5 was excavated approximately 50 feet east of trench LFT-4 in an attempt to constrain the limits of faulting. This trench exposed unbroken materials similar to those observed in LFT-3. No faulting or fault-related structures were observed within the LFT-5 trench exposure.

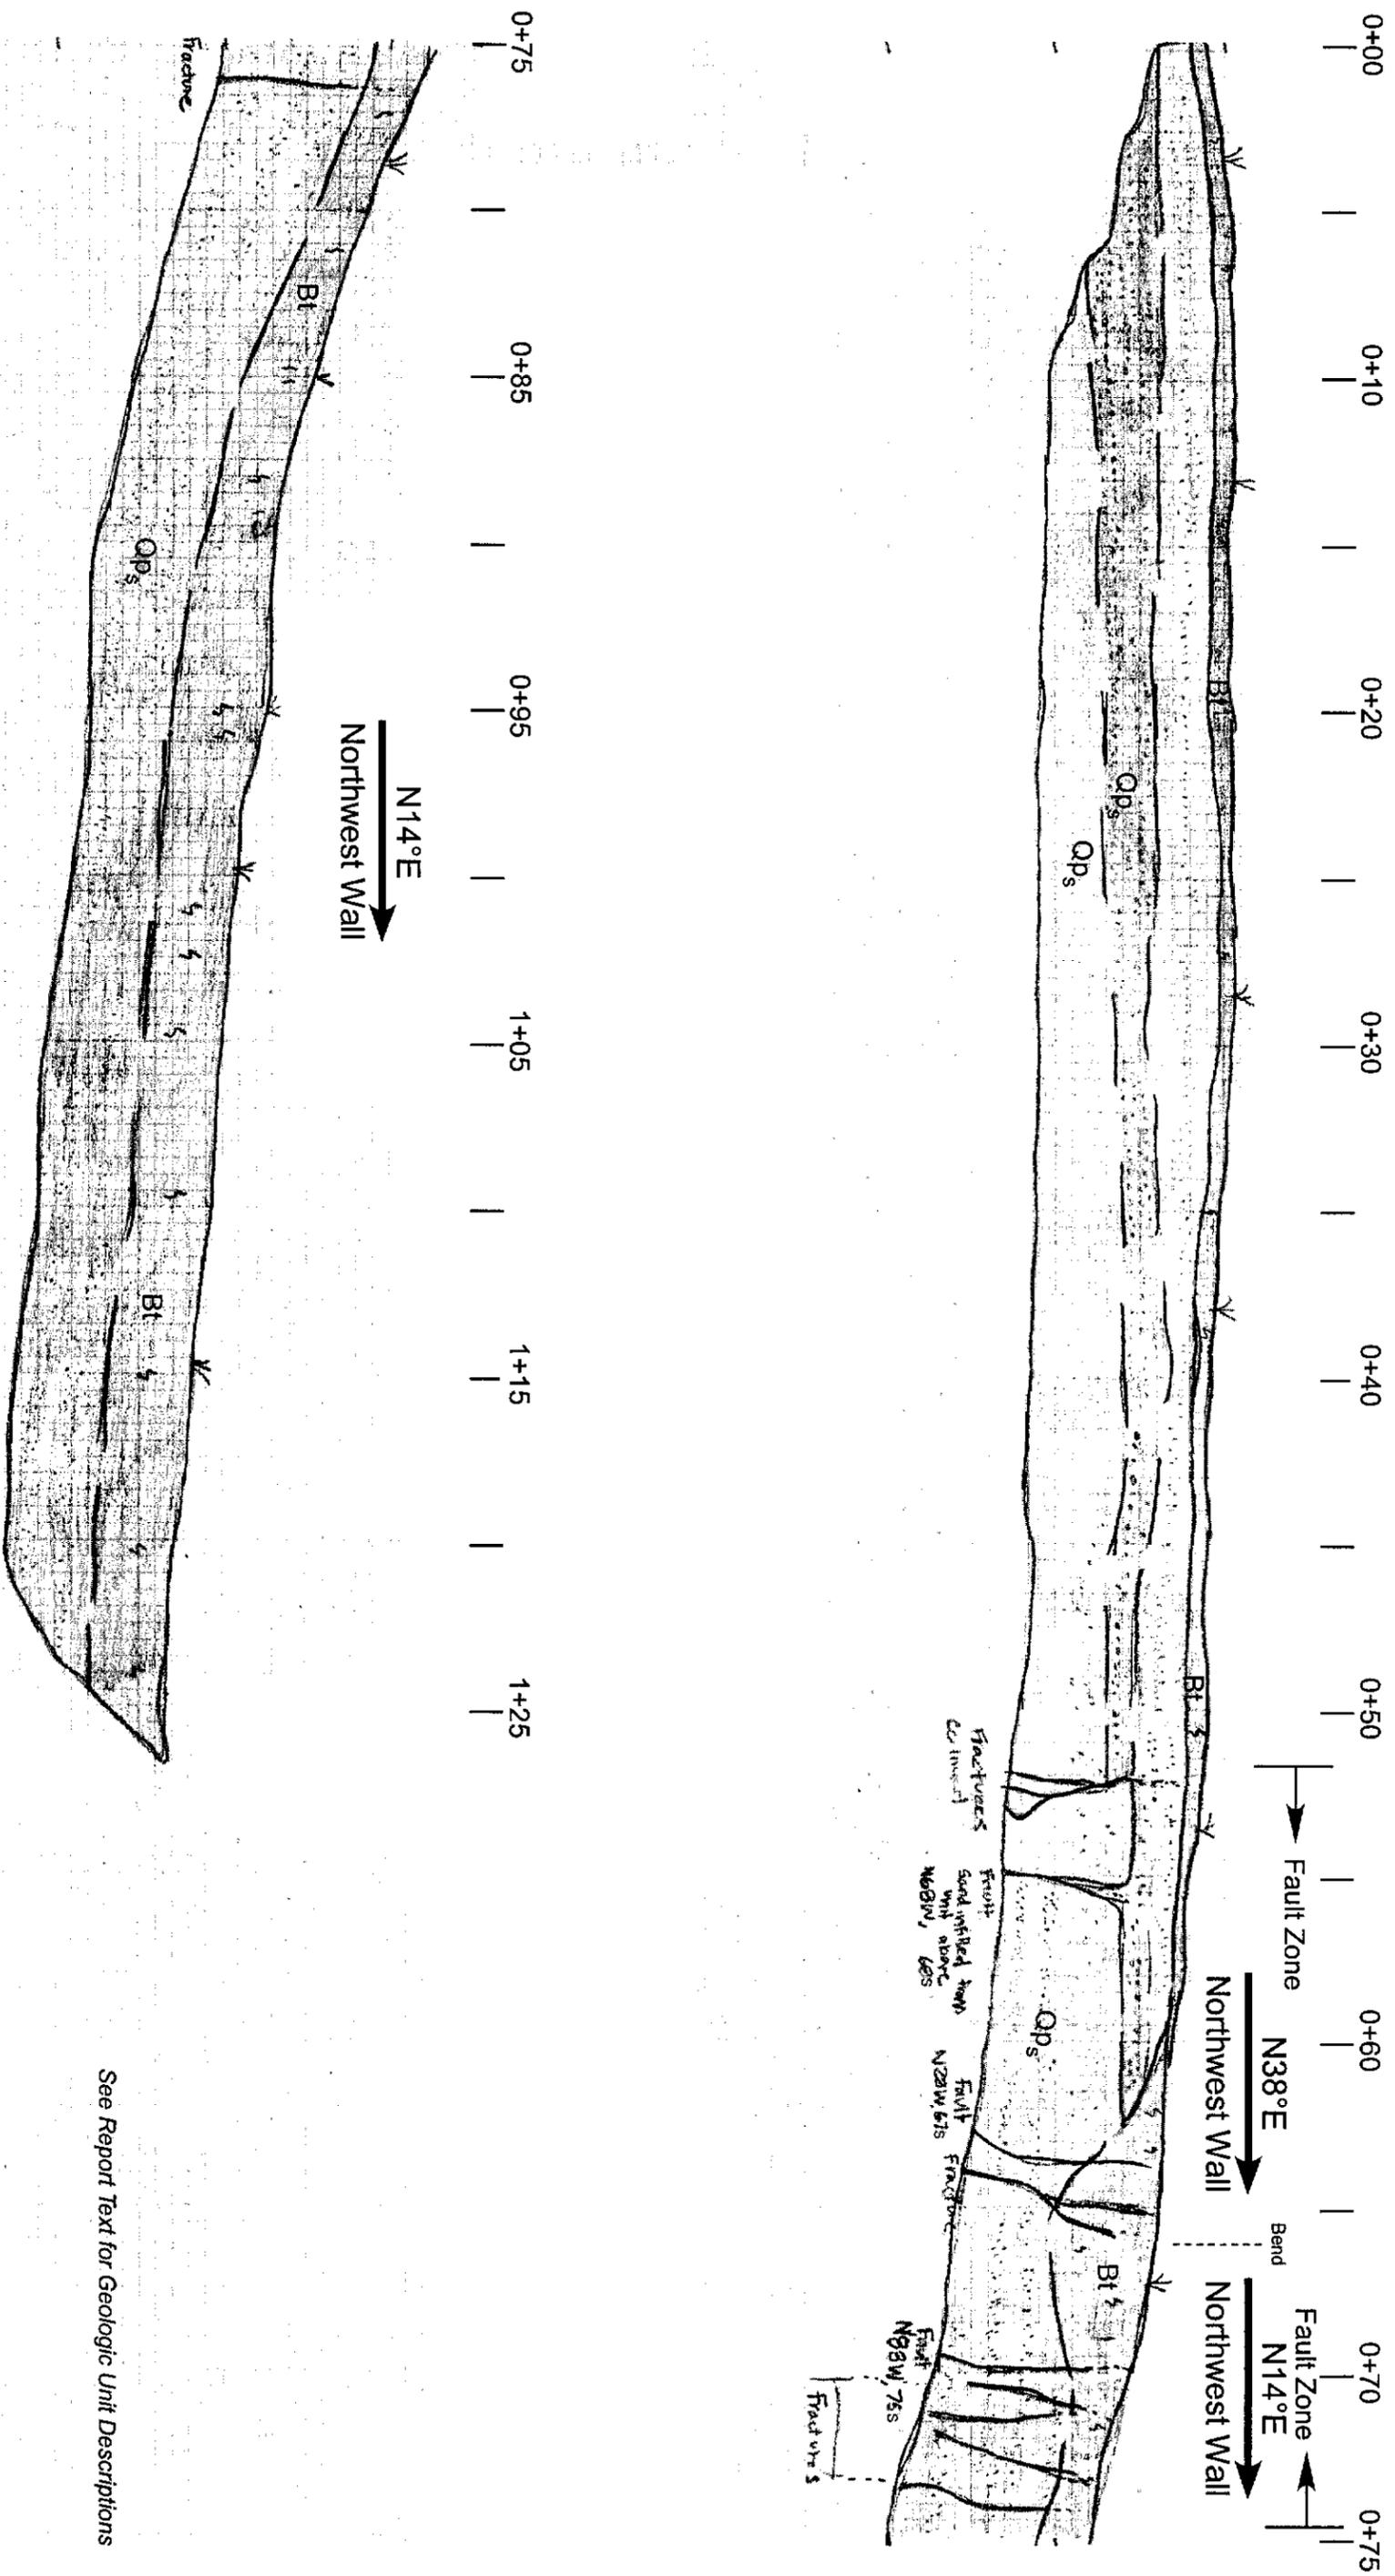
FAULT TRENCH LOG LFT-6
 Geologic Fault Investigation
 Assessor Parcel Numbers 362-250-003 & 362-250-004, Wildomar, California

Fault Trench 6 (Map Symbol LFT-6) - Fault Trench LFT-6 was excavated between trenches LFT-1 and LFT-2 to assist in determining the location and limits of faulting within the proposed development area of the project (parcel 362-250-003). This trench measured approximately 5 feet in depth by 125 feet in length. The geologic deposits and soil within the trench were similar to those observed in

LFT-2. Faults breaking through the Pleistocene soil profile form a zone approximately 25 wide. Apparent vertical separation of approximately 2.5 feet was measured across the fault zone at the base of the argillic soil. The faults forming this zone have an average trend of approximately 68 to 83 degrees to the west of north (N68-83°W) and dip steeply to the southwest.
