3.8-1 JURISDICTIONAL DELINEATION OF WATERS AND WETLANDS

DECEMBER 2010

**JURISDICTIONAL DELINEATION
OF WATERS AND WETLANDS**

PREVIOUS TRACT 28416

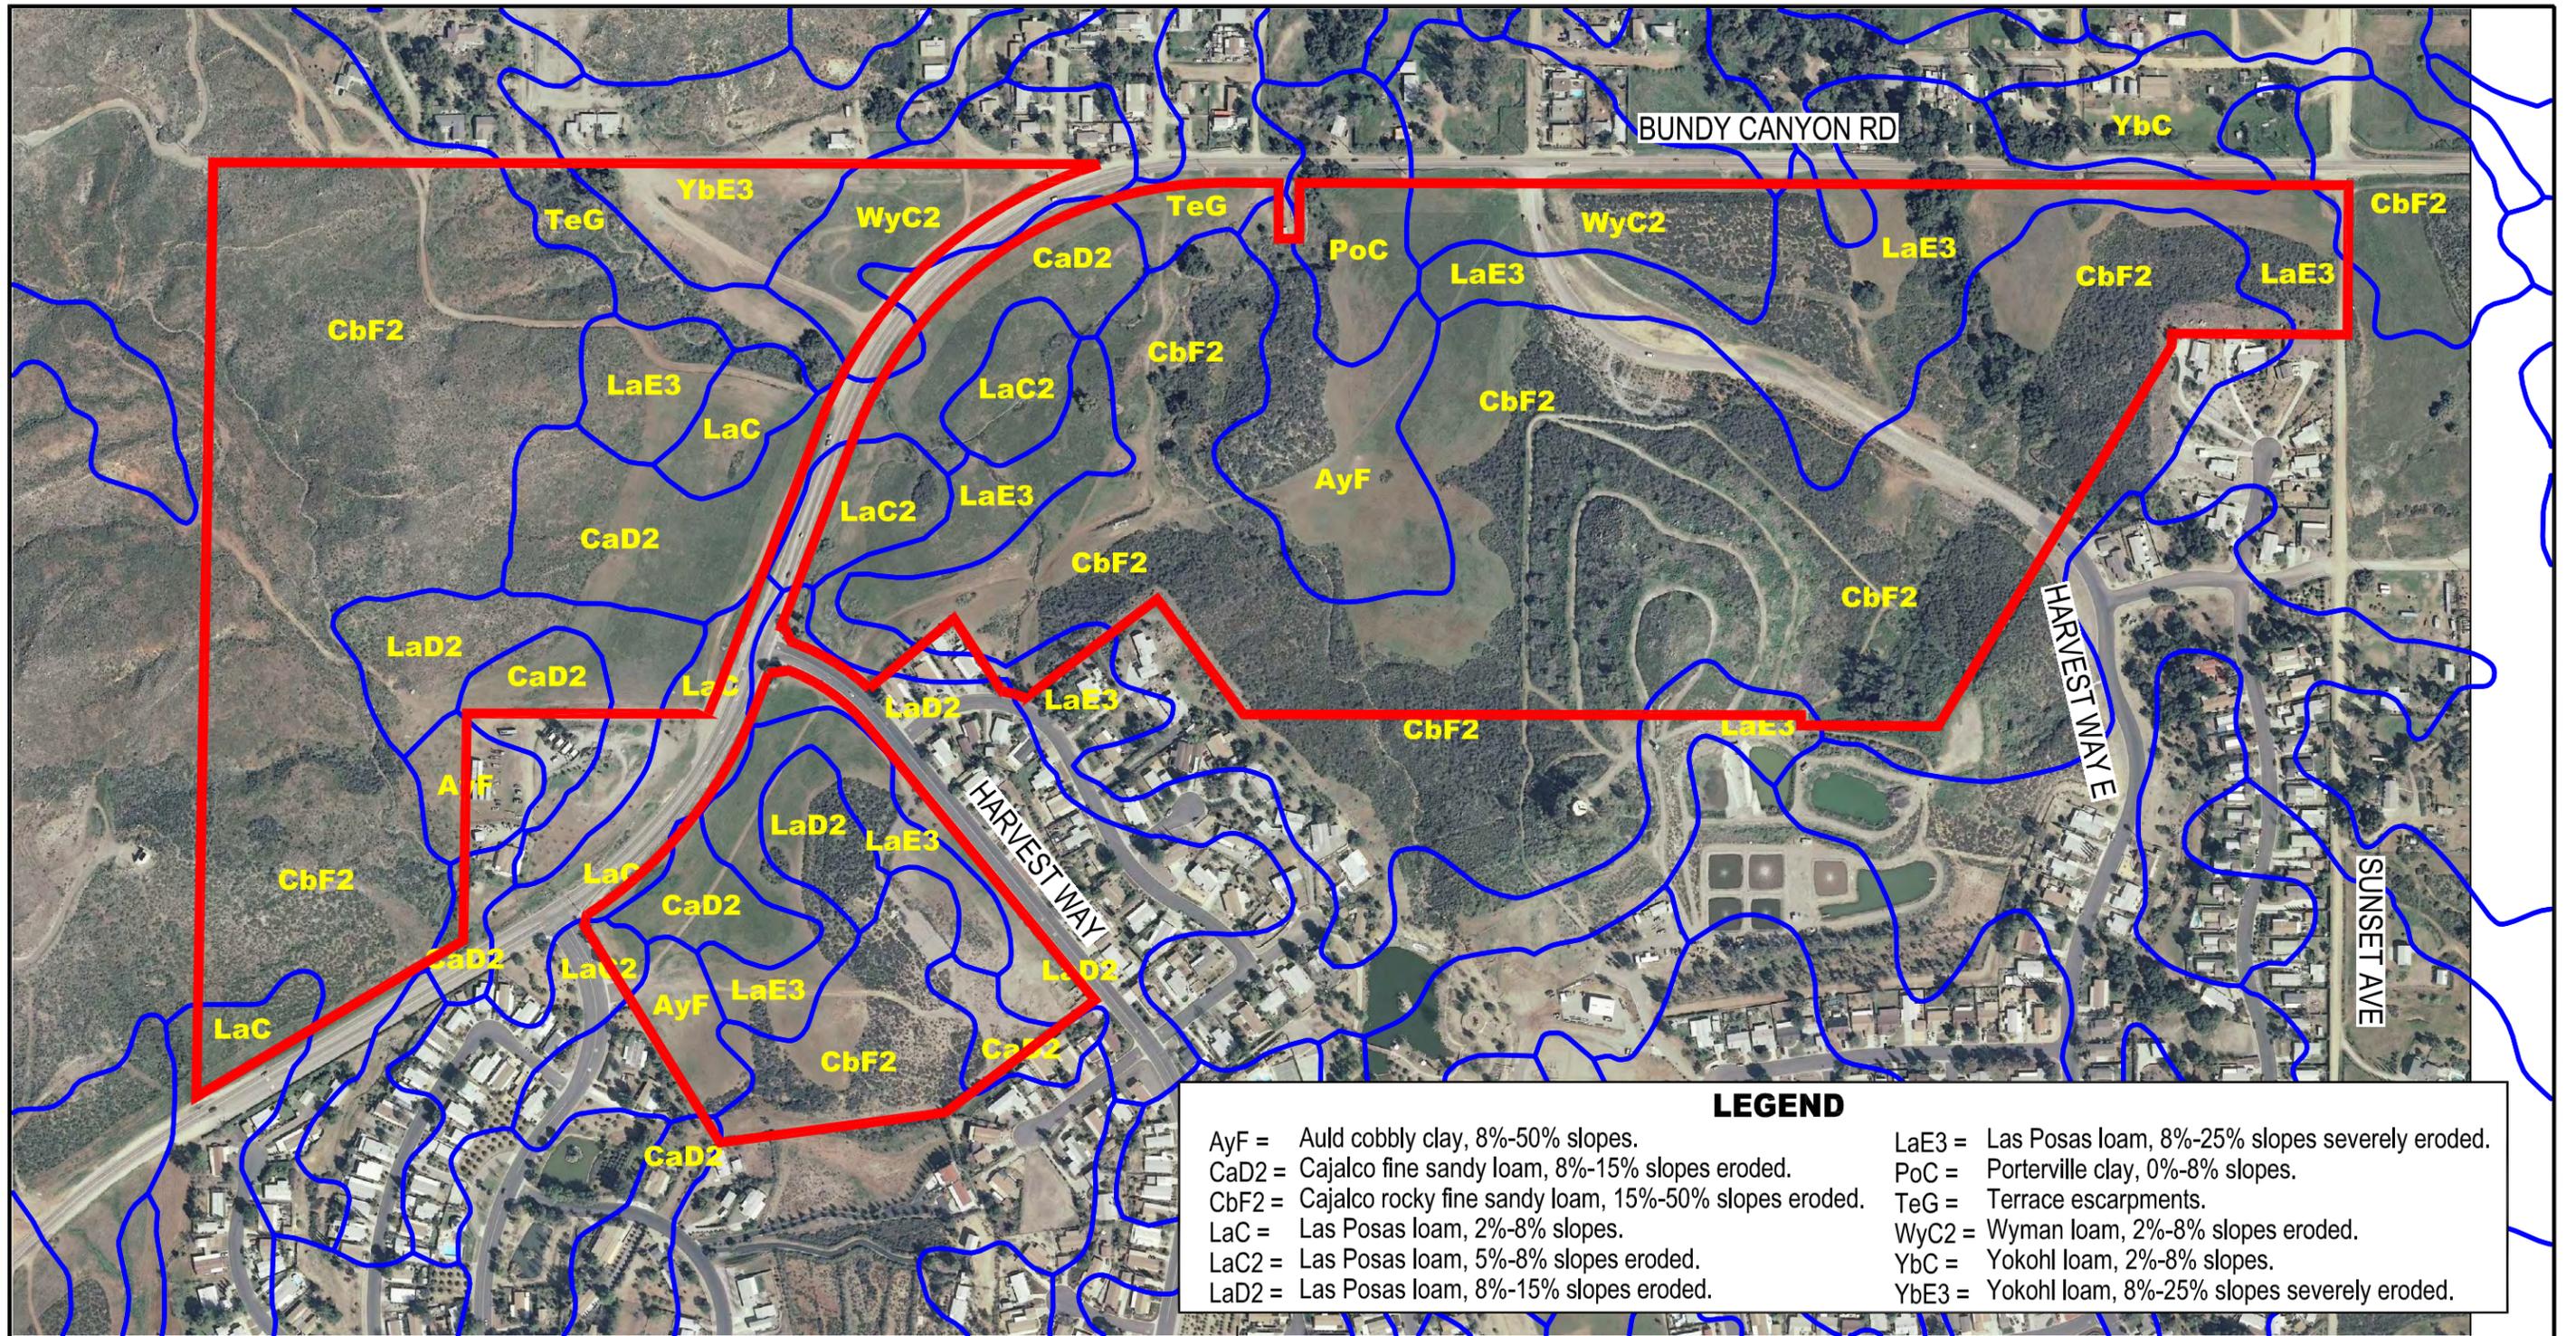
SOILS MAP

AyF – Auld cobbly clay, 8 to 50 percent slopes.
CaD2 – Cajalco fine sandy loam, 8 to 15 percent slopes, eroded.
CbF2 – Cajalco rocky fine sandy loam, 15 to 50 percent slopes, eroded.
LaC – Las Posas loam, 2 to 8 percent slopes.
LaC2 – Las Posas loam, 5 to 8 percent slopes, eroded.
LaD2 – Las Posas loam, 8 to 15 percent slopes, eroded.
LaE3 – Las Posas loam, 8 to 25 percent slopes, severely eroded.
PoC – Poterville clay, 0 to 8 percent slopes.
TeG – Terrace escarpments.
WyC2 – Wyman loam, 2 to 8 percent slopes, eroded.
YbC – Yokohl loam, 2 to 8 percent slopes.
YbE3 – Yokohl loam, 8 to 25 percent slopes, severely eroded.

The jurisdictional areas on the site are found within a variety of soil types, including Auld cobbly clay, Cajalco fine sandy loam, Cajalco rocky fine sandy loam, Las Posas loam, Las Posas loam, Las Posas loam, and Terrace escarpments. Generally, the soils observed in the onsite watercourses were sandy loams, brown in color, with or without gravel and/or cobbles. Typical Riverwash soils were not mapped on this site.

Review of the "Soil Survey of Western Riverside Area, California" revealed that the surficial soils at the site are included in the Cajalco-Temescal-Las Posas Association (Soils of the Southern California Coastal Plain). Within this association, 12 soil types have been mapped on the site (**Soils Map**):

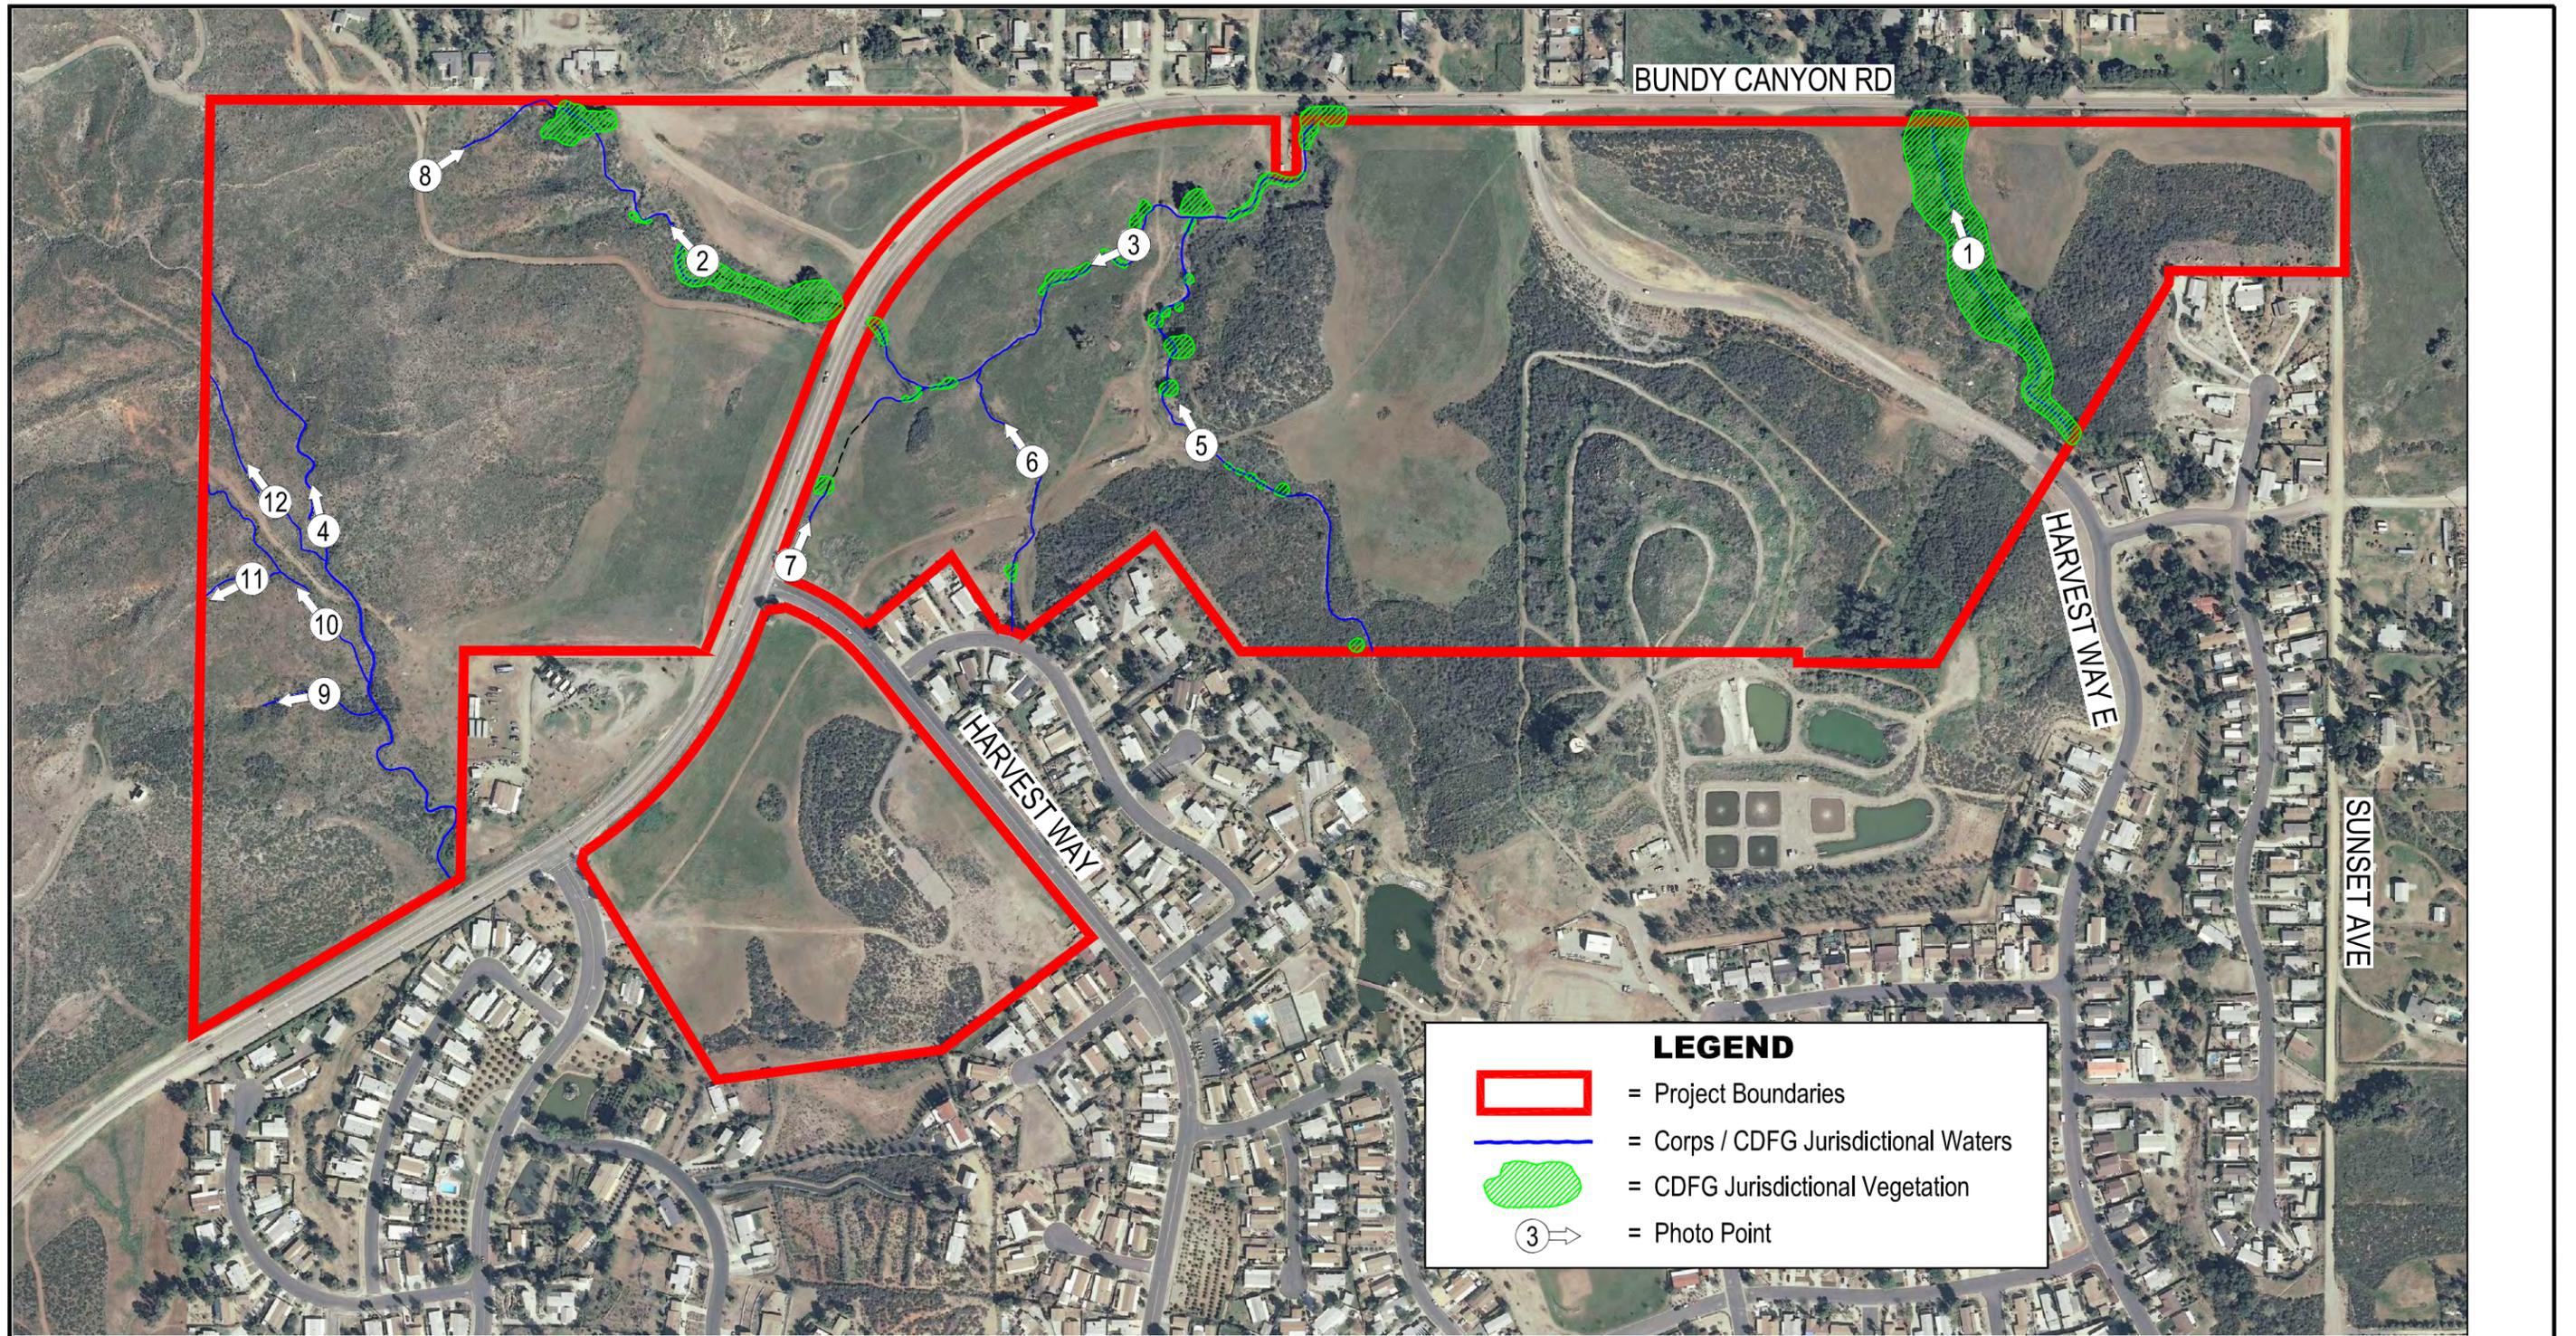
HYDROGRAPHY MAP

All the onsite watercourses exhibit Corps and CDFG jurisdictional features. Their locations are shown on the **Hydrography Map**. 'Photo Points' for all of the Site Photographs are also shown on the Hydrography Map.

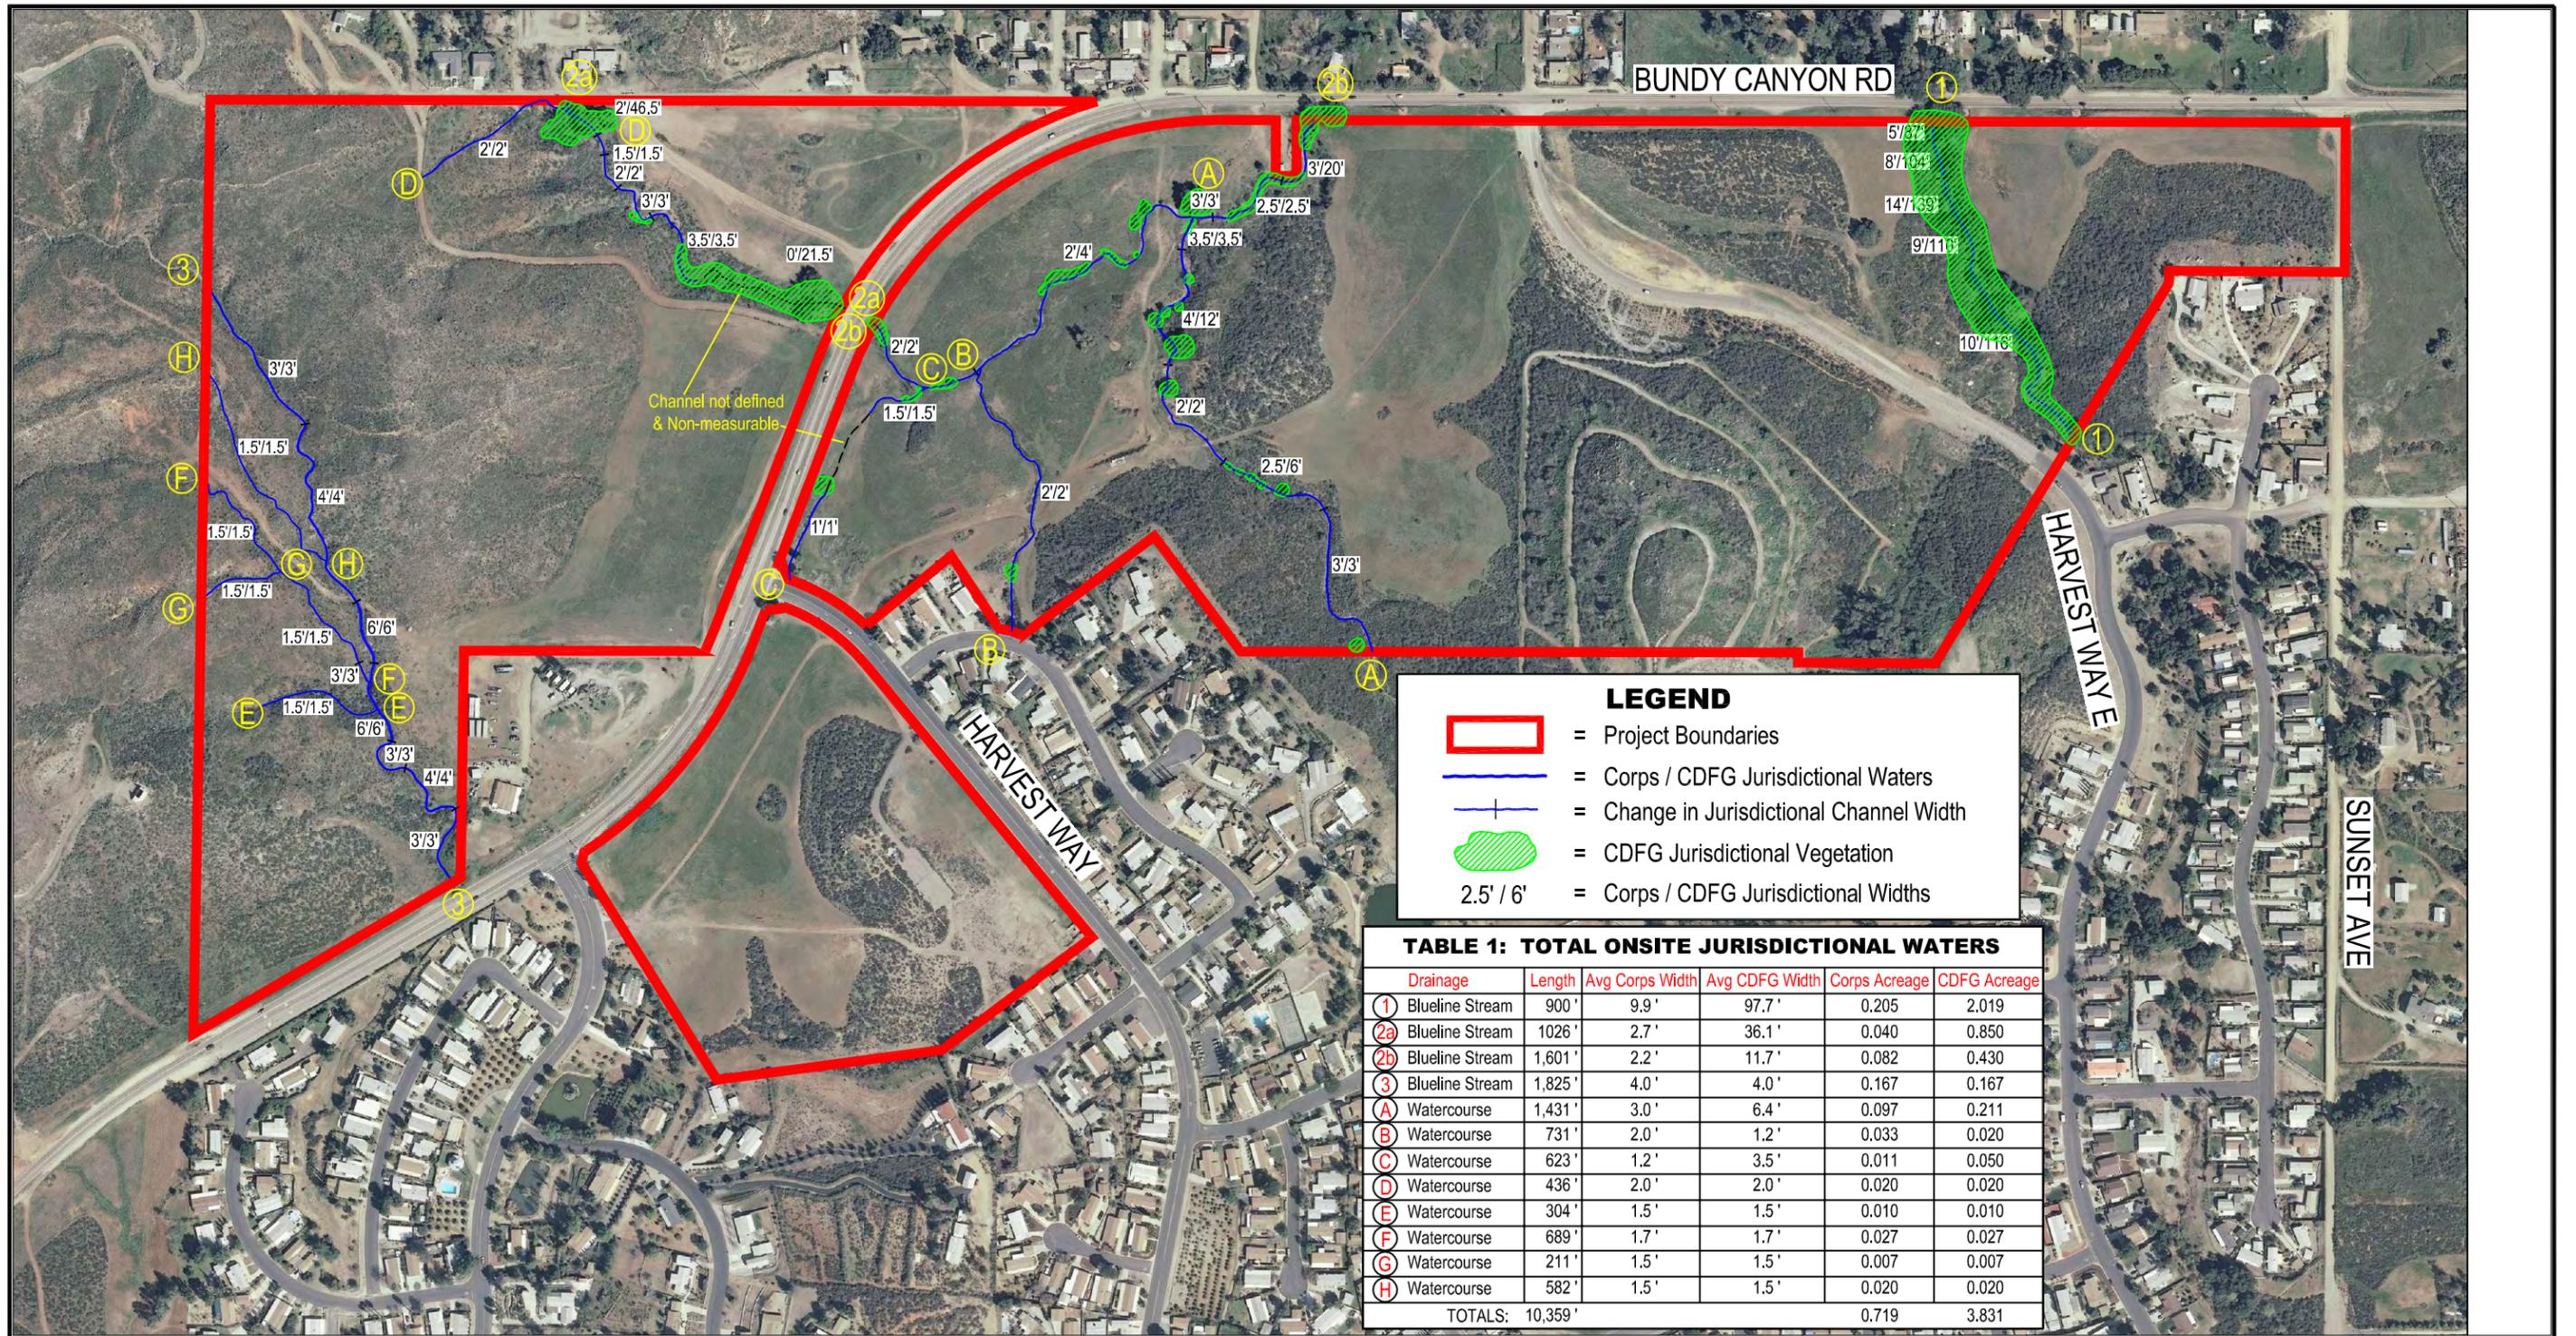
JURISDICTIONAL ASSESSMENT

The boundaries and quantification of Corps Waters of the United States and CDFG Waters of the State and jurisdictional vegetation are shown on the **Jurisdictional Assessment**. **Table 1** summarizes Total Onsite Jurisdictional Waters.

Corps jurisdiction within the site totals 0.719 acres of Waters of the United States.

CDFG jurisdiction totals 3.831 acres of Waters of the State and associated riparian habitat located contiguous to the watercourses.

Drainage	Length	Avg Corps Width	Avg CDFG Width	Corps Acreage	CDFG Acreage
① Blueline Stream	900'	9.9'	97.7'	0.205	2.019
②a Blueline Stream	1026'	2.7'	36.1'	0.040	0.850
②b Blueline Stream	1,601'	2.2'	11.7'	0.082	0.430
③ Blueline Stream	1,825'	4.0'	4.0'	0.167	0.167
④A Watercourse	1,431'	3.0'	6.4'	0.097	0.211
④B Watercourse	731'	2.0'	1.2'	0.033	0.020
④C Watercourse	623'	1.2'	3.5'	0.011	0.050
④D Watercourse	436'	2.0'	2.0'	0.020	0.020
④E Watercourse	304'	1.5'	1.5'	0.010	0.010
④F Watercourse	689'	1.7'	1.7'	0.027	0.027
④G Watercourse	211'	1.5'	1.5'	0.007	0.007
④H Watercourse	582'	1.5'	1.5'	0.020	0.020
TOTALS:	10,359'			0.719	3.831

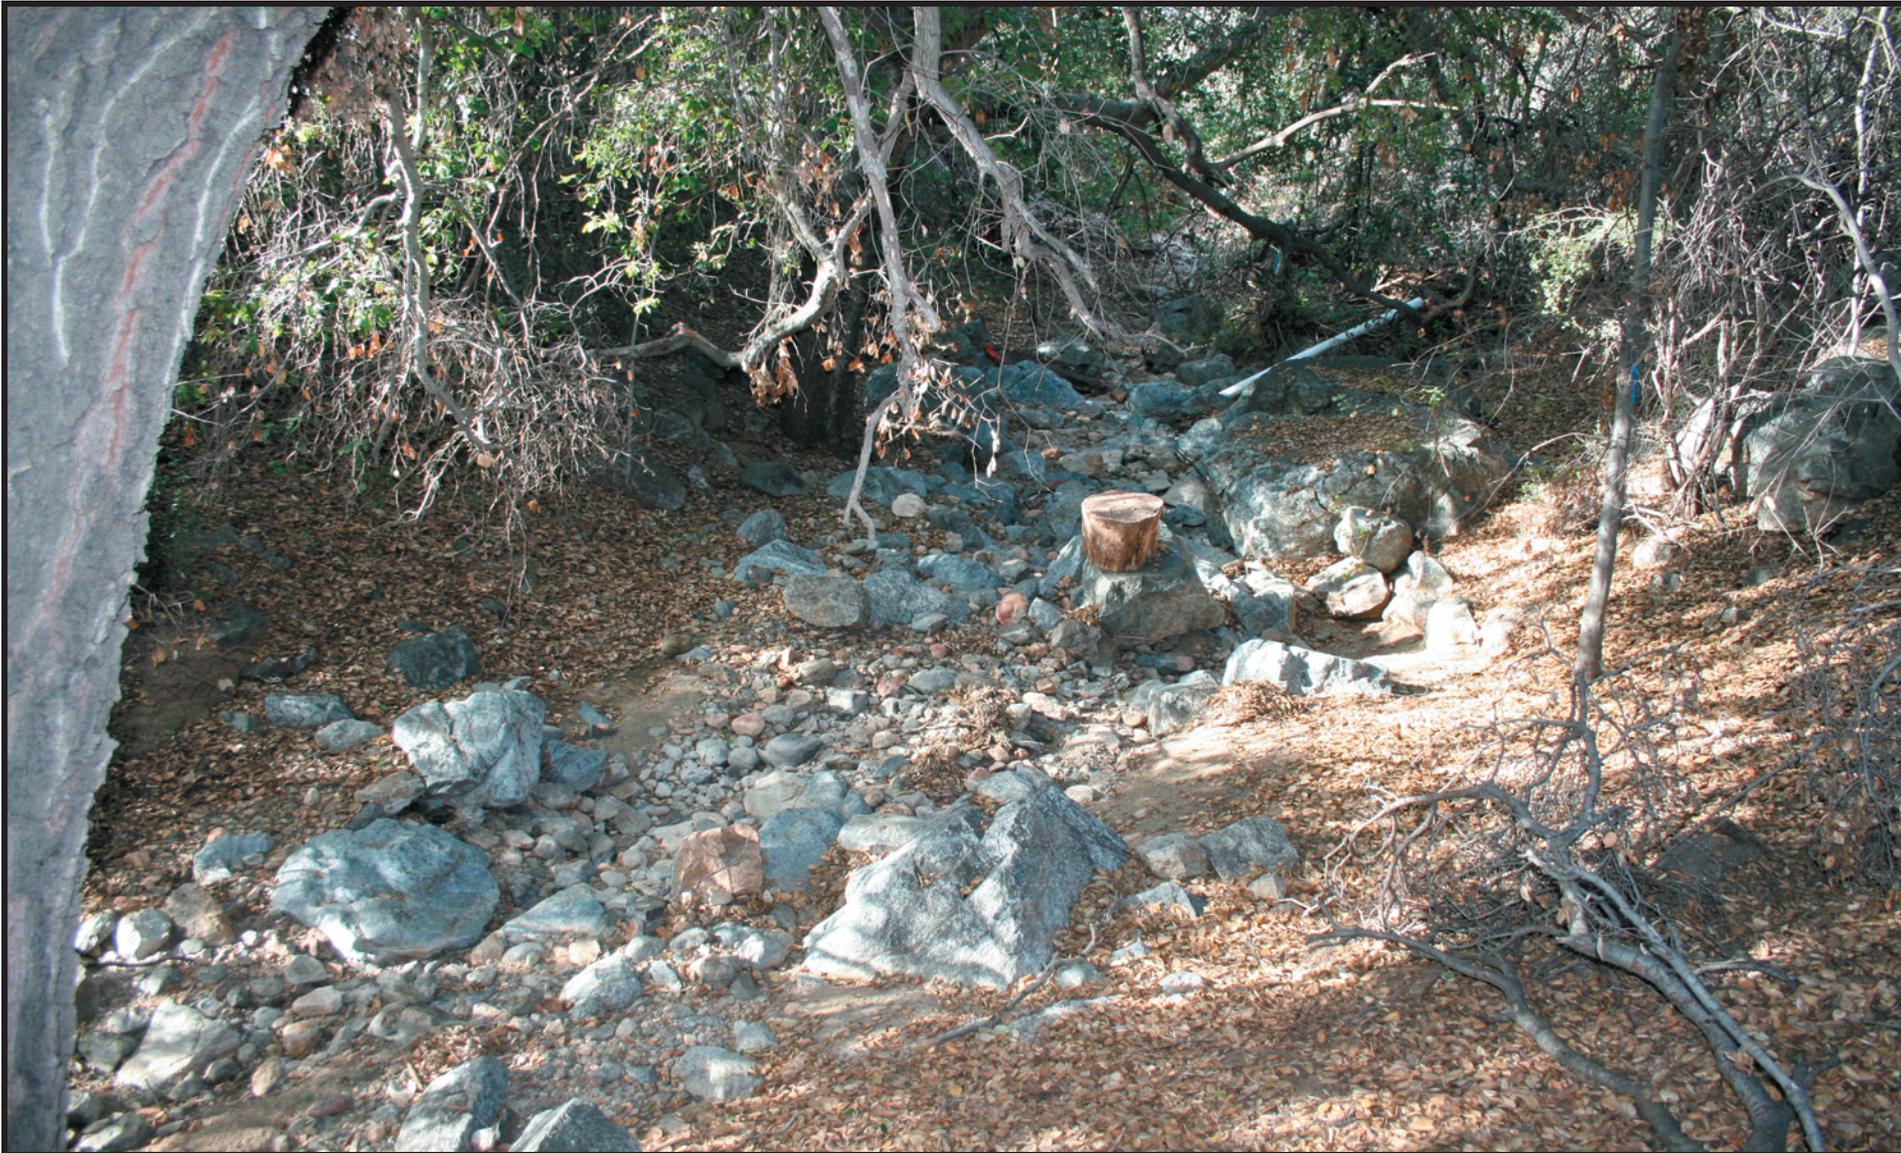
SITE PHOTOGRAPH 1

View of a portion of the channel of Cottonwood Canyon Creek. It is shallow-incised and composed of sandy loam, gray in color, with or without gravels, cobbles and boulders. Riparian Forest vegetation growing along Cottonwood Canyon Creek is dominated by coast live oak trees which form a dense shaded canopy over the channel.

Cottonwood Canyon Creek (Blueline Stream 1 on the exhibit) is an intermittent blueline stream that originates on the Meniffee Hills located south of Bundy Canyon Road. It trends through a rural residential area and The Farm (in a drainage easement) for over a mile before entering the site north of Deep Well Road. It then trends southeast-to-northwest through the eastern portion of the site through a relatively steep-sloped V-shaped valley to Bundy Canyon Road. It shows signs of human disturbances. The channel is shallow-incised and composed of sandy loam, gray in color, with or without gravels, cobbles and boulders (**Site Photograph 1**). The channel is overgrown in the southern half, and unvegetated in the northern half. Its total length on the site is 900 feet. Water was flowing in an approximately 240-foot-long reach of the creek during the November surveys, with urban runoff as its source. Corps jurisdictional widths averaged 9.9 feet, and the total jurisdiction was calculated to be 0.205 acres.

The Riparian Forest vegetation growing along this reach of Cottonwood Canyon Creek is dominated by coast live oak trees (*Quercus agrifolia* var. *agrifolia*) which form a dense shaded canopy over the channel. Other associated riparian species include western ragweed (*Ambrosia psilostachya* var. *californica*), mule fat (*Baccharis salicifolia*), giant wildrye (*Elymus condensatus*), California flowering ash (*Fraxinus dipetala*), western sunflower (*Helianthus annuus*), toyon (*Heteromeles arbutifolia*), *sourclover (*Melilotus indicus*), *tree tobacco (*Nicotiana glauca*), western cottonwood (*Populus fremontii* subsp. *fremontii*), California scrub oak (*Quercus berberidifolia*), narrow-leaved willow (*Salix exigua*), red willow (*Salix laevigata*), arroyo willow (*Salix lasiolepis* var. *lasiolepis*), Mexican elderberry (*Sambucus mexicana*), *Mediterranean tamarisk (*Tamarix ramosissima*), poison oak (*Toxicodendron diversilobum*), hoary nettle (*Urtica dioica* subsp. *holosericea*), and cocklebur (*Xanthium strumarium* var. *canadense*). CDFG jurisdictional widths averaged 97.7 feet due to dense Riparian Forest vegetation, and the total jurisdiction was calculated to be 2.019 acres.

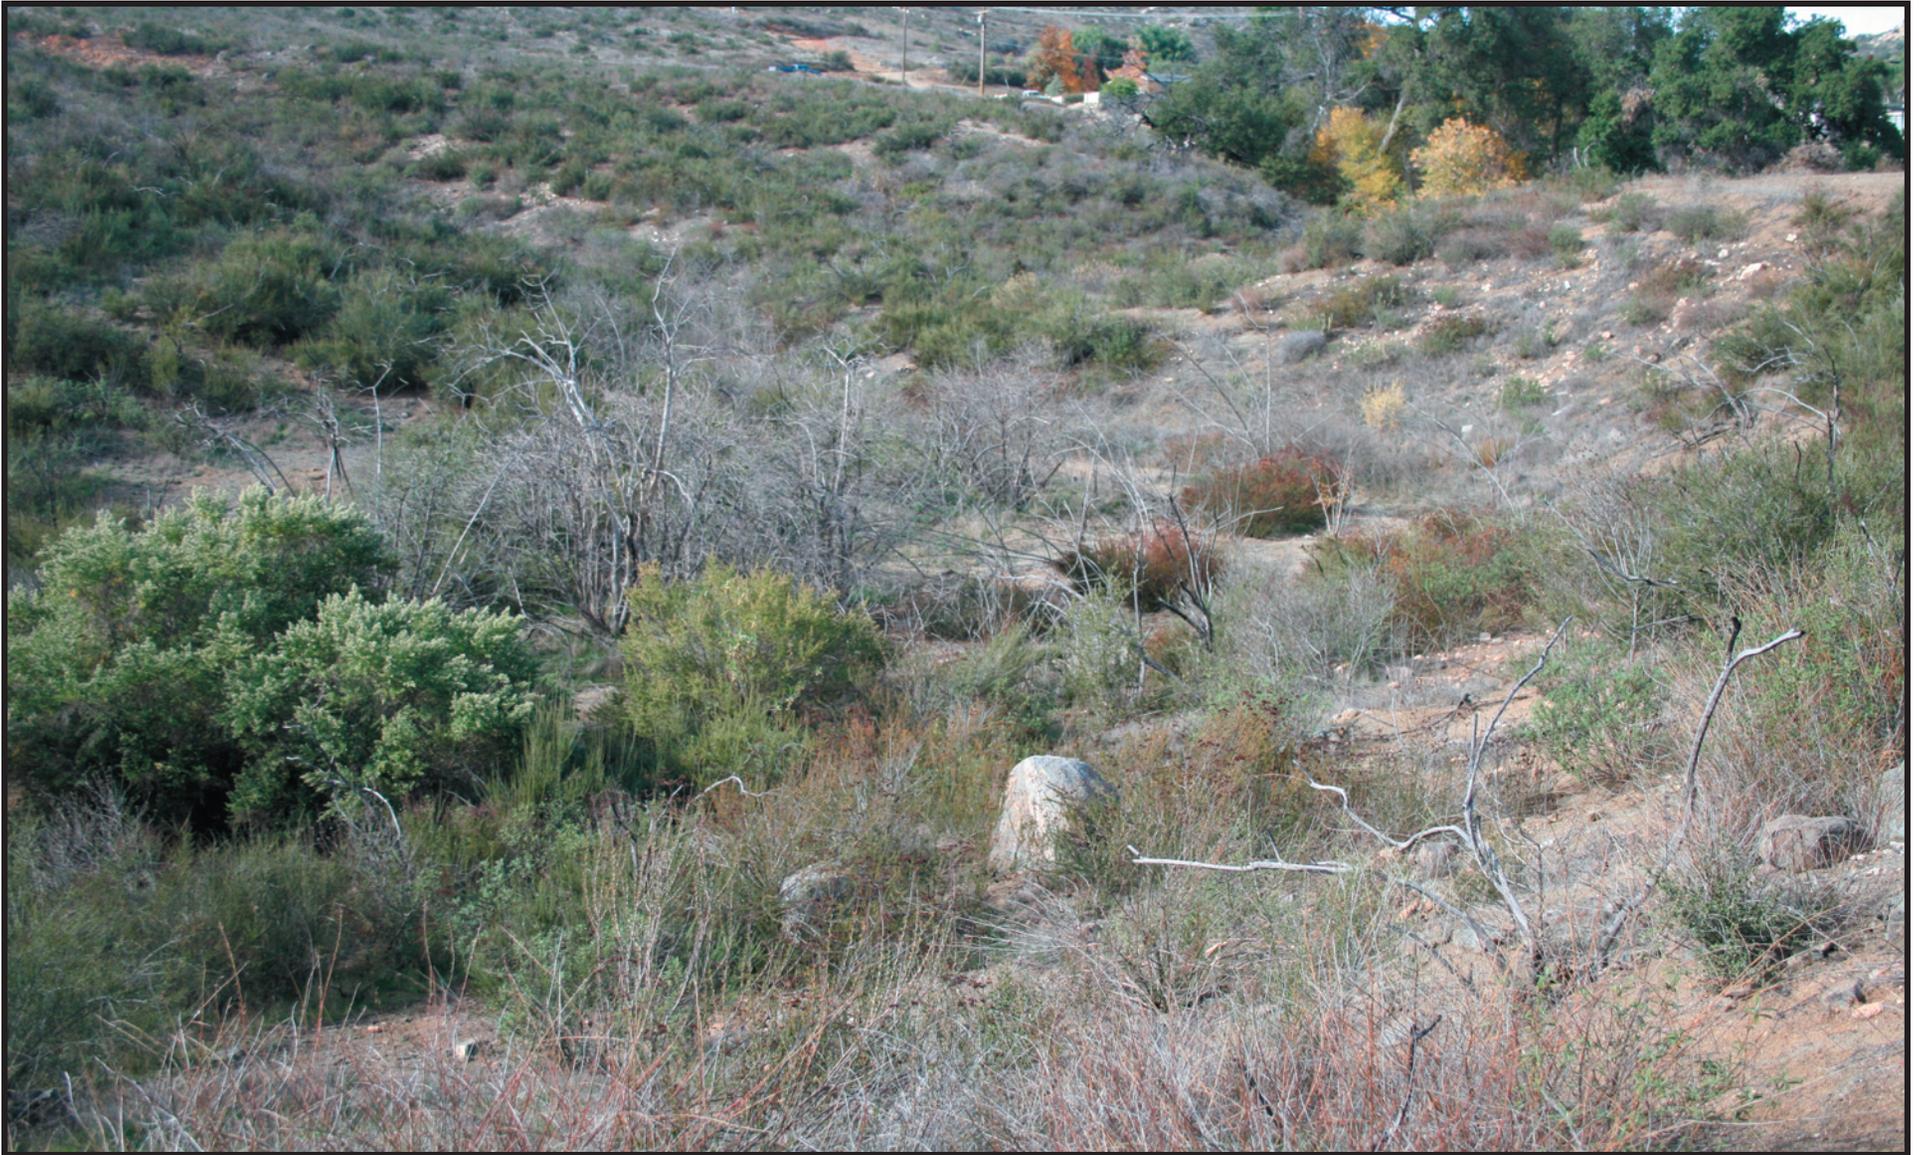
SITE PHOTOGRAPH 2

View of the upstream portion of Blueline Stream 2 located north of Bundy Canyon Road. It has an unvegetated channel composed of sandy loam, brown in color, with or without gravel. It is mostly shallow-incised, braided in one downstream reach, and cannot be detected adjacent to Bundy Canyon Road.

North of Bundy Canyon Road (2a on the exhibit), the blueline stream trends through a V-shaped valley. It is relatively undisturbed, with an unvegetated channel composed of sandy loam, brown in color, with or without gravel (**Site Photograph 2**). The channel is mostly shallow-incised. It is braided in one downstream reach, and cannot be detected beneath the dense riparian vegetation growing just north of Bundy Canyon Road. Corps jurisdictional widths averaged 2.7 feet, and the total Corps jurisdiction was calculated to be 0.040 acres.

Dense Riparian Forest vegetation is present where the blueline stream enters and exits the reach located north of Bundy Canyon Road. It is dominated by coast live oak trees (*Quercus agrifolia* var. *agrifolia*), with lesser amounts of chamise (*Adenostoma fasciculatum* var. *fasciculatum*) mule fat (*Baccharis salicifolia*), coyote brush (*Baccharis pilularis* subsp. *consanguinea*), giant wildrye (*Elymus condensatus*), California flowering ash (*Fraxinus dipetala*), western sunflower (*Helianthus annuus*), toyon (*Heteromeles arbutifolia*), western cottonwood (*Populus fremontii* subsp. *fremontii*), narrow-leaved willow (*Salix exigua*), red willow (*Salix laevigata*), and arroyo willow (*Salix lasiolepis* var. *lasiolepis*). CDFG jurisdictional widths averaged 36.1 feet, and the total CDFG jurisdiction was calculated to be 0.850 acres.

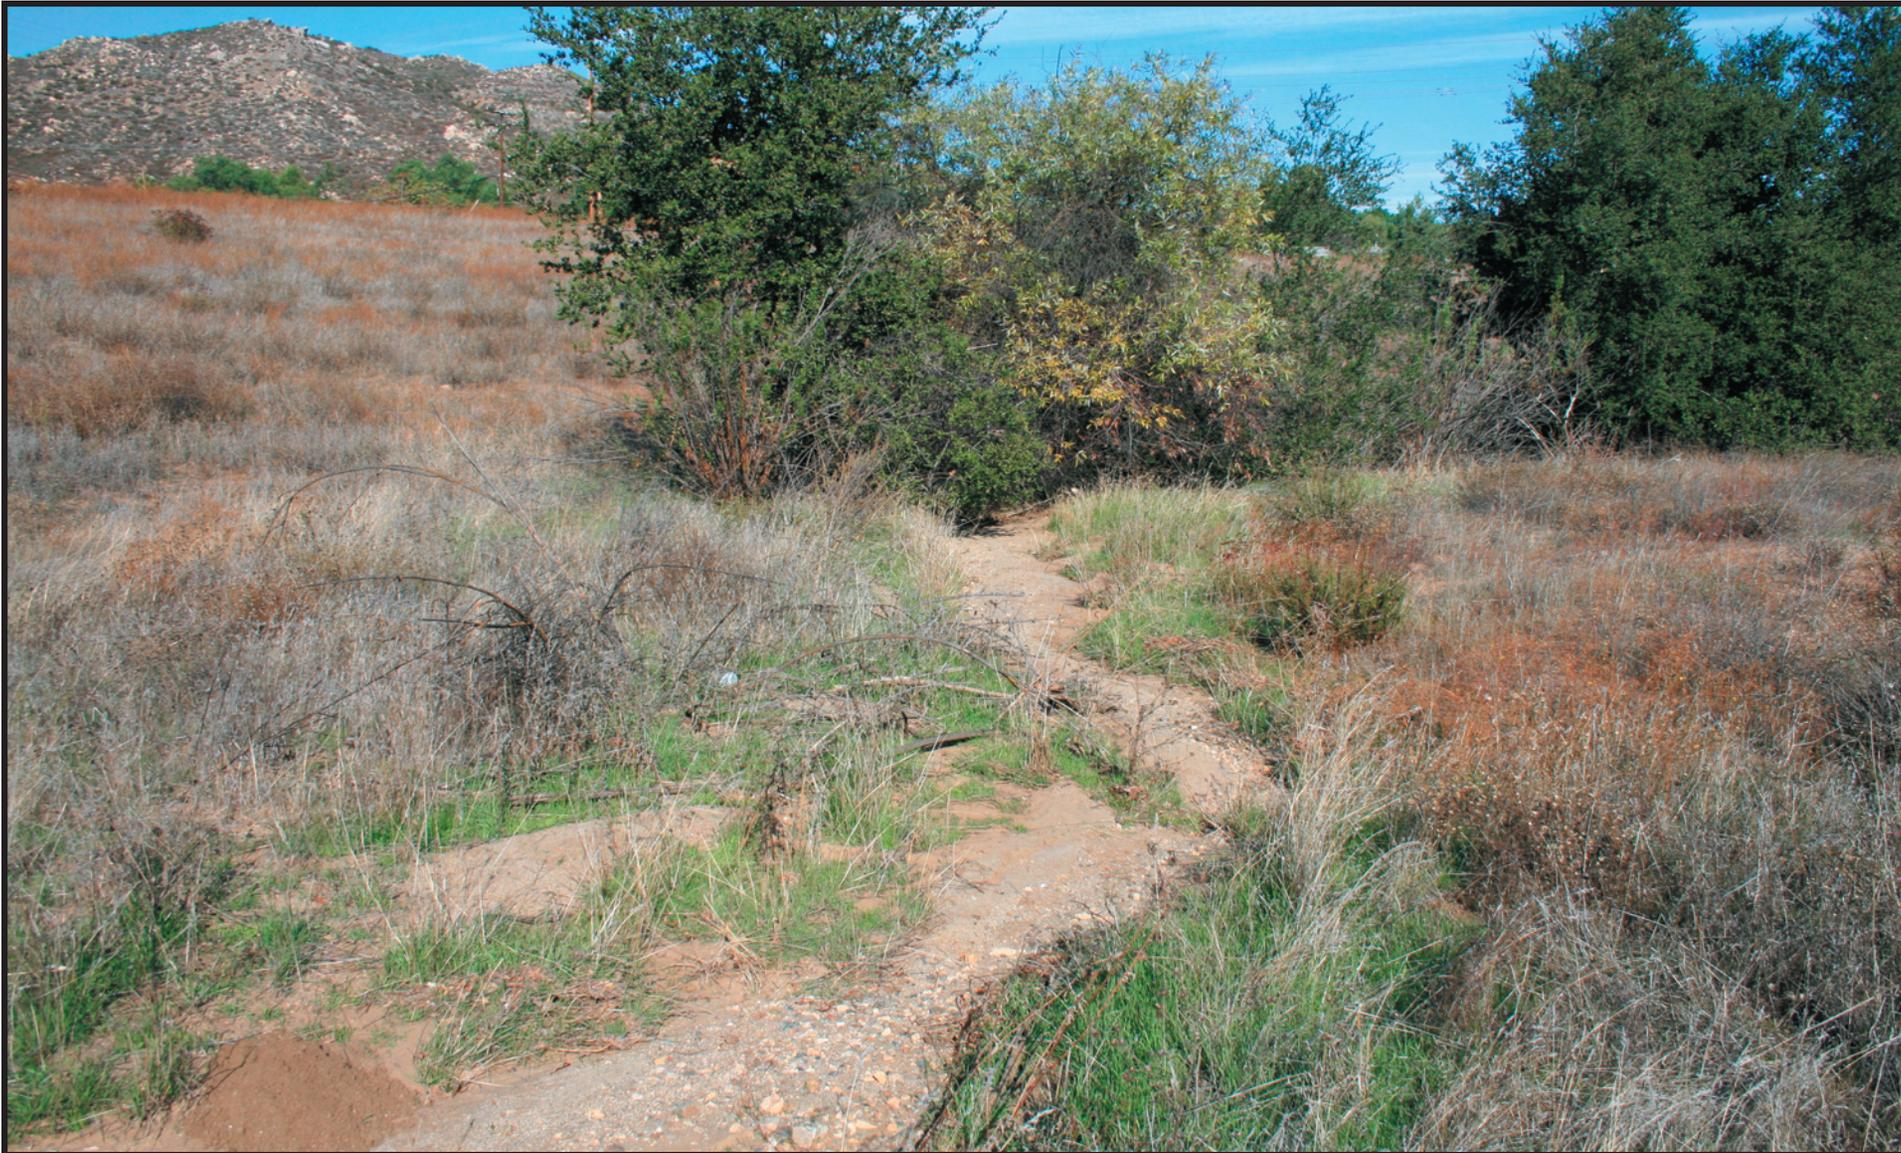
SITE PHOTOGRAPH 3

View of a portion of the channel of the unnamed Blueline Stream 2 located south of Bundy Canyon Road. It is shallow-incised and composed of sandy loam, brown in color, with or without gravels and cobbles. It trends through Grasslands, with isolated patches of riparian vegetation scattered alongside its banks.

South of Bundy Canyon Road (2b on the exhibit), the blueline stream trends through gentle rolling terrain that slopes downward to the north. It is highly disturbed, with a shallow-incised and unvegetated channel composed of sandy loam, brown in color, with or without gravels and cobbles (**Site Photograph 3**). The channel is buried beneath green waste adjacent to an old pump station. Corps jurisdictional widths averaged 2.2 feet, and the total Corps jurisdiction was calculated to be 0.082 acres.

The channel is unvegetated, except adjacent to Bundy Canyon Road. Otherwise, patches of riparian Forest vegetation are growing along its banks, and are separated by hundreds of feet of typical Grasslands vegetation. Coast live oak trees dominate the vegetation adjacent to Bundy Canyon Road (downstream), while the patches were dominated by mule fat (*Baccharis salicifolia*), western sunflower (*Helianthus annuus*), narrow-leaved willow (*Salix exigua*), arroyo willow (*Salix lasiolepis* var. *lasiolepis*), and an occasional red willow (*Salix laevigata*). The Grasslands vegetation growing alongside of the channel includes western ragweed (*Ambrosia psilostachya* var. *californica*), *cultivated oats (*Avena sativa*), *shortpod mustard (*Brassica geniculata*), *brome grasses (*Bromus diandrus* and *B. madritensis* subsp. *rubens*), fascicled tarplant (*Deinandra fasciculata*), leafy daisy (*Erigeron foliosus* var. *foliosus*), interior California buckwheat (*Eriogonum fasciculatum* subsp. *foliolosum*), California matchweed (*Gutierrezia californica*), slender sunflower (*Helianthus gracilentus*), valley lessingia (*Lessingia glandulifera* var. *glandulifera*), Granny's hairnet (*Pterostegia drymarioides*), and virgate wreath-plant (*Stephanomeria virgata* subsp. *virgata*). CDFG jurisdictional widths averaged 11.7 feet, and the total CDFG jurisdiction was calculated to be 0.430 acres.

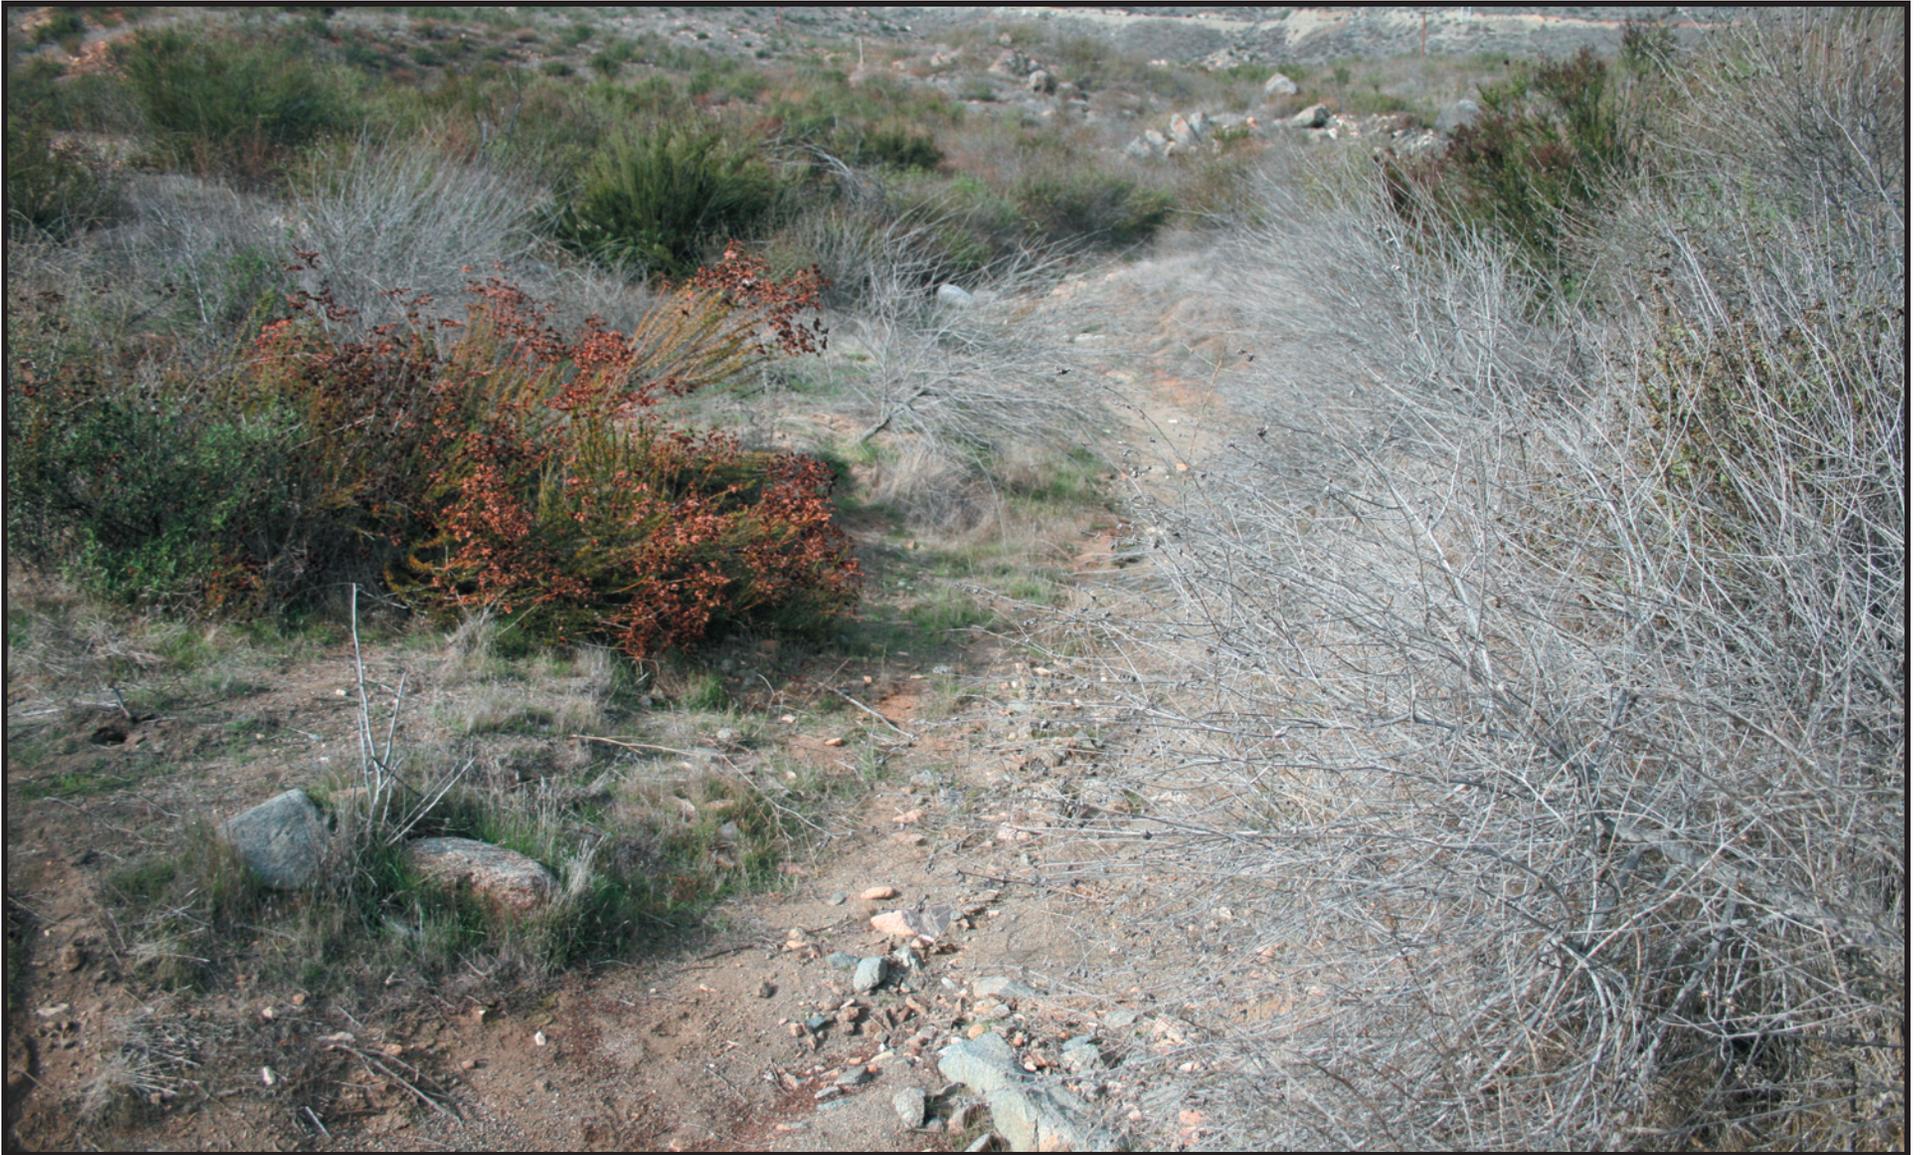
SITE PHOTOGRAPH 4

View of a portion of the channel of unnamed Blueline Stream 3. It is shallow-incised, unvegetated and composed of sandy loam, gray in color, with or without gravels, cobbles and boulders. The banks are vegetated with typical Chaparral species (no riparian component).

Blueline Stream 3 is an intermittent blueline stream that originates on the Sedco Hills located north of Bundy Canyon Road. It enters the site at an elevation of 1860 feet, about 1,300 feet from its origin on the Sedco Hills. It trends northwest-to-southeast through a steep-sloped V-shaped valley to Bundy Canyon Road, then continues through The Farm in a drainage easement. It is undisturbed, with a shallow-incised and unvegetated channel composed of sandy loam, gray in color, with or without gravels, cobbles and boulders (**Site Photograph 4**). Its total length on the site is 1,826 feet. Corps jurisdictional widths averaged 4.0 feet, and the total jurisdiction was calculated to be 0.167 acres. Without the presence of riparian vegetation, the total CDFG jurisdiction was also calculated to be 0.167 acres.

The banks of this blueline stream are vegetated with typical Chaparral species, including chamise (*Adenostoma fasciculatum* var. *fasciculatum*), thick-leaved lilac (*Ceanothus crassifolius* var. *crassifolius*), interior California buckwheat (*Eriogonum fasciculatum* subsp. *foliolosum*), and black sage (*Salvia mellifera*). Understory species include *shortpod mustard (*Brassica geniculata*), *brome grasses (*Bromus diandrus* and *B. madritensis* subsp. *rubens*), California everlasting (*Gnaphalium californicum*), and slender sunflower (*Helianthus gracilentus*).
