3.8-1 JURISDICTIONAL DELINEATION OF WATERS AND WETLANDS

DECEMBER 2010

**JURISDICTIONAL DELINEATION
OF WATERS AND WETLANDS**

PREVIOUS TRACT 28416

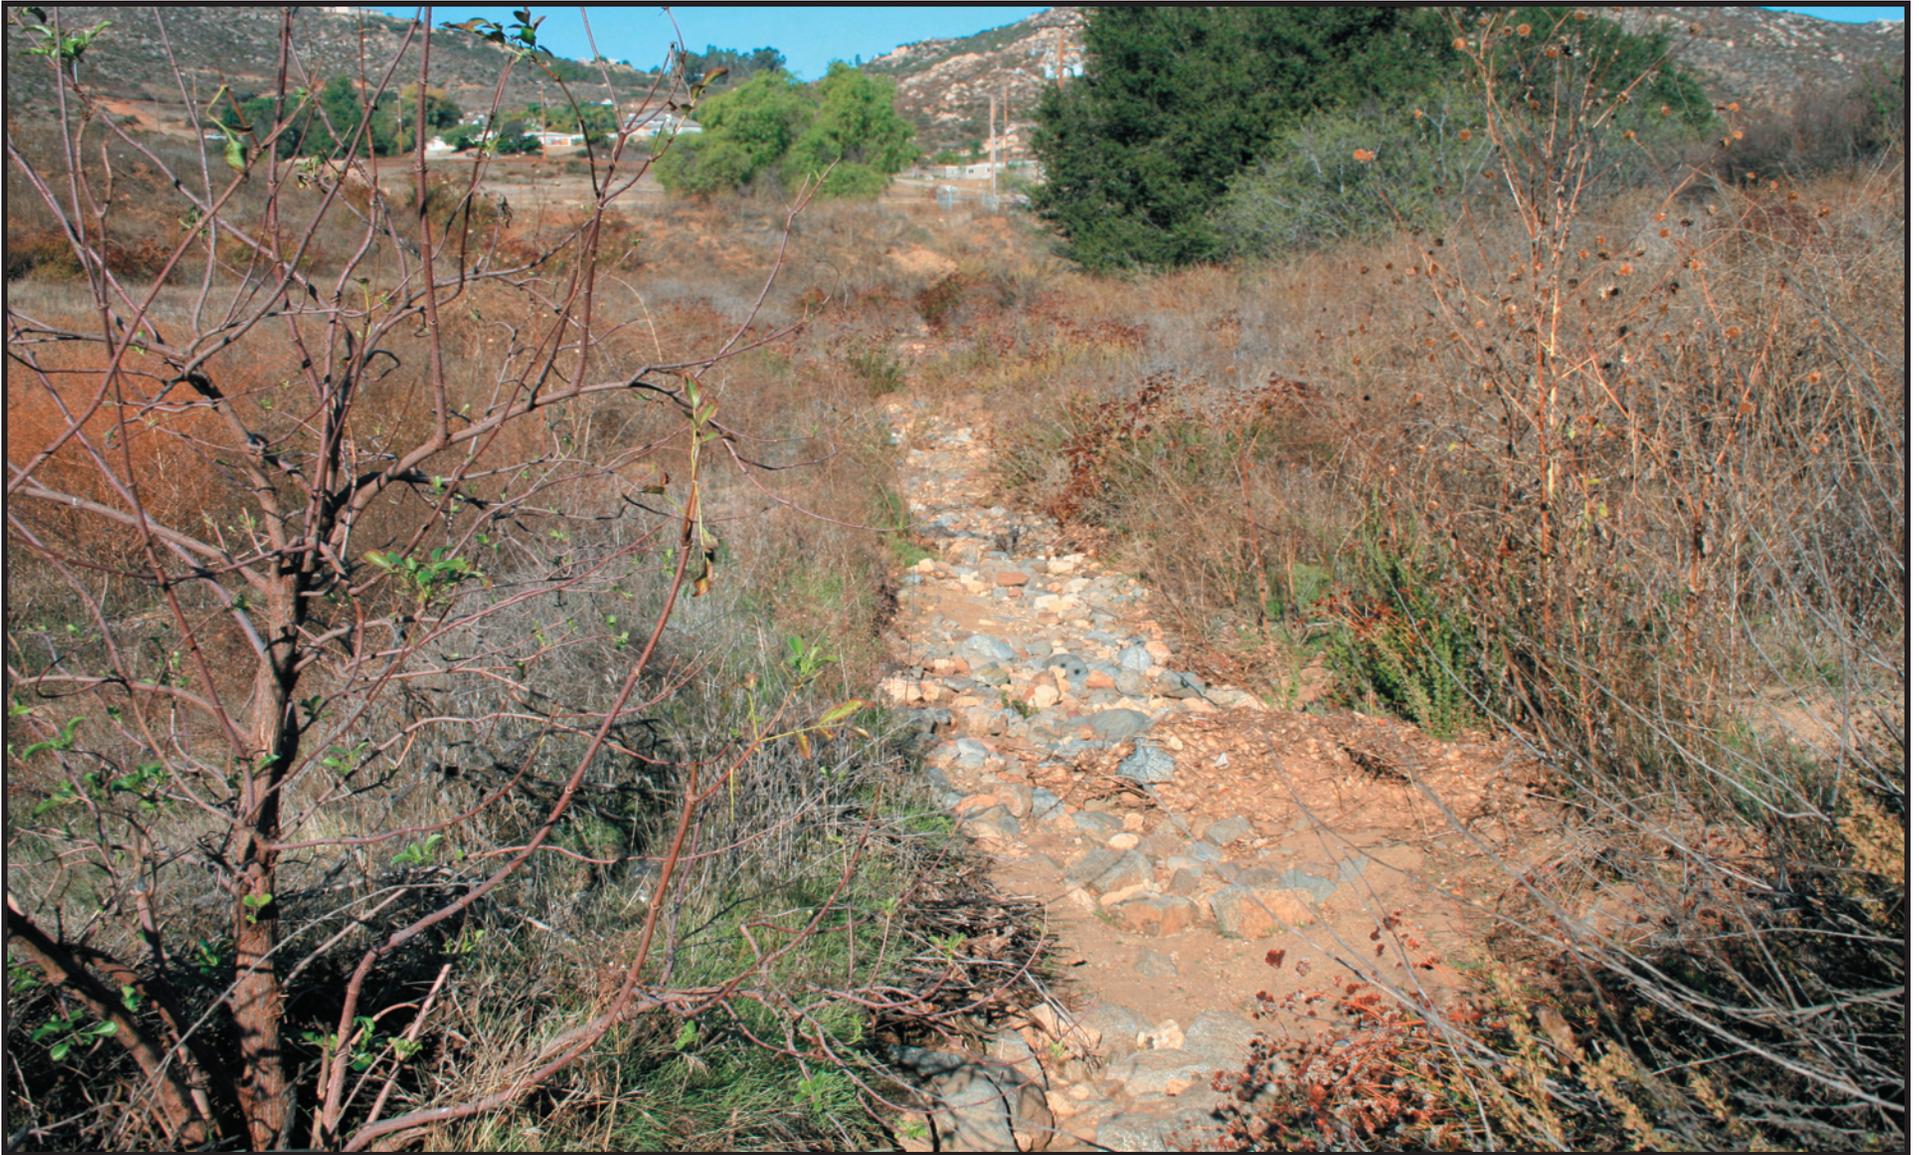
SITE PHOTOGRAPH 5

View of a portion of the channel of Watercourse A. It is unvegetated, and composed of sandy loam, brown in color, with or without gravels and cobbles. The upper-half is shallow-incised and vegetated with Chaparral species, while the lower-half is vegetated with Grasslands species and patches of riparian vegetation.

Watercourse A is ephemeral, and appears to originate downstream of a pond that was previously built on The Farm. On the site, it trends south for 1,431 feet before its confluence with Blueline Stream 2. Its steep-sloping upper-half is relatively undisturbed, and trends north through a V-shaped valley. The lower-half opens onto gentle rolling terrain. A culvert crossing has been constructed through the lower-half, and much of the reach is covered by green waste. The channel is unvegetated, and composed of sandy loam, brown in color, with or without gravels and cobbles (**Site Photograph 5**). Corps jurisdictional widths averaged 3.0 feet, and the total jurisdictional area was calculated to be 0.097 acres.

The upper-half channel is shallow-incised and its banks are vegetated with typical Chaparral species and three isolated riparian plants. The Chaparral species include chamise (*Adenostoma fasciculatum* var. *fasciculatum*), coastal sagebrush (*Artemisia californica*), thick-leaved lilac (*Ceanothus crassifolius* var. *crassifolius*), interior California buckwheat (*Eriogonum fasciculatum* subsp. *foliolosum*), yellow bush-penstemon (*Keckiella antirrhinoides* subsp. *antirrhinoides*), spiny redberry (*Rhamnus crocea*), and black sage (*Salvia mellifera*), while the riparian species include coast live oak (*Quercus agrifolia* var. *agrifolia*), mule fat (*Baccharis salicifolia*), and arroyo willow (*Salix lasiolepis*).

The lower-half channel is also shallow-incised, but its banks are vegetated with typical Grasslands species and patches of riparian vegetation. The Grasslands vegetation growing alongside of the channel includes *cultivated oats (*Avena sativa*), *shortpod

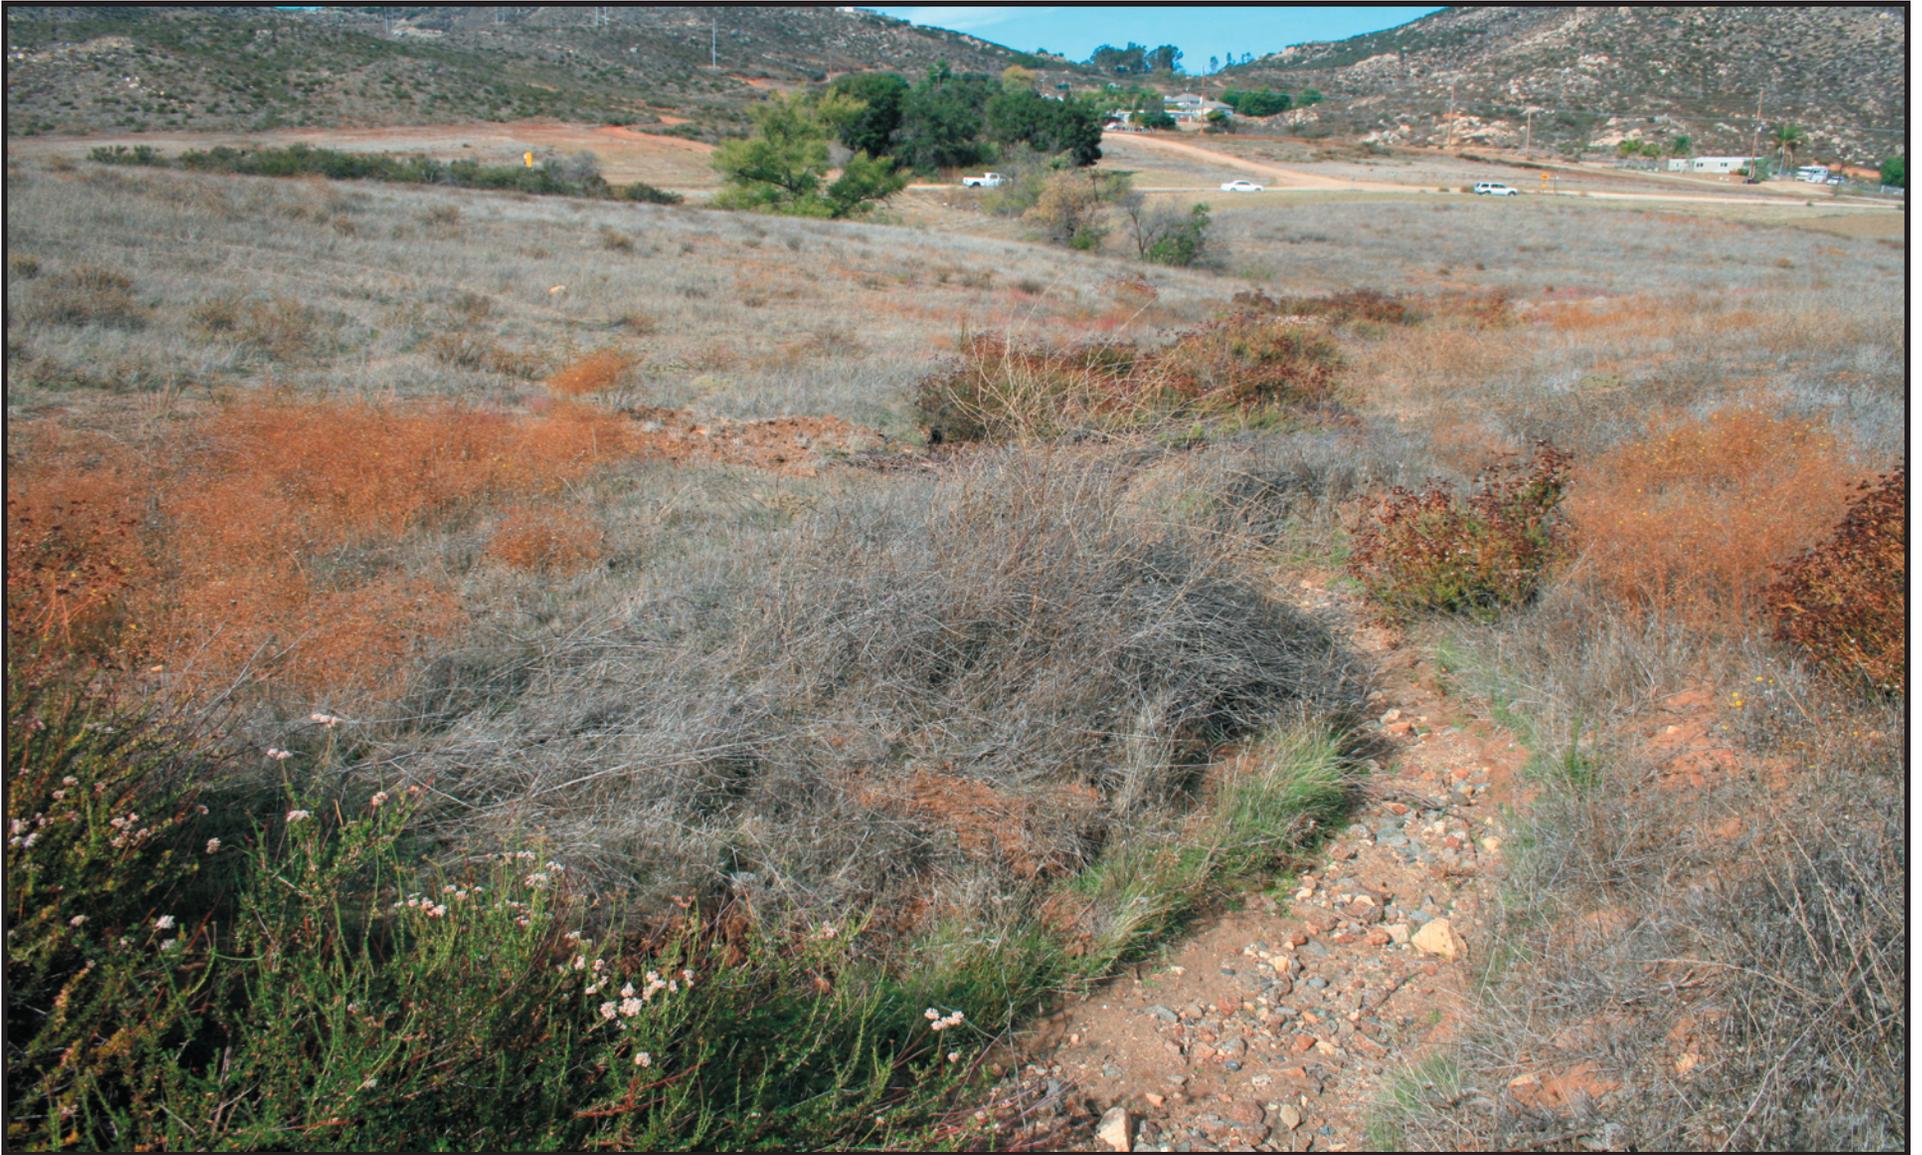
SITE PHOTOGRAPH 6

View of a portion of the channel of Watercourse B. It enters the site via a culvert beneath Homestead Lane. It is unvegetated, and composed of sandy loam, brown in color, with or without gravels and cobbles. It is shallow-incised with banks vegetated with Grasslands species and one small patch of riparian vegetation.

Watercourse B is ephemeral, and originates in a developed portion of The Farm. On the site, it trends south for 731 feet before its confluence with Blueline Stream 2. It enters the site via a culvert beneath Homestead Lane. Its upper portion is relatively steep-sloping, while its lower portion opens onto gentle rolling terrain. The channel is unvegetated, and composed of sandy loam, brown in color, with or without gravels and cobbles (**Site Photograph 6**). Below the culvert, boulder rip-rap has been placed in the channel. Corps jurisdictional widths averaged 2.0 feet, and the total jurisdictional area was calculated to be 0.033 acres.

The channel is shallow-incised, except where erosion has cut approximately one foot into the soil at a seldom used dirt road crossing. The banks are vegetated with typical Grasslands species and one small patch of riparian vegetation. The Grasslands vegetation includes *shortpod mustard (*Brassica geniculata*), *brome grasses (*Bromus diandrus* and *B. madritensis* subsp. *rubens*), leafy daisy (*Erigeron foliosus* var. *foliosus*), interior California buckwheat (*Eriogonum fasciculatum* subsp. *foliolosum*), valley lessingia (*Lessingia glandulifera* var. *glandulifera*), *common horehound (*Marrubium vulgare*), and *tree tobacco (*Nicotiana glauca*). The small patch of riparian vegetation includes a few mule fat (*Baccharis salicifolia*) and arroyo willow (*Salix lasiolepis* var. *lasiolepis*). CDFG jurisdictional widths averaged 1.2 feet, and the total jurisdictional area was calculated to be 0.020 acres.

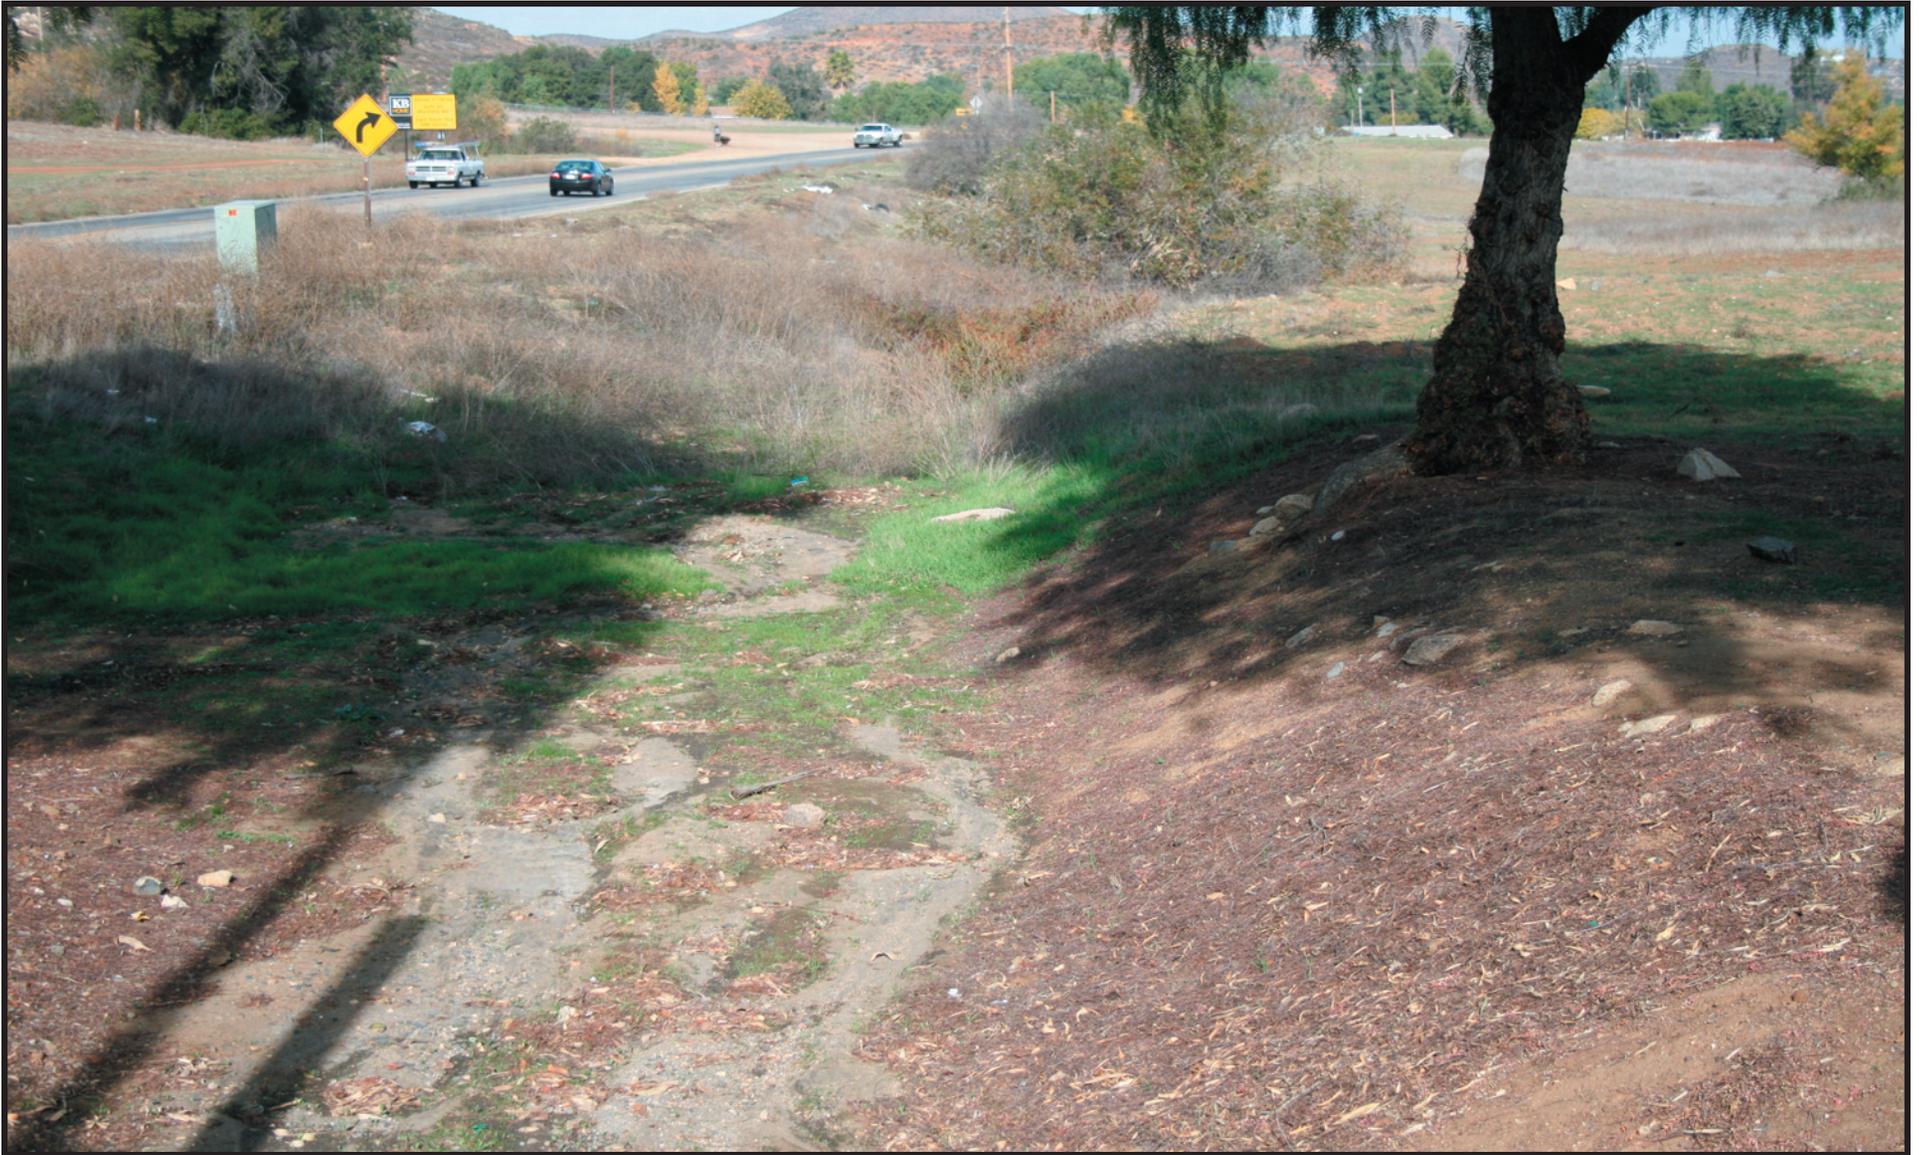
SITE PHOTOGRAPH 7

View of a portion of the channel of Watercourse. It enters the site via a culvert placed beneath the intersection of Bundy Canyon Rd. and Harvest Way. The channel disappears in active agricultural land, and continues as sheet flow until a channel reappears before its confluence with Blueline Stream 2.

Watercourse C is ephemeral, and enters the site via a culvert placed beneath the intersection of Bundy Canyon Road and Harvest Way. It parallels Bundy Canyon Road through agricultural land for approximately 250 feet before signs of jurisdiction end. It continues as sheet flow for approximately 150 feet through the agricultural land until the channel reappears. It then trends for approximately 250 feet before its confluence with Blueline Stream 2. The channel is sparsely vegetated, and composed of sandy loam, brown in color, with or without gravels and cobbles (**Site Photograph 7**). Corps

jurisdictional widths averaged 1.2 feet, and the total jurisdictional area was calculated to be 0.011 acres.

The channel is shallow-incised, and is vegetated with typical Grasslands vegetation and two small patches of riparian vegetation. The Grasslands vegetation includes *shortpod mustard (*Brassica geniculata*), *brome grasses (*Bromus diandrus* and *B. madritensis* subsp. *rubens*), leafy daisy (*Erigeron foliosus* var. *foliosus*), interior California buckwheat (*Eriogonum fasciculatum* subsp. *foliolosum*), valley lessingia (*Lessingia glandulifera* var. *glandulifera*), *common horehound (*Marrubium vulgare*), and *tree tobacco (*Nicotiana glauca*). The riparian vegetation includes mule fat (*Baccharis salicifolia*) and arroyo willow (*Salix lasiolepis* var. *lasiolepis*). CDFG jurisdictional widths averaged 3.5 feet, and the total CDFG jurisdiction was calculated to be 0.050 acres.

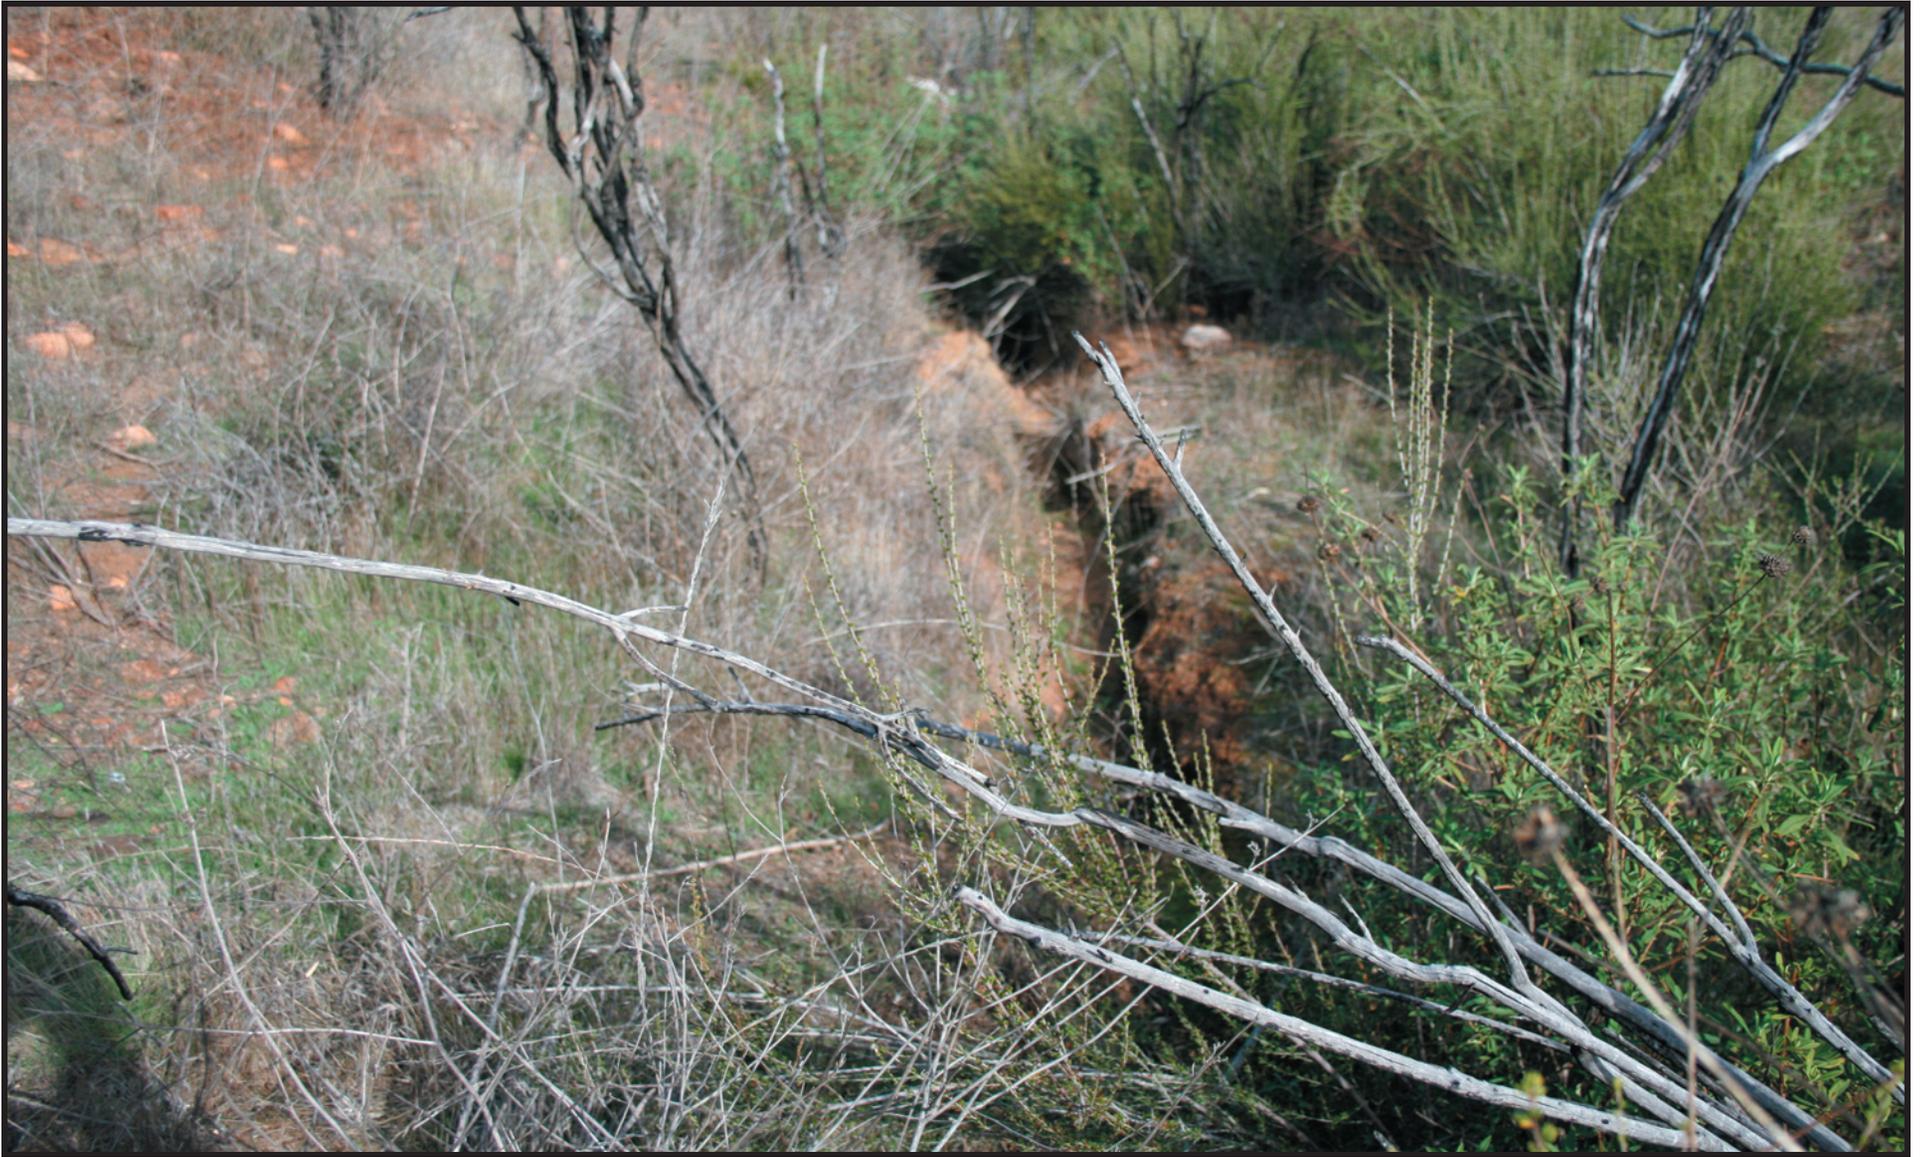
SITE PHOTOGRAPH 8

View of a portion of the channel of Watercourse D. A metal trough has been placed in the channel. It is unvegetated, and composed of sandy loam, brown in color, with or without gravels and cobbles. It is mostly vegetated with Chaparral vegetation, but downstream it merges with Riparian Forest vegetation.

Watercourse D is ephemeral, and originates on the Sedco Hills located north of Bundy Canyon Road. It is a tributary of Blueline Stream 2. It begins downstream of a dirt road where a metal trough has been placed in the channel to prevent or reduce erosion from storm water runoff. It trends for 436 feet southwest-to-northeast through a narrow valley to its confluence with Blueline Stream 2. The channel is unvegetated, and composed of sandy loam, brown in color, with or without gravels and cobbles (**Site Photograph 8**). Corps jurisdictional widths averaged 2.0 feet, and the total jurisdictional area was calculated to be 0.020 acres.

The channel is shallow-incised, except where erosion has cut deeply into the soil. Upstream, it is vegetated with typical Chaparral vegetation, while downstream it merges with the large patch of Riparian Forest vegetation growing in a depression where Blueline Stream 2 enters the site. The sparse Chaparral vegetation includes chamise (*Adenostoma fasciculatum* var. *fasciculatum*), thick-leaved lilac (*Ceanothus crassifolius* var. *crassifolius*), interior California buckwheat (*Eriogonum fasciculatum* subsp. *foliolosum*), and black sage (*Salvia mellifera*). Understory species include *shortpod mustard (*Brassica geniculata*) and *brome grasses (*Bromus diandrus* and *B. madritensis* subsp. *rubens*). The Riparian Forest vegetation includes mule fat (*Baccharis salicifolia*), California flowering ash (*Fraxinus dipetala*), western cottonwood (*Populus fremontii* subsp. *fremontii*), coast live oak (*Quercus agrifolia* var. *agrifolia*), narrow-leaved willow (*Salix exigua*), red willow (*Salix laevigata*), and arroyo willow (*Salix lasiolepis* var. *lasiolepis*). CDFG jurisdictional widths averaged 2.0 feet, and the total CDFG jurisdiction area was calculated to be 0.020 acres. Note that the CDFG jurisdictional vegetation acreage for Watercourse D is included with the total CDFG jurisdiction calculated for Blueline Stream 2 (2a).

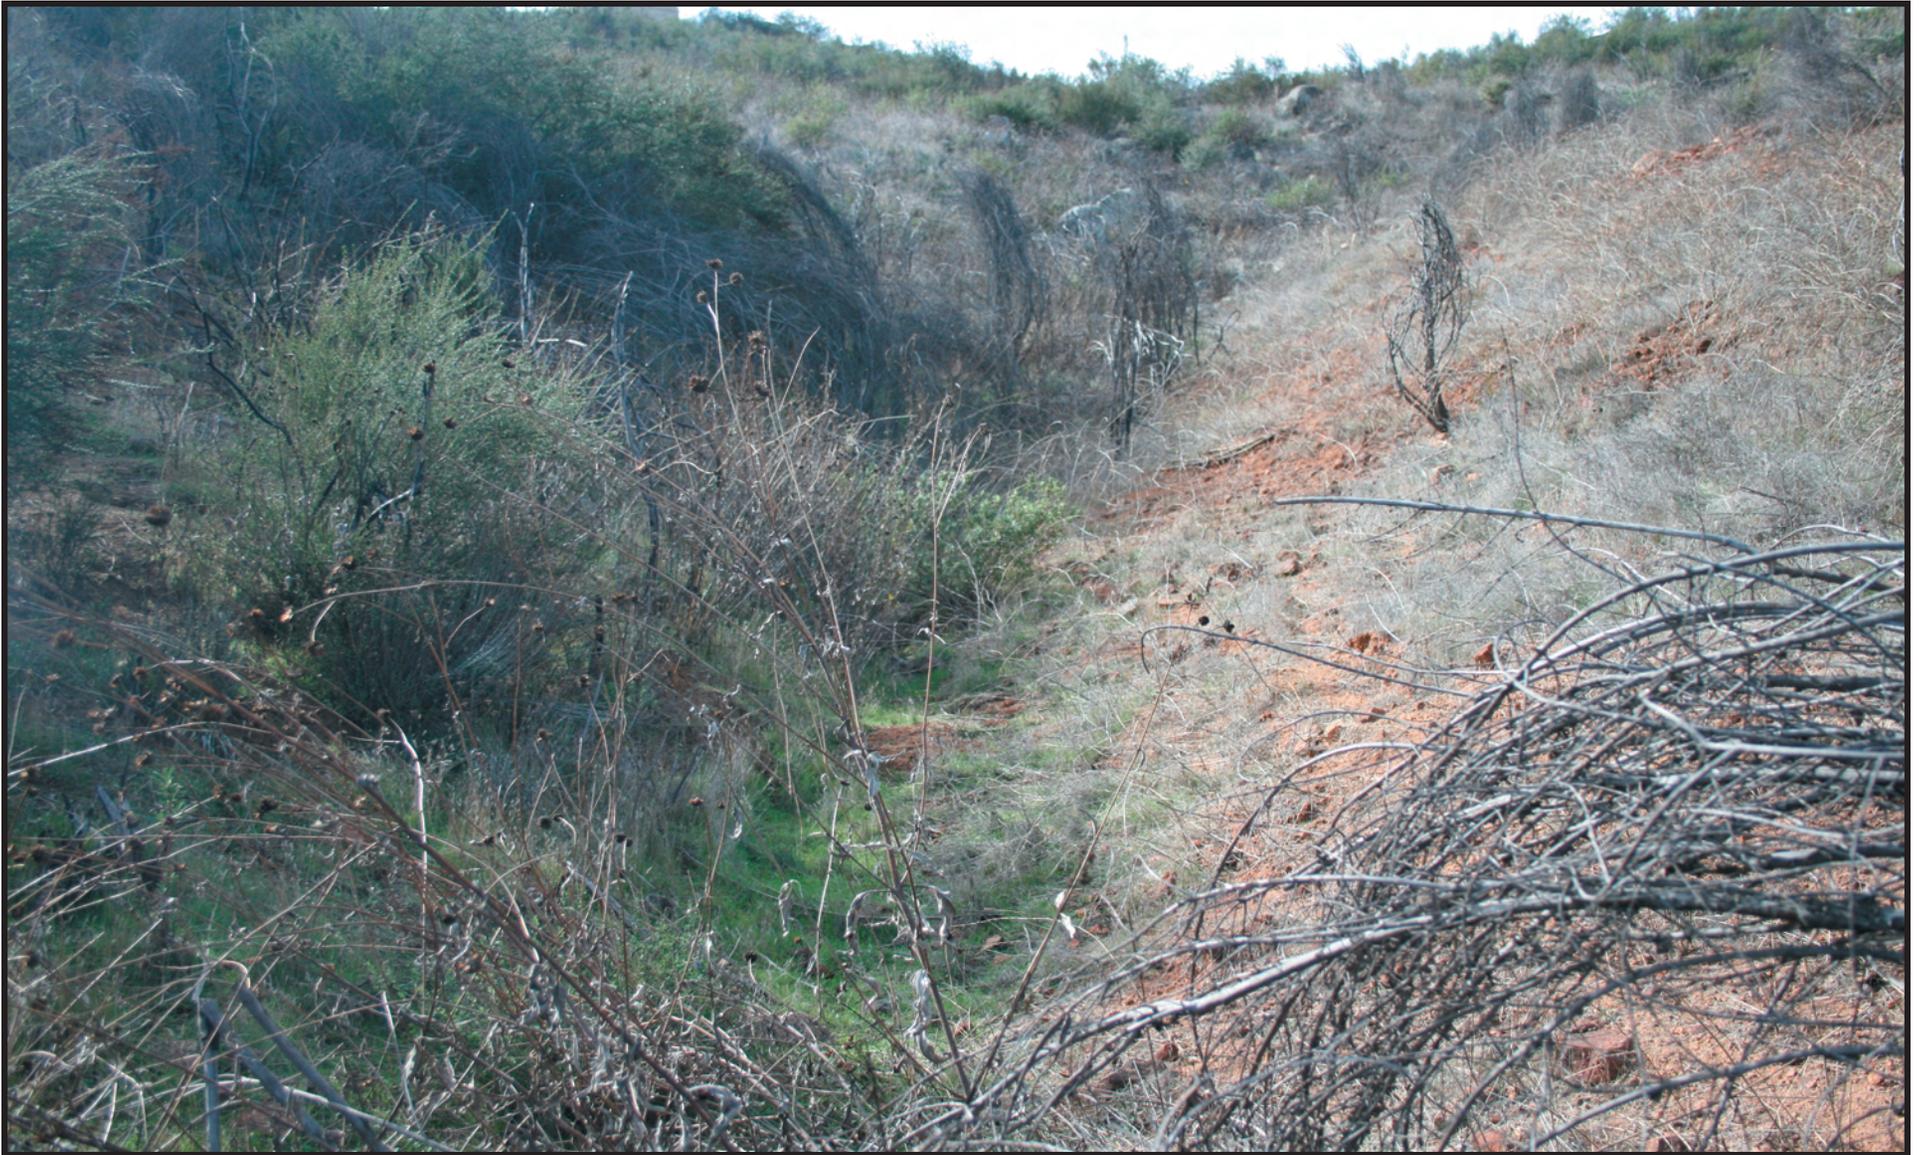
SITE PHOTOGRAPH 9

View of a portion of the channel of Watercourse E. It is ephemeral, and originates on the Sedco Hills. It has a shallow-incised channel composed of sandy loam, brown in color, with or without gravels. It is carpeted with Grasslands vegetation upstream and Chaparral vegetation downstream.

east through a steep-sloped V-shaped valley to its confluence with Blueline Stream 2. It is undisturbed, but the surrounding hillsides have been burned by wildfire. It has a shallow-incised channel composed of sandy loam, brown in color, with or without gravels (**Site Photograph 9**). Its total length on the site is 304 feet. Corps jurisdictional widths averaged 1.5 feet, and the total jurisdiction was calculated to be 0.010 acres. Without the presence of riparian vegetation, the total CDFG jurisdiction was also calculated to be 0.010 acres.

The upper half of this watercourse's channel is carpeted with *brome grasses (*Bromus diandrus* and *B. madritensis* subsp. *rubens*), while the lower half is unvegetated. Dense Chaparral vegetation is growing along its banks, including chamise (*Adenostoma fasciculatum* var. *fasciculatum*), thick-leaved lilac (*Ceanothus crassifolius* var. *crassifolius*), interior California buckwheat (*Eriogonum fasciculatum* subsp. *foliolosum*), and black sage (*Salvia mellifera*). Understory species are mostly limited to *brome grasses (*Bromus diandrus* and *B. madritensis* subsp. *rubens*).

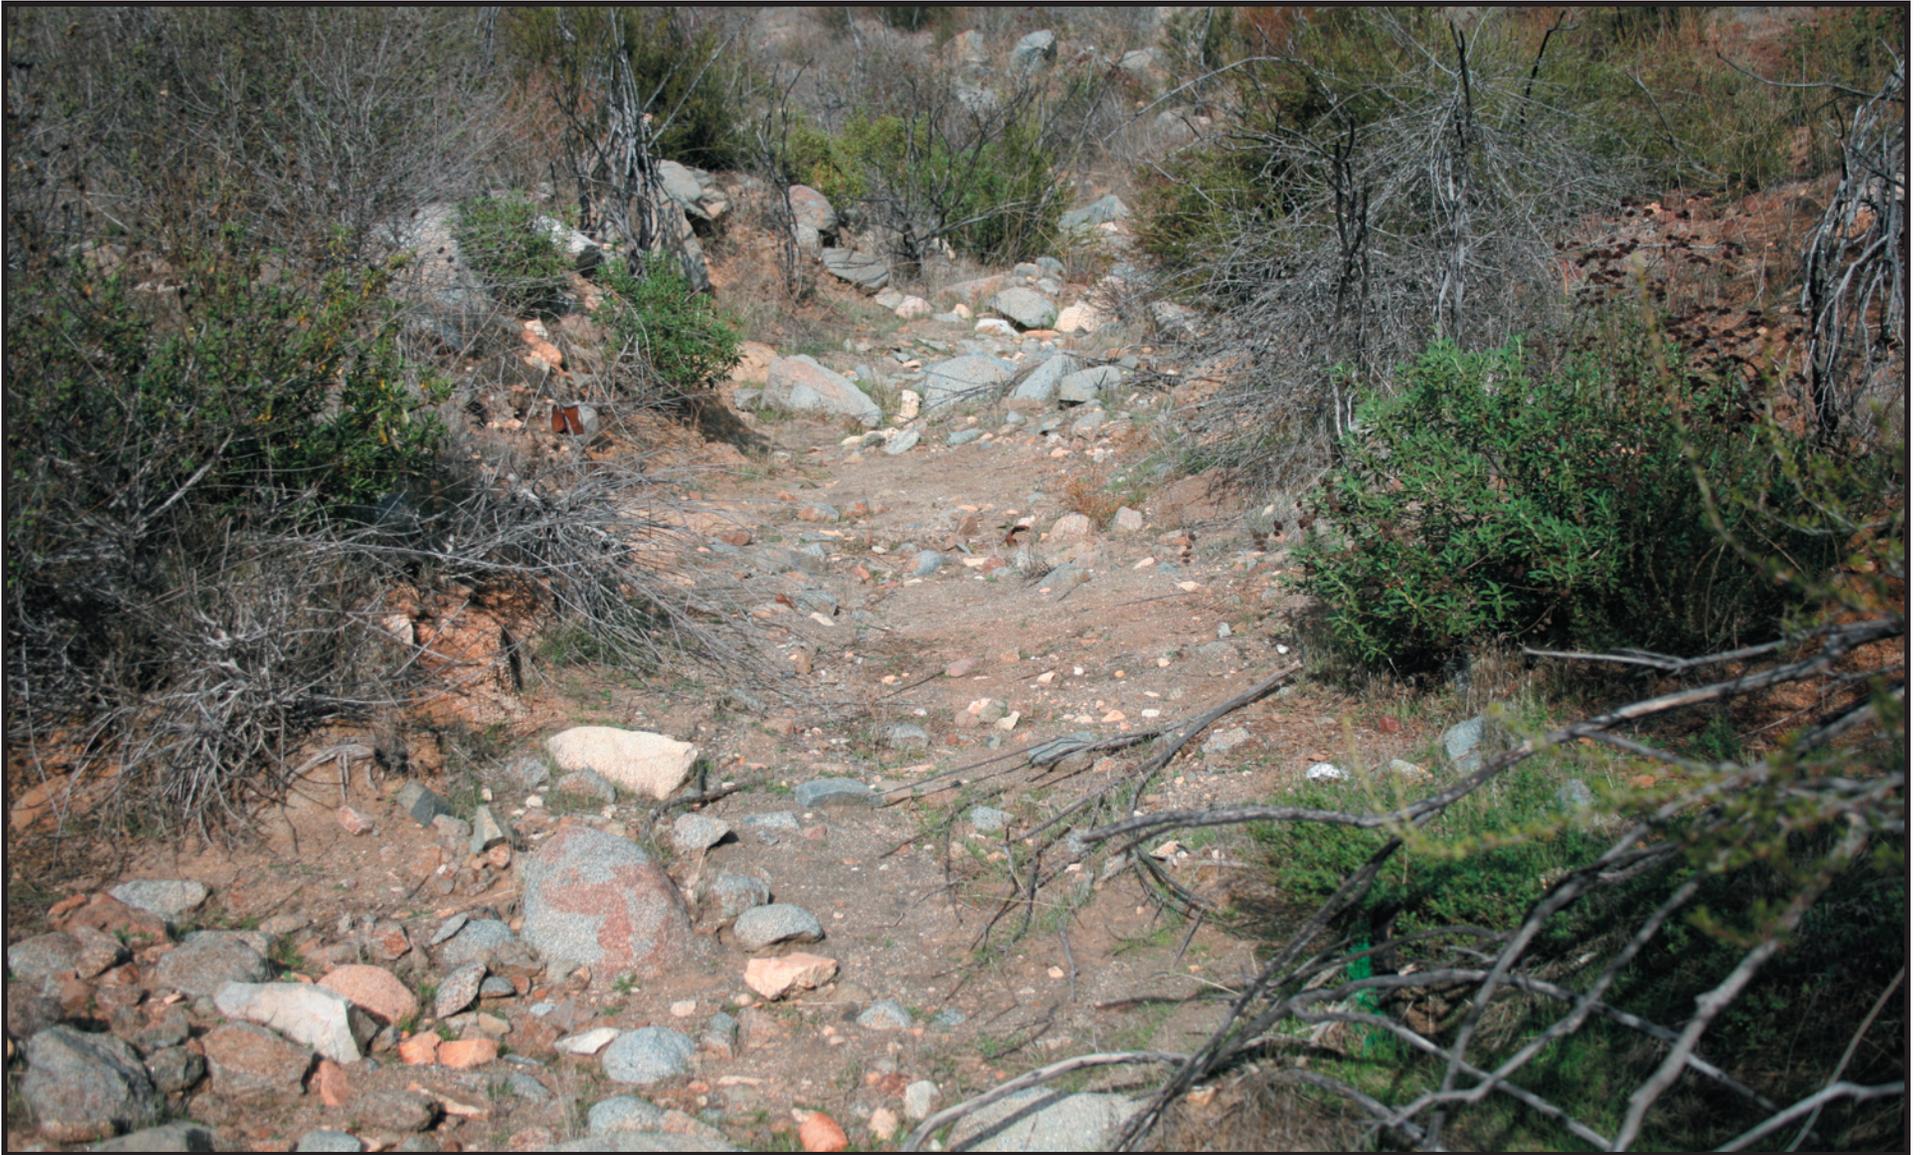
SITE PHOTOGRAPH 10

View of a portion of the channel of Watercourse F. It is also ephemeral, and originates on the Sedco Hills. It is shallow-incised, and composed of sandy loam, brown in color, with or without gravels, cobbles and boulders. The banks are vegetated with Chaparral species.

Watercourse F is ephemeral, and originates on the Sedco Hills located north of Bundy Canyon Road and off the site. It is also a tributary of Blueline Stream 2. It trends northwest-to-southeast through a relatively steep-sloped V-shaped valley to its confluence with Blueline Stream 2. It is undisturbed, but the surrounding hillsides have been burned by wildfire. The channel is shallow-incised and unvegetated, and composed of sandy loam, brown in color, with or without gravels, cobbles and boulders (**Site Photograph 10**). Its total length on the site is 689 feet. Corps jurisdictional widths averaged 1.7 feet, and the total jurisdictional area was calculated to be 0.027 acres. Without the presence of riparian vegetation, the total CDFG jurisdiction was also calculated to be 0.027 acres.

The banks of this blueline stream are sparsely vegetated with typical Chaparral species, including chamise (*Adenostoma fasciculatum* var. *fasciculatum*), thick-leaved lilac (*Ceanothus crassifolius* var. *crassifolius*), interior California buckwheat (*Eriogonum fasciculatum* subsp. *foliolosum*), and black sage (*Salvia mellifera*). Understory species include *shortpod mustard (*Brassica geniculata*), *brome grasses (*Bromus diandrus* and *B. madritensis* subsp. *rubens*), California everlasting (*Gnaphalium californicum*), and slender sunflower (*Helianthus gracilentus*).

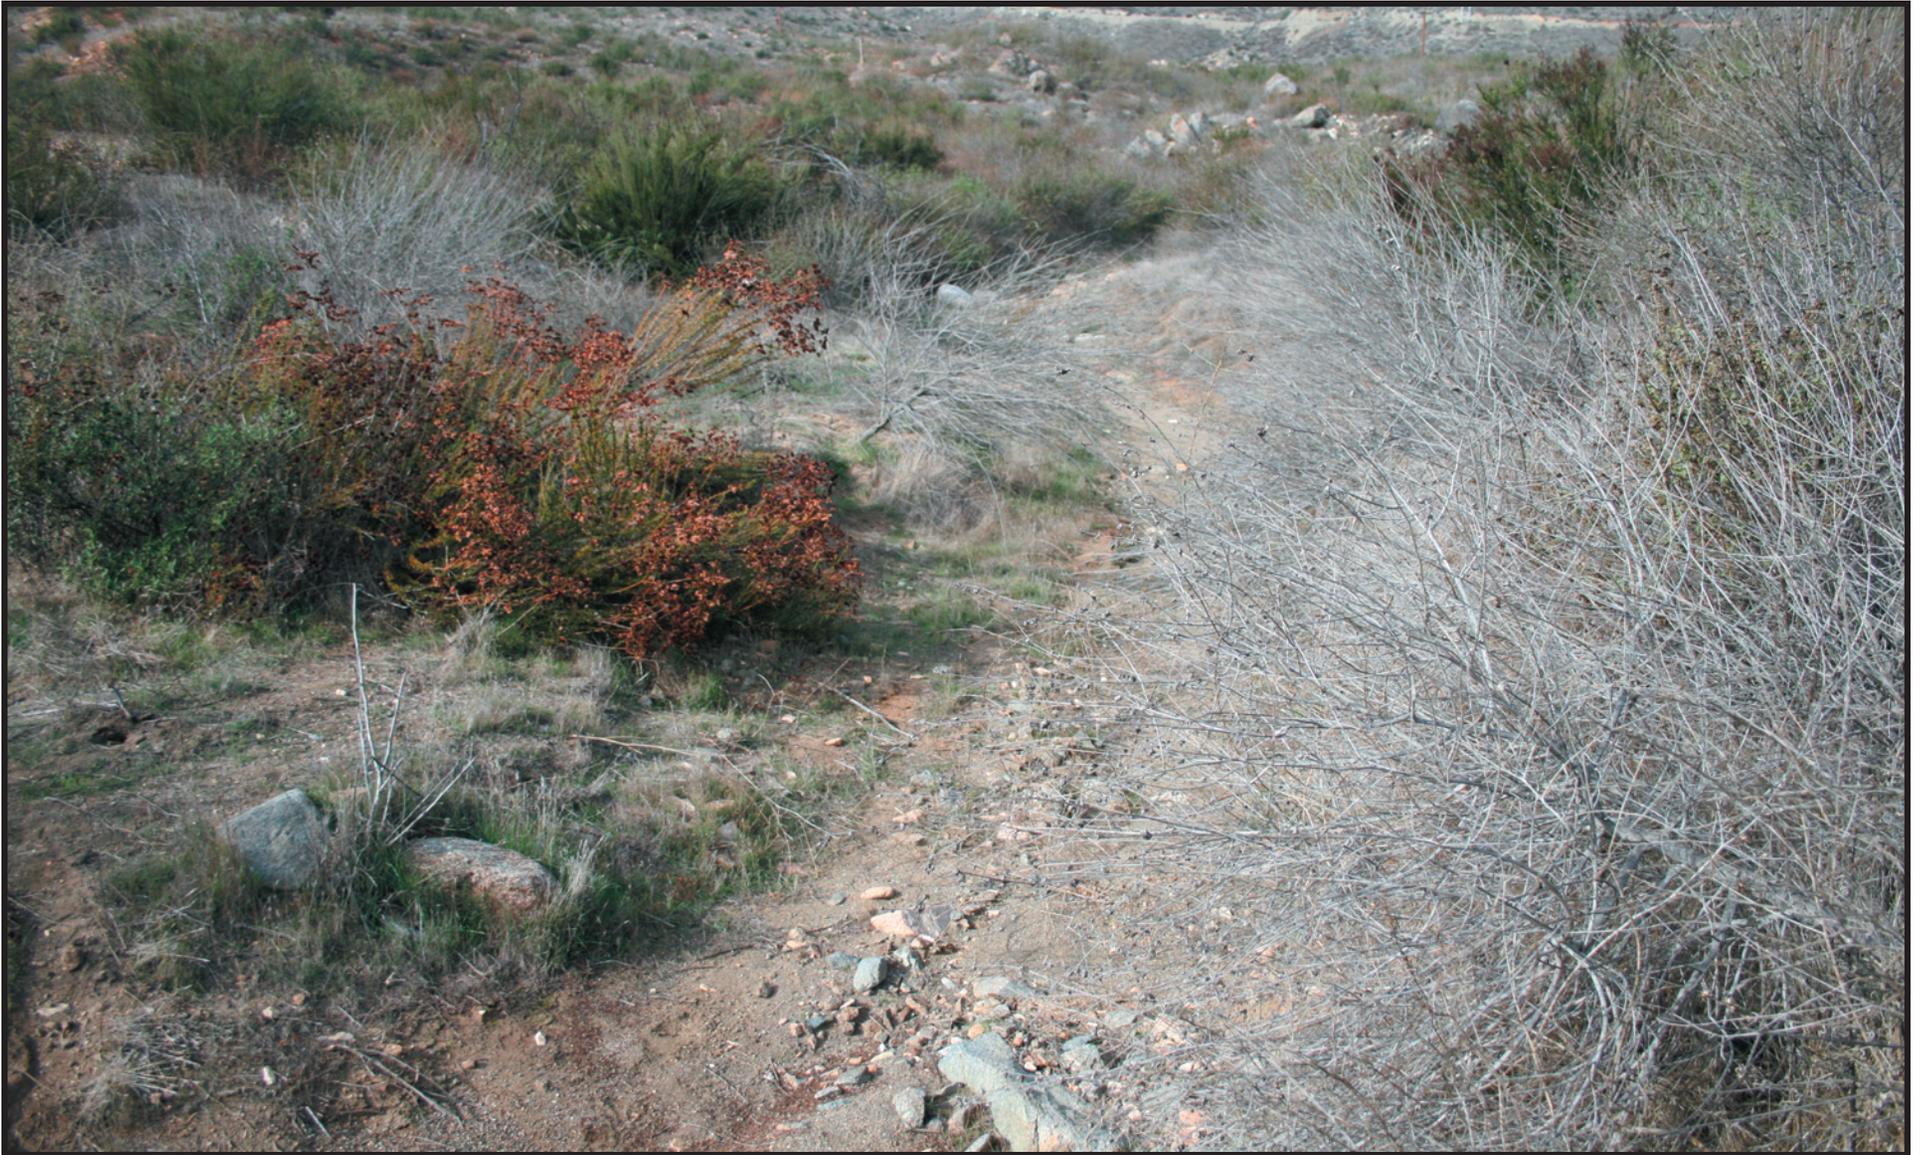
SITE PHOTOGRAPH 11

View of a portion of the channel of Watercourse G. It is also ephemeral, and originates on the Sedco Hills. It is shallow-incised, unvegetated and composed of sandy loam, brown with or without gravels, cobbles and boulders. The banks are sparsely vegetated with Chaparral species.

Watercourse G is ephemeral, and originates on the Sedco Hills located north of Bundy Canyon Road and off the site. It is also a tributary of Blueline Stream 2. It trends northwest-to-southeast through a relatively steep-sloped V-shaped valley to its confluence with Blueline Stream 2. It is undisturbed, but the surrounding hillsides have been burned by wildfire. The channel is shallow-incised and unvegetated, and composed of sandy loam, brown in color, with or without gravels, cobbles and boulders

(Site Photograph 11). Its total length on the site is 211 feet. Corps jurisdictional widths averaged 1.5 feet, and the total jurisdictional area was calculated to be 0.007 acres. Without the presence of riparian vegetation, the total CDFG jurisdiction was also calculated to be 0.007 acres.

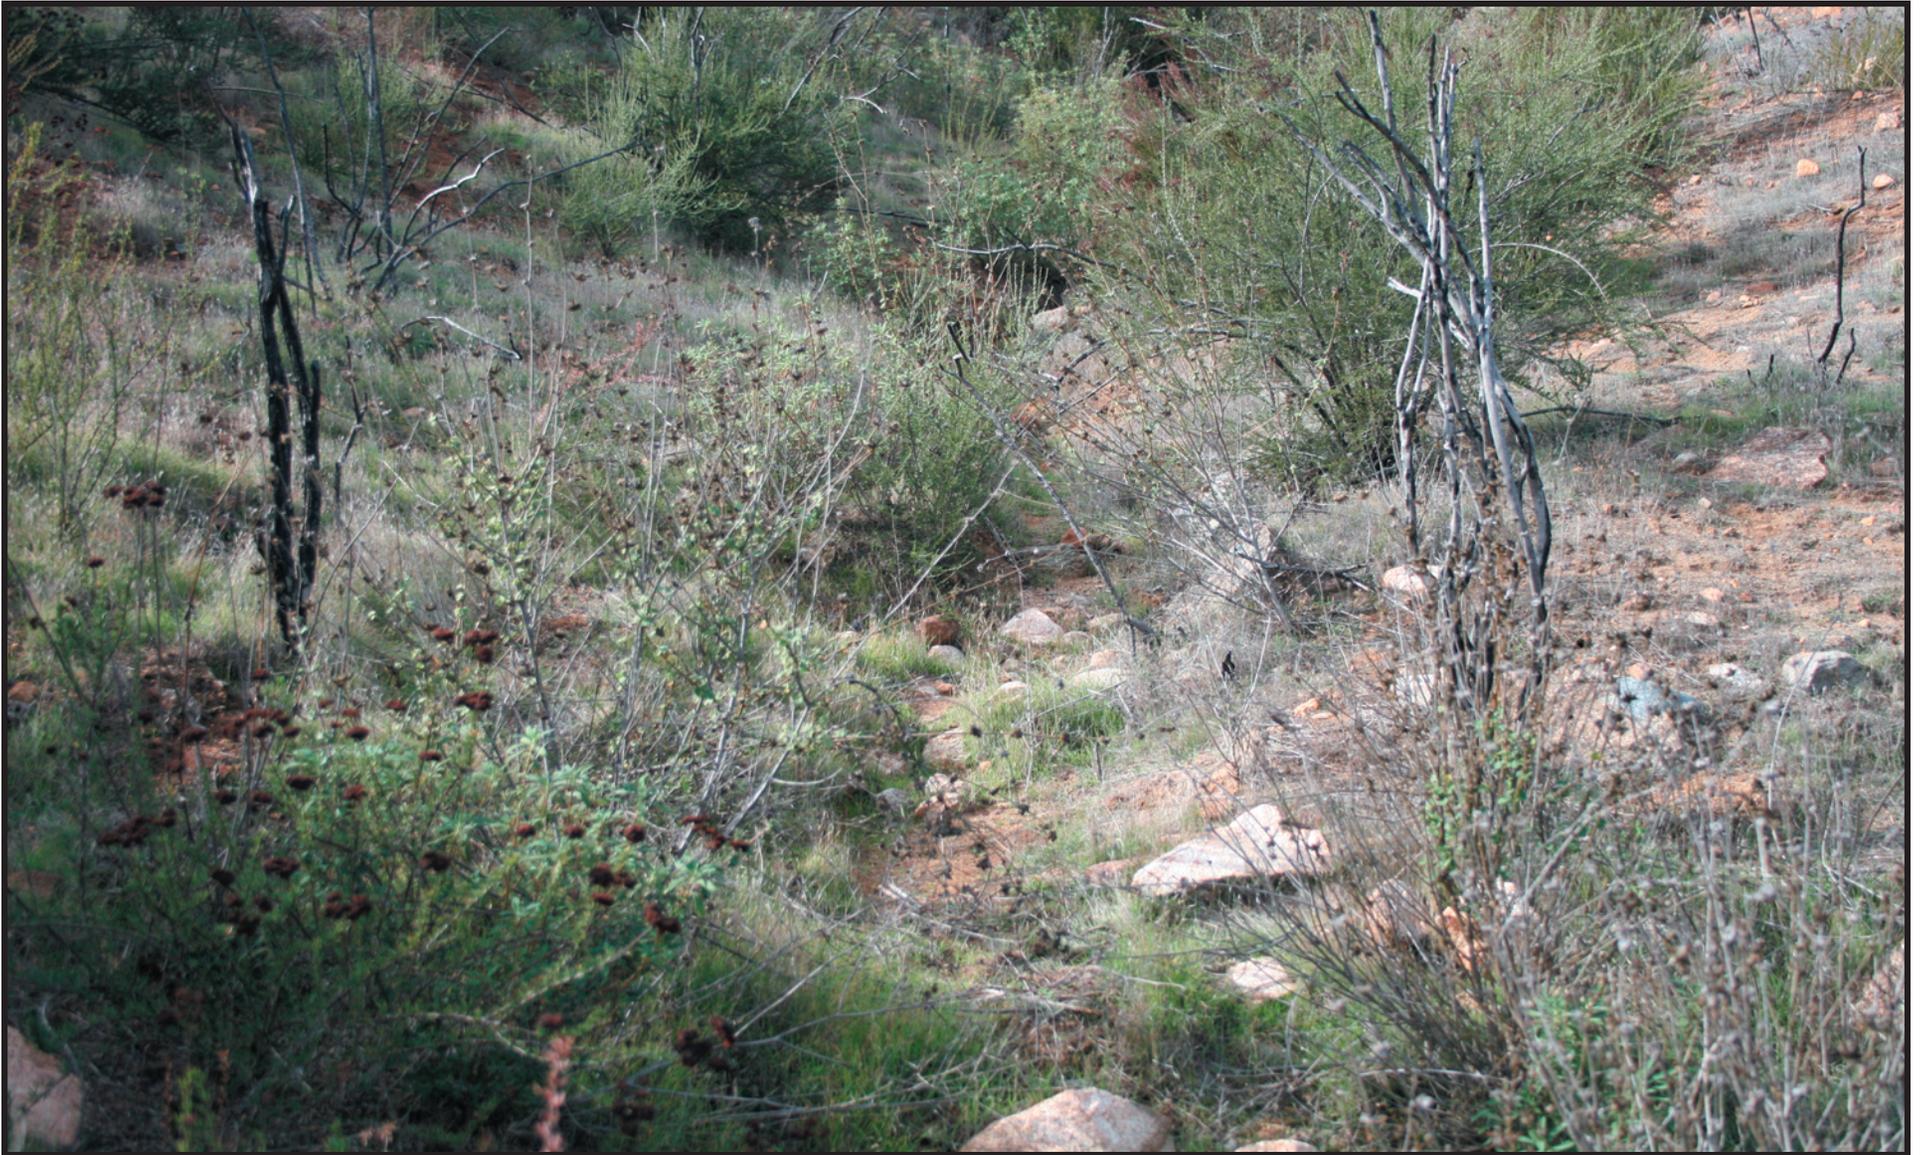
SITE PHOTOGRAPH 12

View of a portion of the channel of Watercourse H. It is also ephemeral, and originates on the Sedco Hills. It is shallow-incised, and composed of sandy loam, brown in color, with or without gravels, cobbles and boulders. The banks are sparsely vegetated with Chaparral species.

Watercourse H is ephemeral, and originates on the Sedco Hills located north of Bundy Canyon Road and off the site. It is also a tributary of Blueline Stream 2. It trends northwest-to-southeast through a relatively steep-sloped V-shaped valley to its confluence with Blueline Stream 2. It is undisturbed, but the surrounding hillsides have been burned by wildfire. The channel is shallow-incised and unvegetated, and composed of sandy loam, brown in color, with or without gravels, cobbles and boulders **(Site Photograph 12)**. Its total length on the site is 582 feet. Corps jurisdictional widths averaged 1.5 feet, and the total jurisdictional area was calculated to be 0.020 acres. Without the presence of riparian vegetation, the total CDFG jurisdiction was also calculated to be 0.020 acres.

The banks of this blueline stream are sparsely vegetated with typical Chaparral species, including chamise (*Adenostoma fasciculatum* var. *fasciculatum*), thick-leaved lilac (*Ceanothus crassifolius* var. *crassifolius*), interior California buckwheat (*Eriogonum fasciculatum* subsp. *foliolosum*), and black sage (*Salvia mellifera*). Understory species include *shortpod mustard (*Brassica geniculata*), *brome grasses (*Bromus diandrus* and *B. madritensis* subsp. *rubens*), California everlasting (*Gnaphalium californicum*), and slender sunflower (*Helianthus gracilentus*).
