PHASE I ENVIRONMENTAL SITE ASSESSMENT REPORT

UNDEVELOPED LAND
23151 PALOMAR STREET
WILDOMAR, CALIFORNIA 92595

**SUBJECT: Report of Phase I Environmental Site Assessment
Undeveloped land
23151 Palomar Street
Wildomar, California 92595**

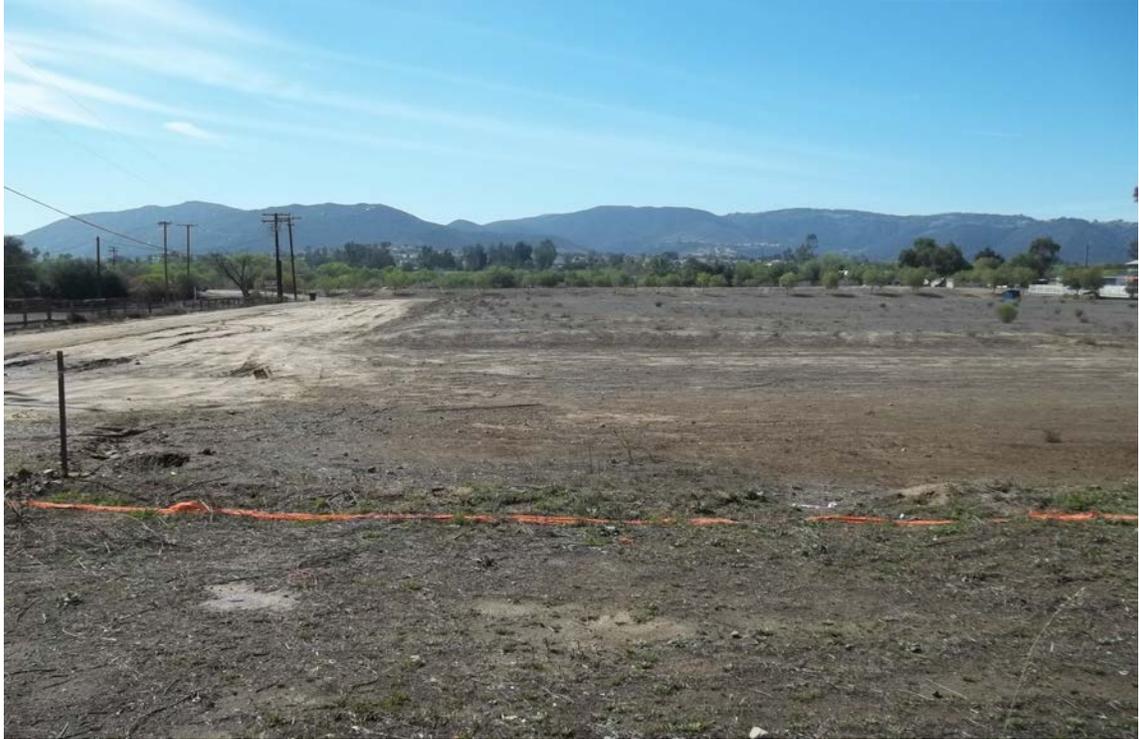
The subject property consisted of a parcel of undeveloped land. AAI observed clearing and grading activities have occurred on the northern portion of the property. The subject property parcel was approximately 9.7 acres in size.

Photo 1 – View looking south from the northern portion of the subject property.

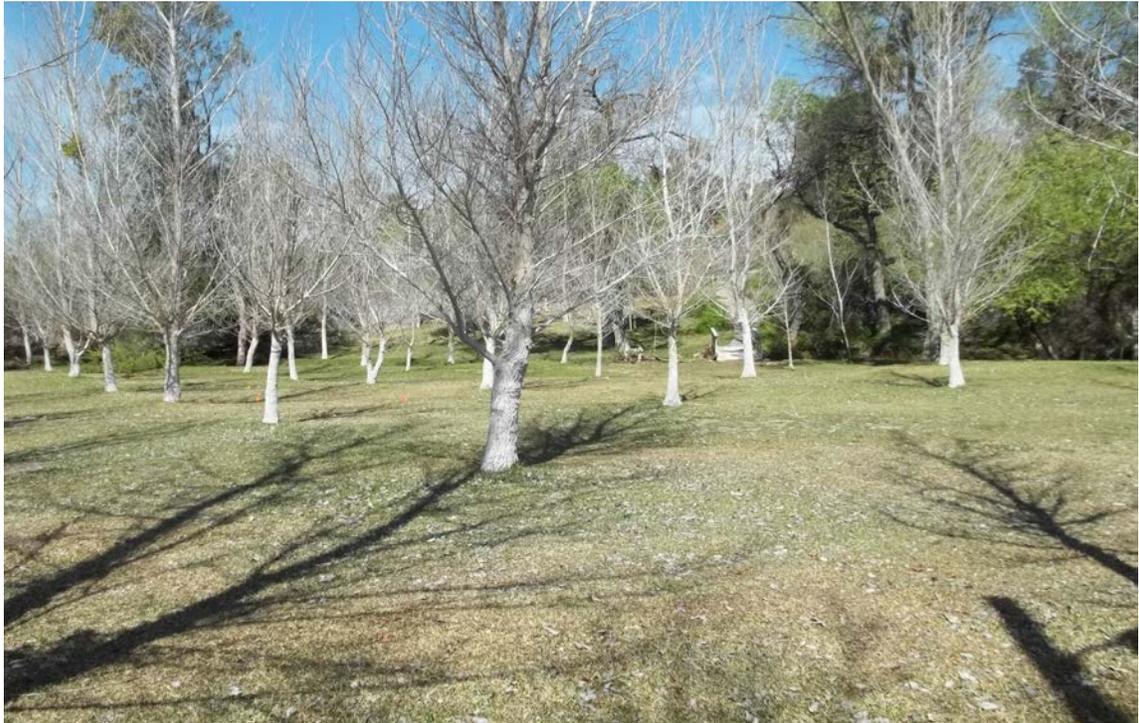
- Based on the potential for arsenic and other pesticide contamination, the small orchard identified near the center of the southwest boundary of the property was considered to be a Recognized Environmental Condition (REC) at the subject property.
- Based on the potential for subsurface contamination the evidence of potential “wildcat” oil drilling in the central area of the property was considered to be a REC at the subject property.
- No conclusions are made regarding asbestos-containing materials or lead-based paint since these issues are not part of the ASTM standard.

Photo 12 – View of small park and orchard adjacent to the southwestern portion of the subject property.

AAI recommends that a Phase II Environmental Site Assessment be conducted at the subject property to determine if there is a significant environmental liability present at the subject property due to evidence of historic oil well drilling activities and a former orchard on the subject property.

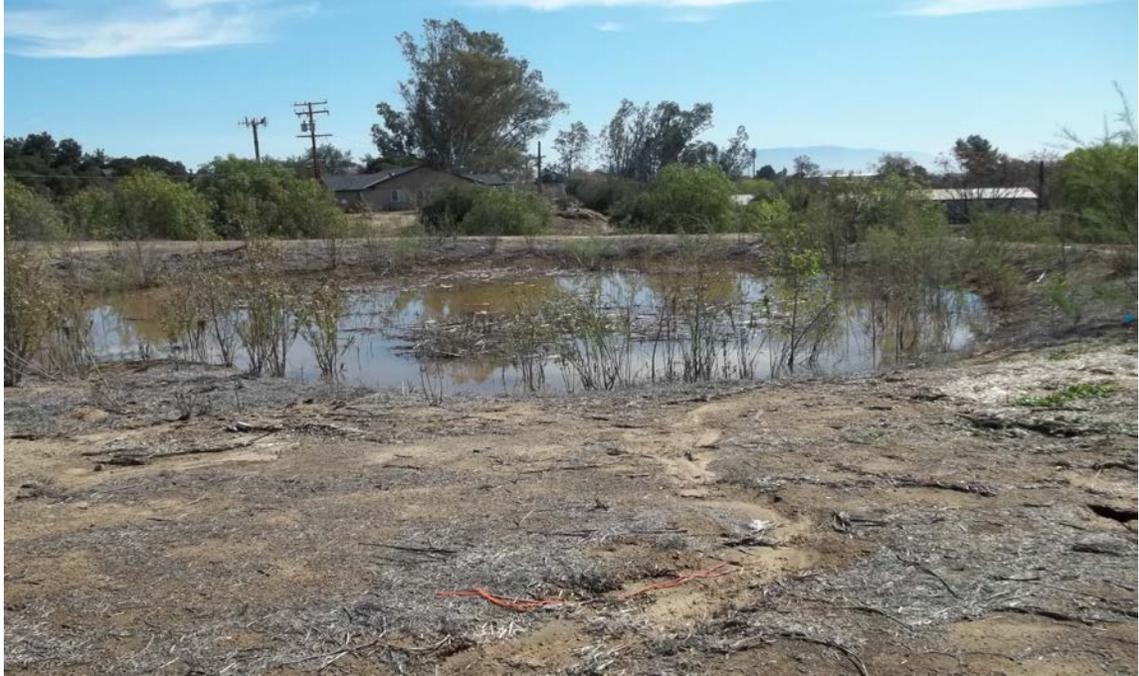
Photo 15 - View of pond located on the west central portion of the subject property.

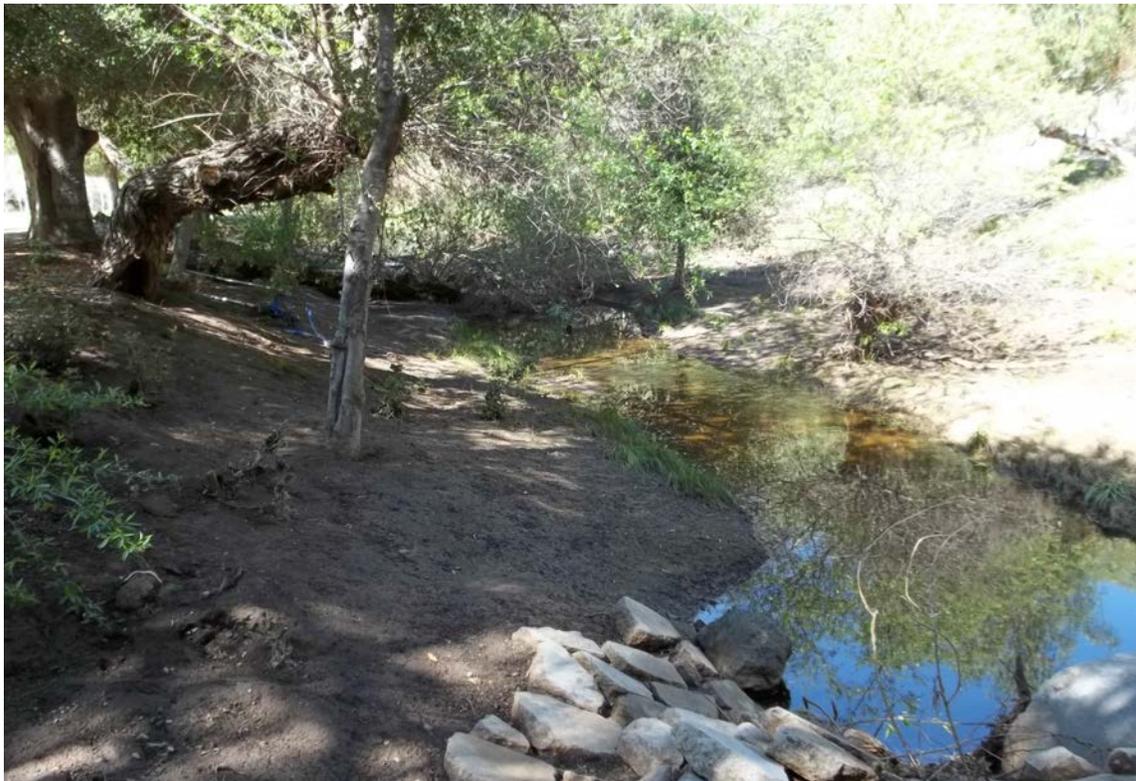
No groundwater supply or monitoring wells were noted or observed on the subject property. AAI identified the stream crossing the southern portion of the property as Murrieta Creek.

Photo 16 - View of the creek located on the southern portion of the subject property.

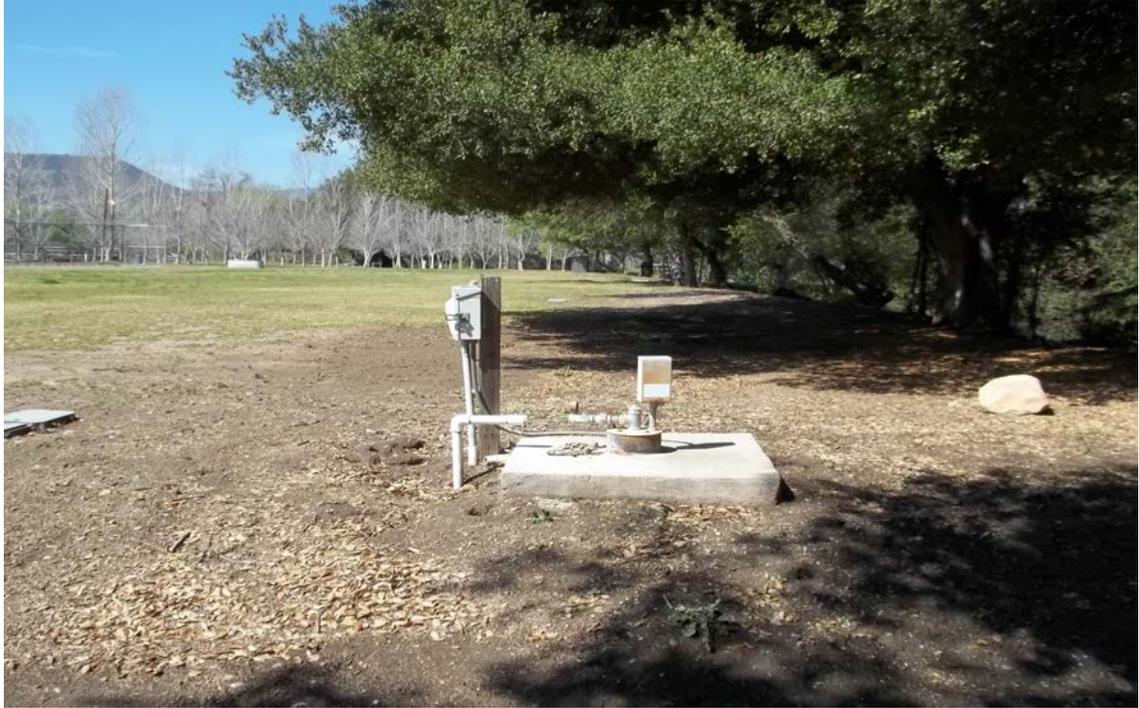
Photo 19 - View of irrigation controls for the southern area of the subject property.

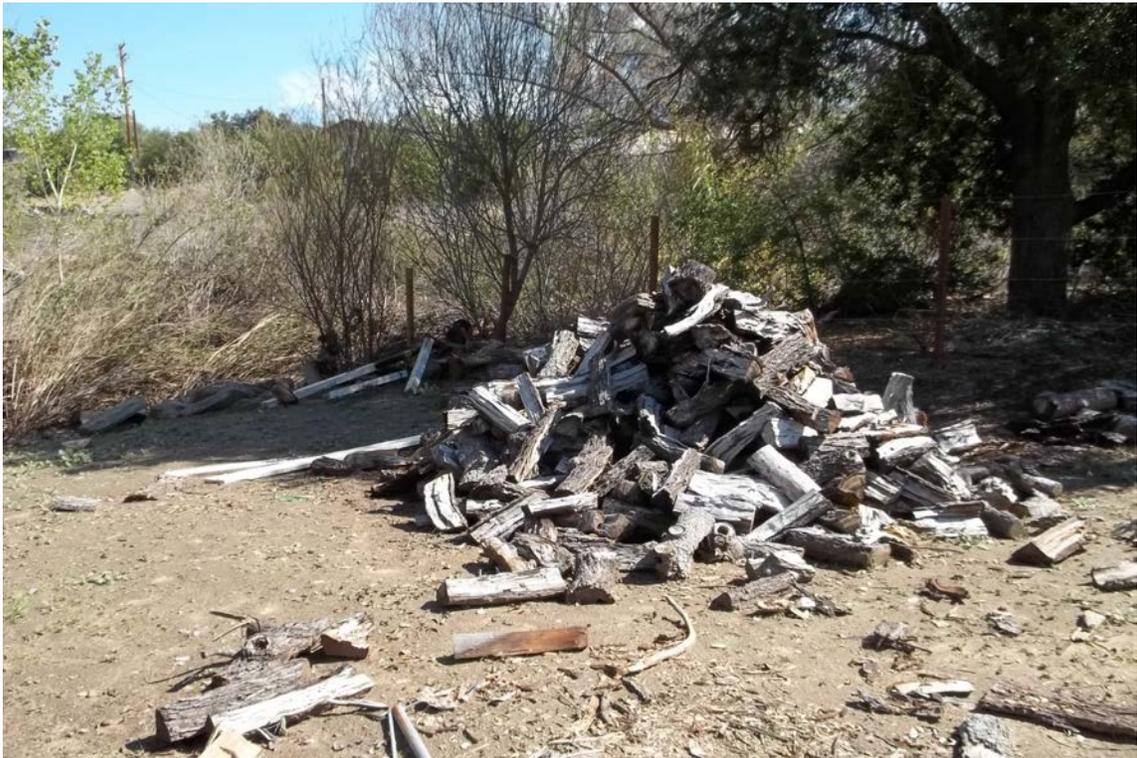
Photo 20 - View of wood pile on the southeastern area of the subject property.

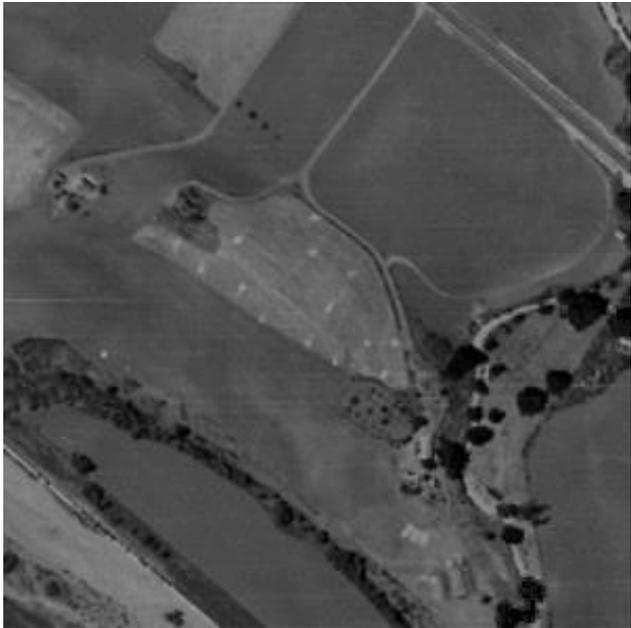
1938

During review of a historic aerial photograph (1938), evidence of potential wildcat drilling wells was observed in the central area of the property. According to California Department of Conservation, Division of Oil, Gas, & Geothermal Resources, no specific well records were identified for the subject property. AAI made multiple attempts to contact Ms. Kordelia Jenkins (Records assistant at DOGGR) for further information regarding database records for exploratory oil well drilling in the vicinity and the area of the subject property. At the time of the report, Ms. Jenkins had not replied to the request for information.

AAI recommends that a Phase II Environmental Site Assessment be conducted at the subject property to determine if there is a significant environmental liability present at the subject property due to evidence of historic oil well drilling activities and a former orchard on the subject property.
