Subject: **Updated Geotechnical Report – Clinton Keith Village, LLC**
Geotechnical/Geological Engineering Study – APN: 326-250 & 004
 Project Number: 3351-GS

Photographic Survey
(May 2013)

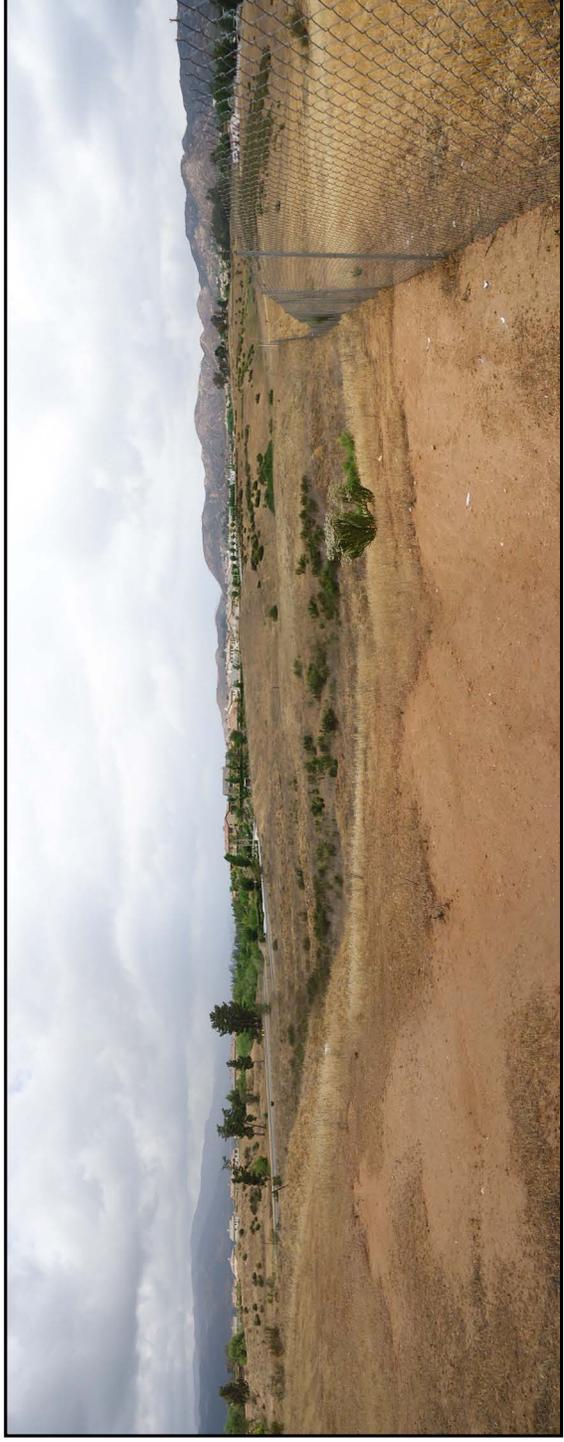
Panoramic photo of subject site taken from the approximate southeast property corner, looking in a general northerly direction across site with George Avenue in the approximately center left of frame.

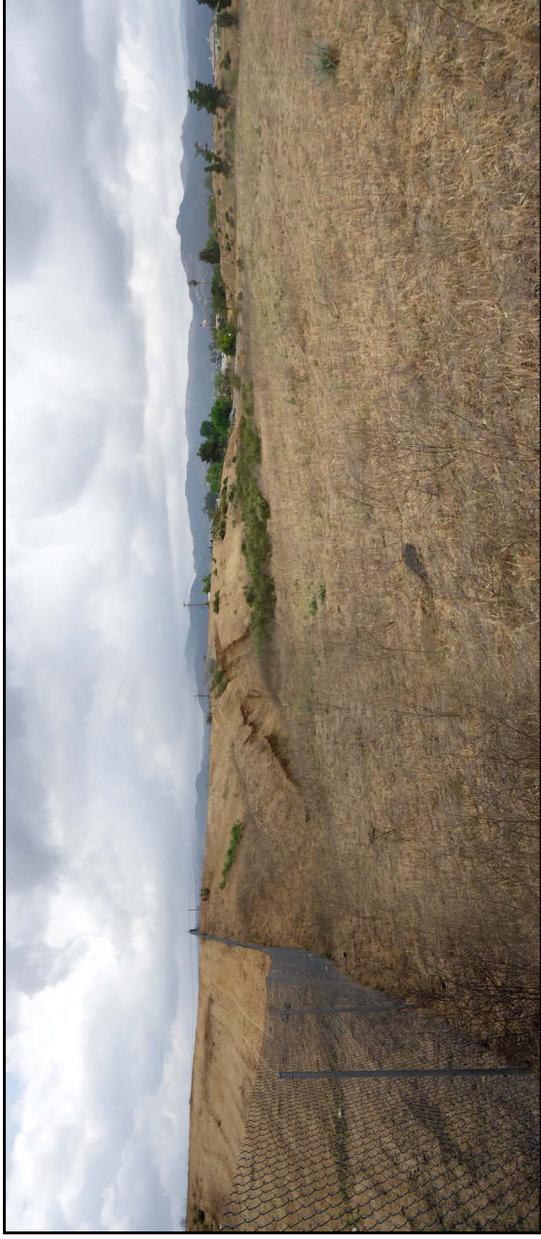
Panoramic photo of subject site taken from the approximate northeast property corner, looking south across site open trenches in the hillsides middle of frame.

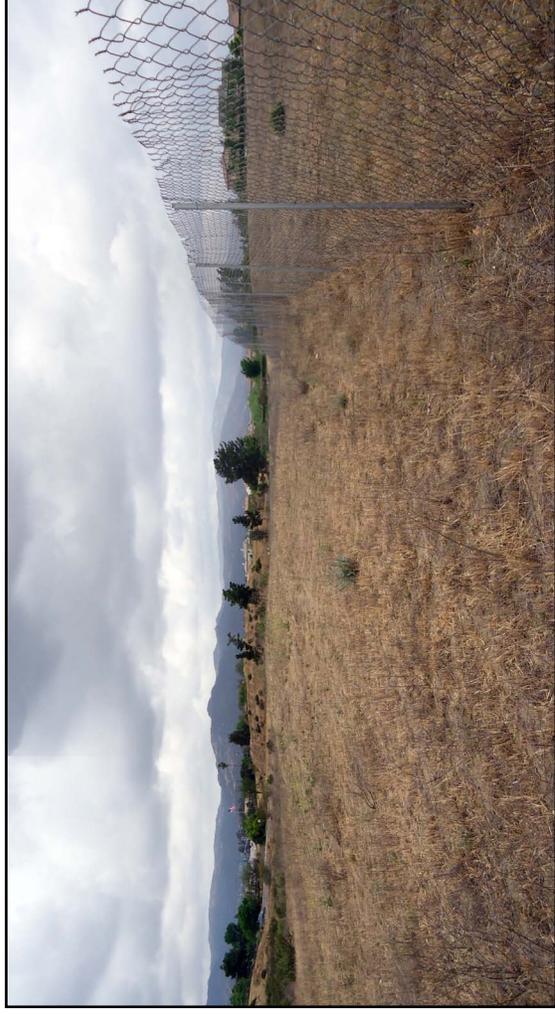
Panoramic photo of subject site taken from the approximate northeast corner of the property, looking in a westerly direction with George Avenue in middle center of frame.

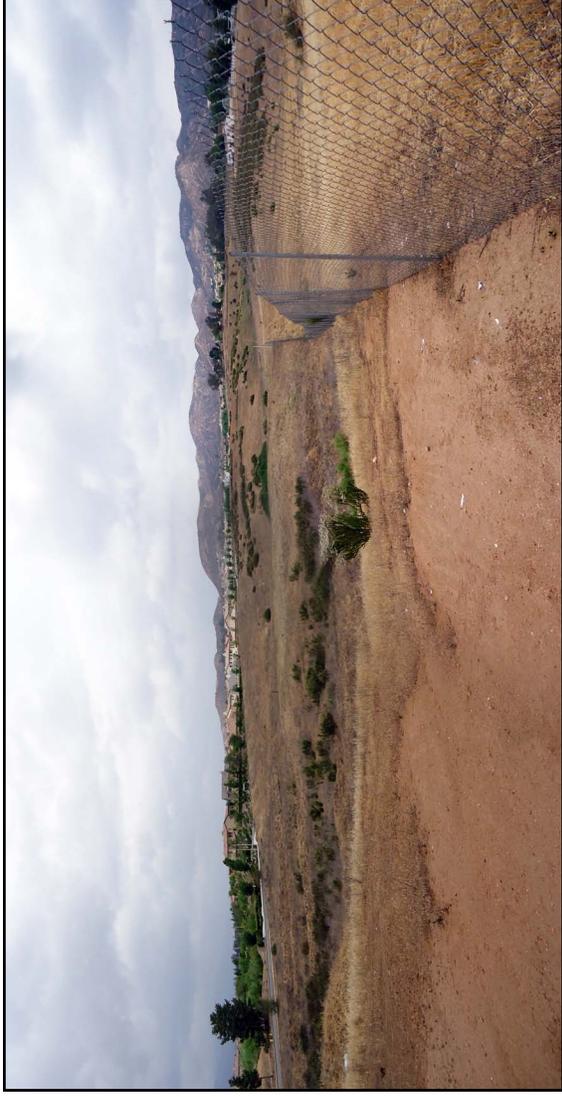
Panoramic photo of subject site taken from the approximate southeast property corner, looking in a northerly direction with George Avenue in upper left of frame.

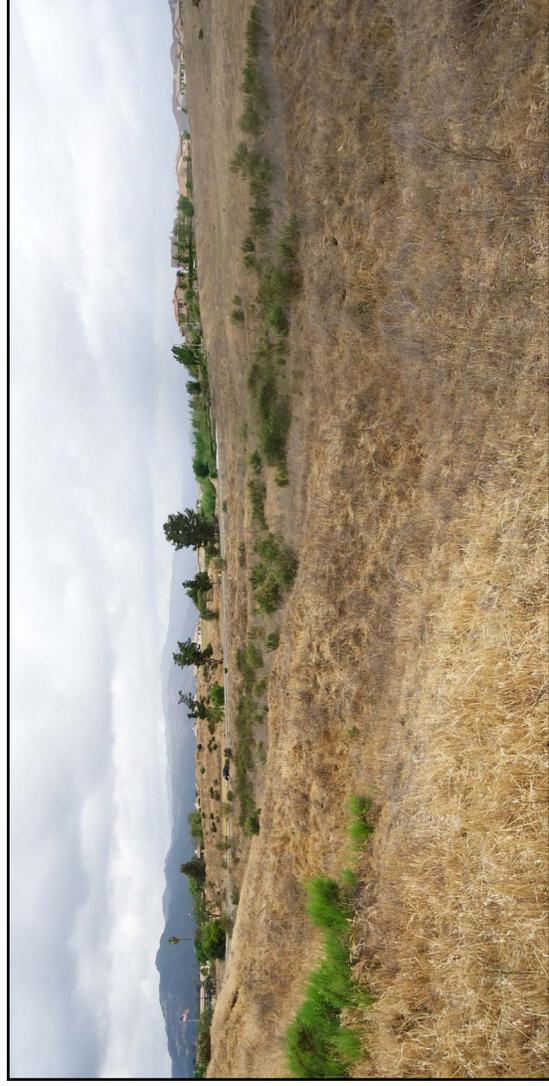
Panoramic photo of subject site taken from the approximate southeast area of the property, looking in an approximately westerly direction with George Avenue in upper middle frame.

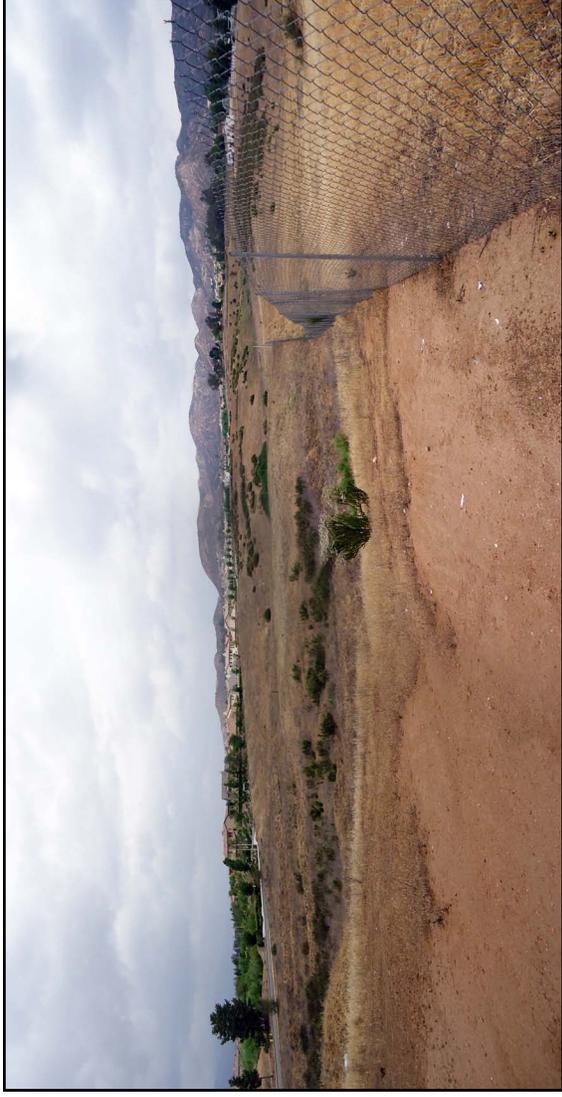
Panoramic photo of subject site taken from the approximate southeast property corner, looking in a northerly direction with George Avenue in upper left of frame.

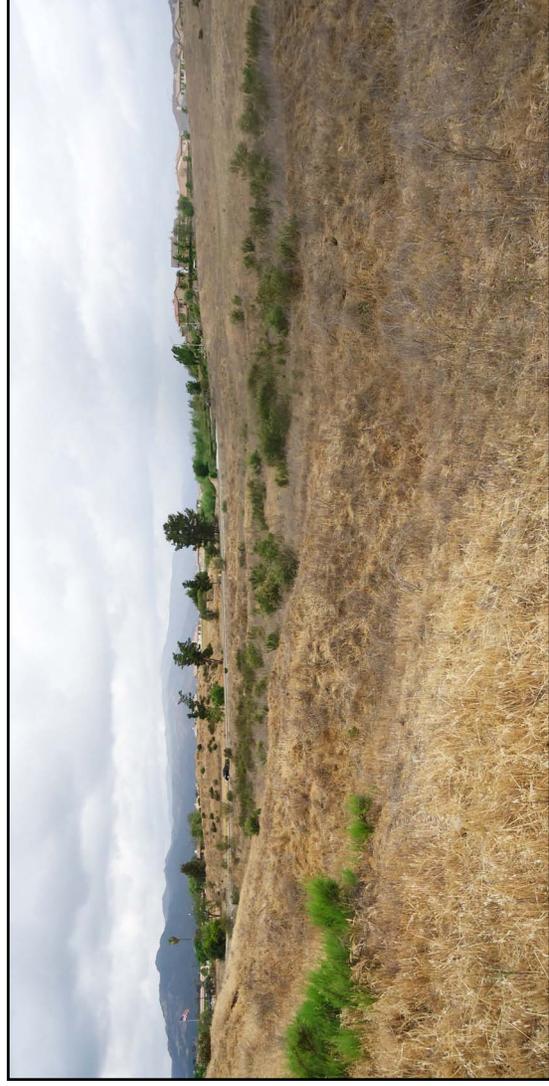
Panoramic photo of subject site taken from the approximate southeast area of the property, looking in an approximately northwesterly direction with George Avenue in upper middle frame.

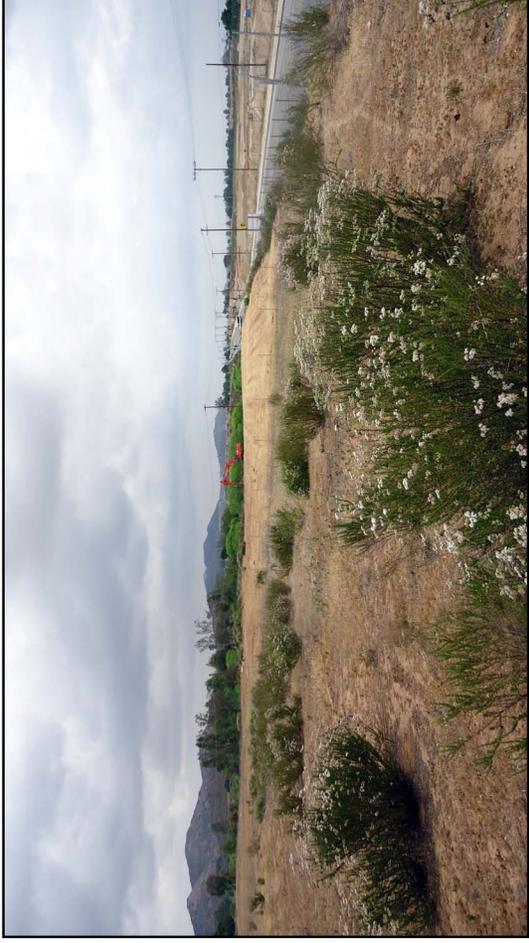
Panoramic photo of subject site taken from the approximate southwest corner, looking in an easterly with Clinton Keith Road in right of frame.

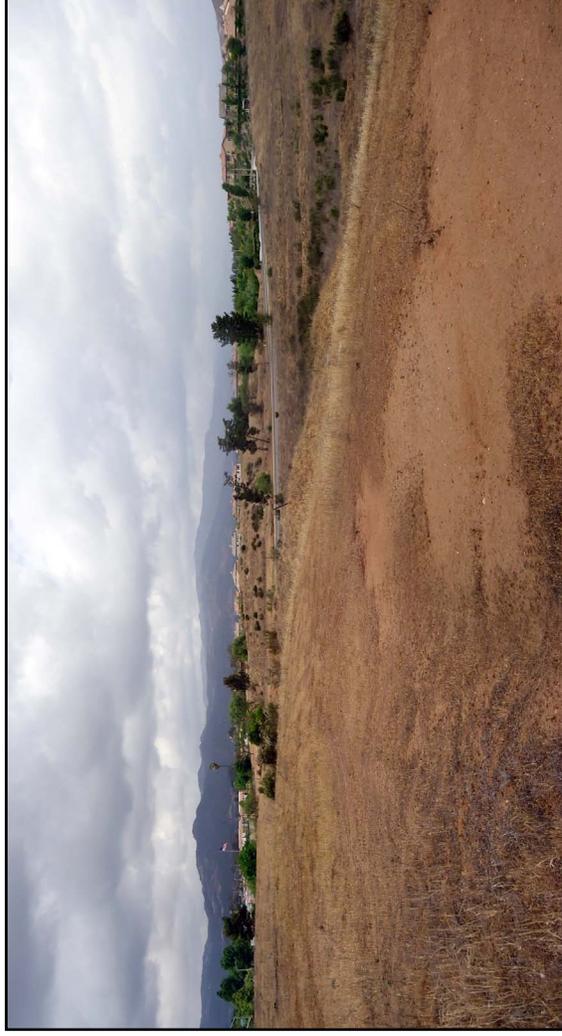
Panoramic photo of subject site taken from the approximate southeast corner of the property, looking in an approximately northwesterly direction.

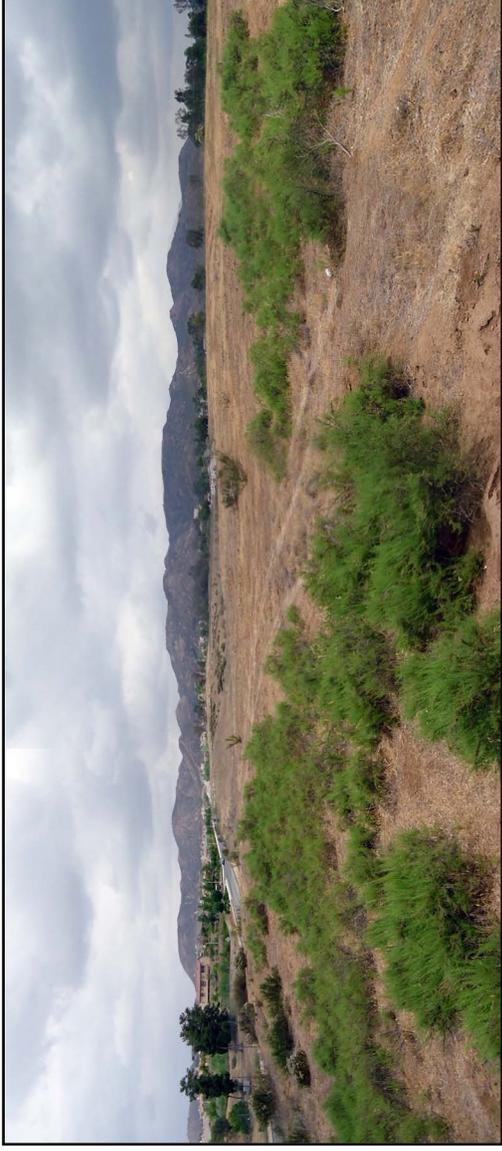
Panoramic photograph of subject site taken from the approximate southwest corner, looking in an approximately southwesterly direction.

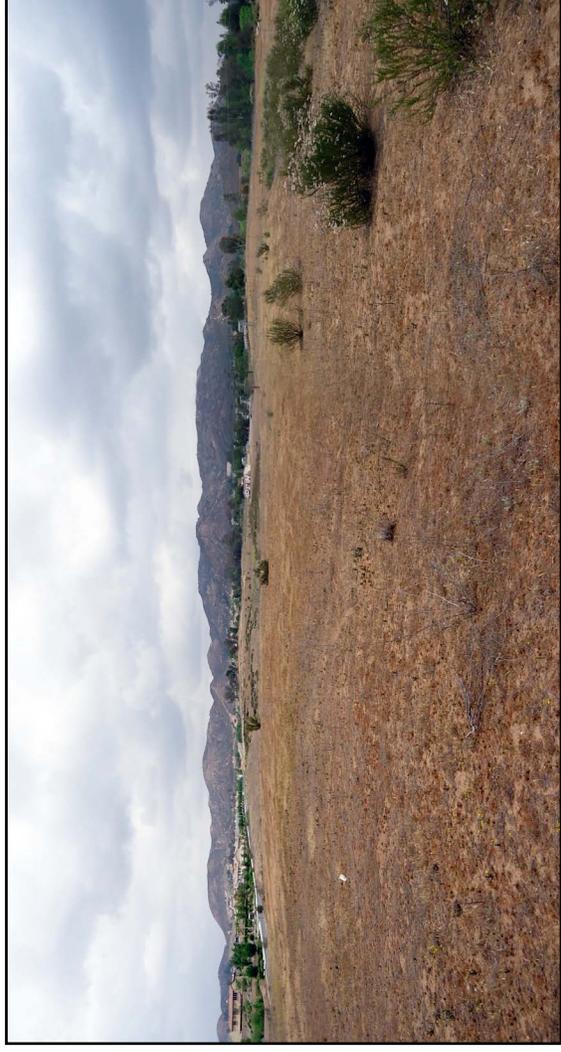
Panoramic photograph of subject site taken from the approximate southwest center of the property line, looking in an approximately northerly direction.
