## LIMITED PHASE II SOIL SAMPLING INVESTIGATION REPORT

APNs 367-180-015 & 367-180-043  
WILDOMAR, CALIFORNIA

Hillmann Project Number

C3-6222 March 9, 2015

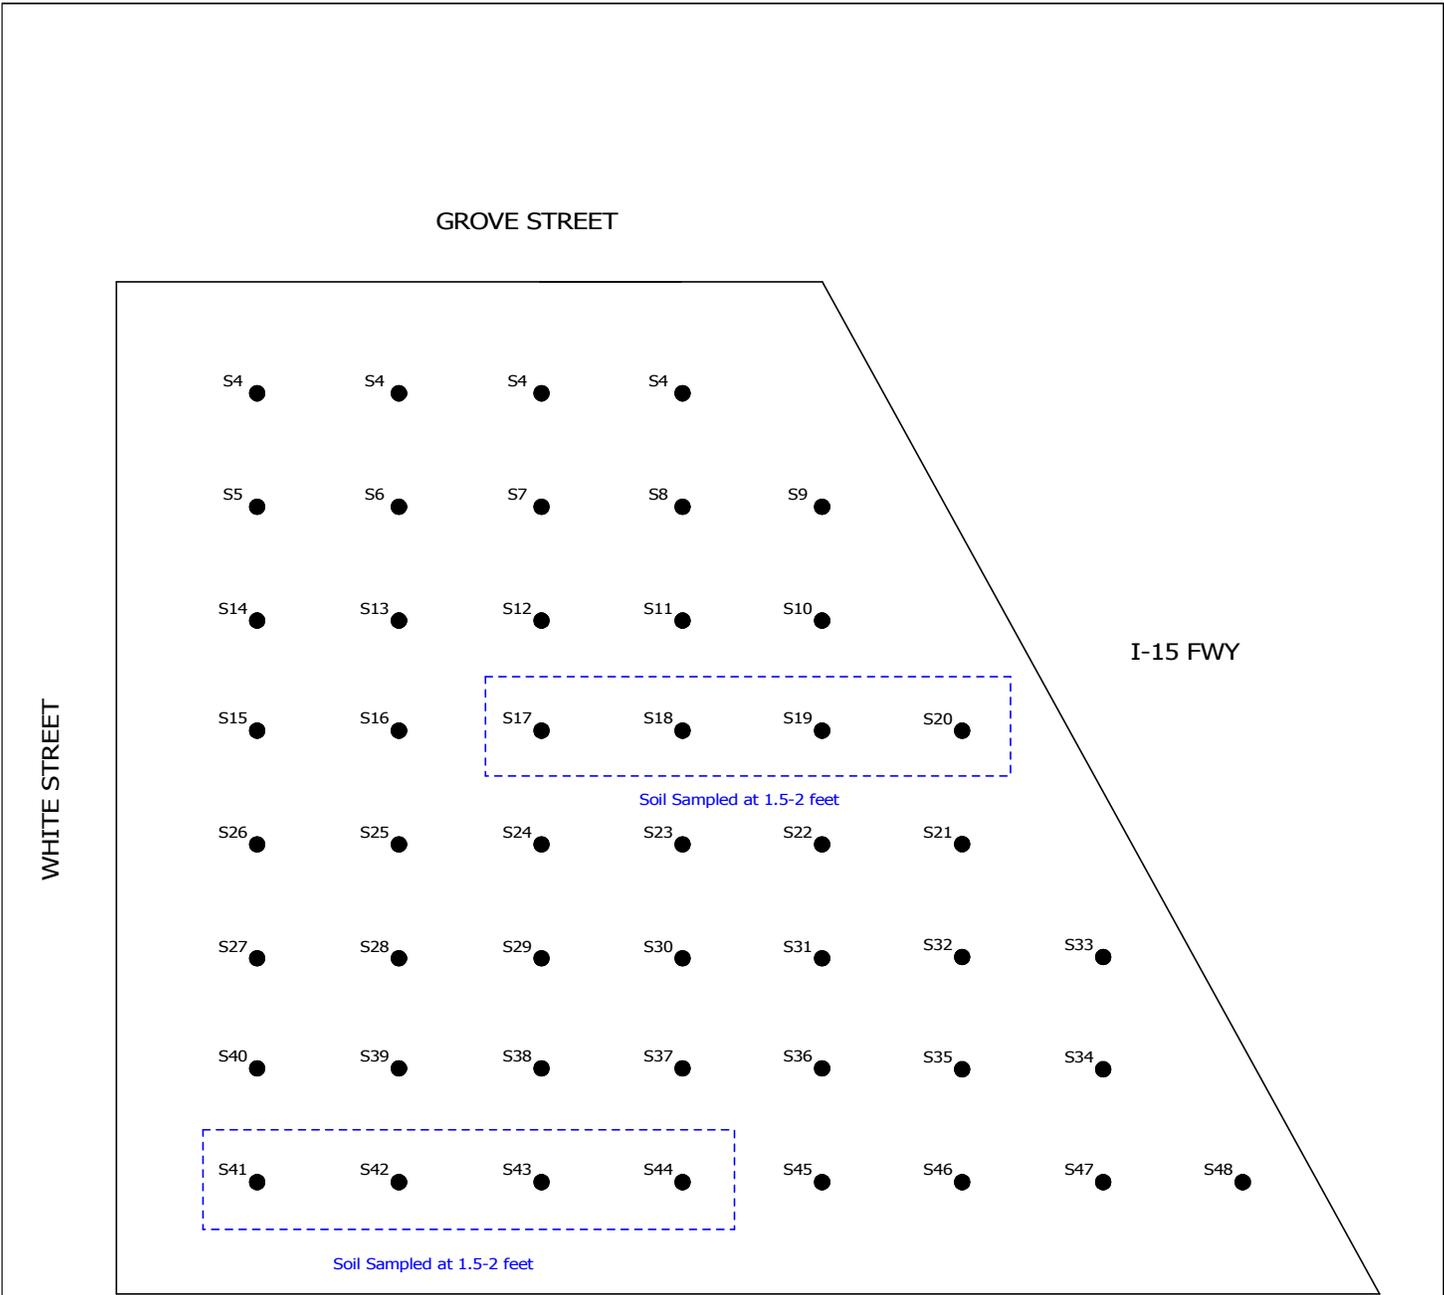
**FIGURE 1**  
**SAMPLE LOCATIONS**  
 APNs 367-180-015 & 367-180-043  
 Wildomar, California

The rationale for this sampling pattern is based on the assumption that any pesticide applications would have been evenly distributed over time and area. This is a reasonable assumption and is recommended in regulatory guidance prepared by DTSC (Interim Guidance for Sampling Agricultural Properties, August 2008). The sampling locations are shown on **Figure 1**.

Soil Sampled at 1.5-2 feet

- Soil Samples
- Samples collected at 1.5-2 feet below grade, all others at 0.5-1 feet below grade.
