**DETERMINATION OF BIOLOGICALLY
EQUIVALENT OR SUPERIOR PRESERVATION**

BAXTER VILLAGE
APNs 367-180-015 & 367-180-043

CITY OF WILDOMAR, RIVERSIDE COUNTY, CALIFORNIA

**SECTION 6.1.2 RIPARIAN/RIVERINE AND VERNAL POOLS OF THE
WESTERN RIVERSIDE COUNTY MULTIPLE SPECIES HABITAT CONSERVATION PLAN**

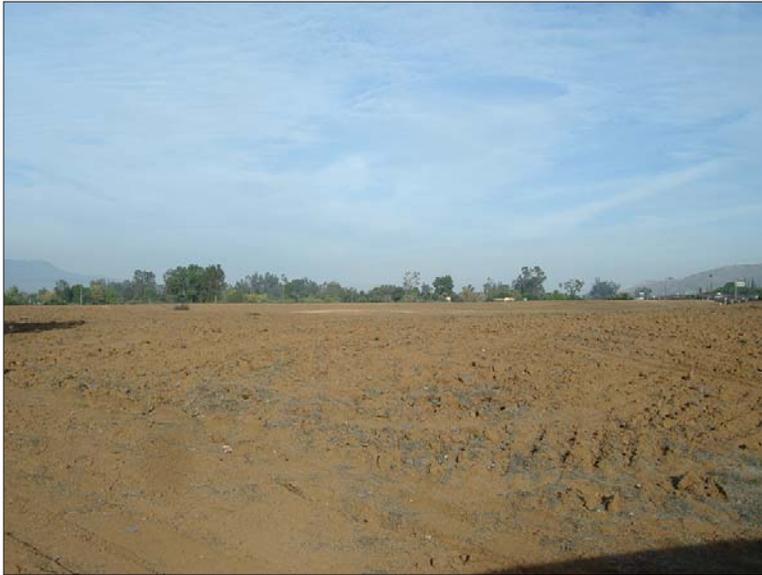
Photograph 1: Photograph of Disturbed habitat located in the southeastern corner of the project site.

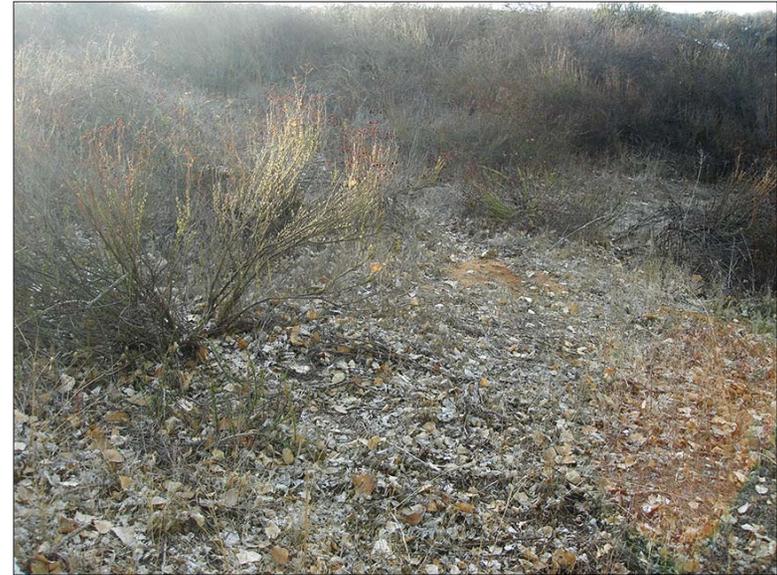
Photograph 2: Photograph of Buckwheat Scrub/Ruderal located within the southeastern portion of the project site.

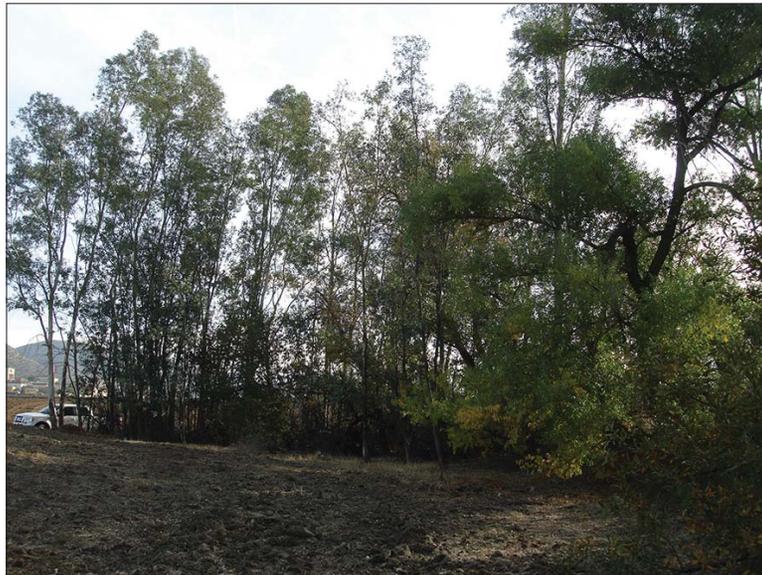
Photograph 3: Photograph of Southern Willow Scrub/Eucalyptus Woodland located within the southern portion of the project site.

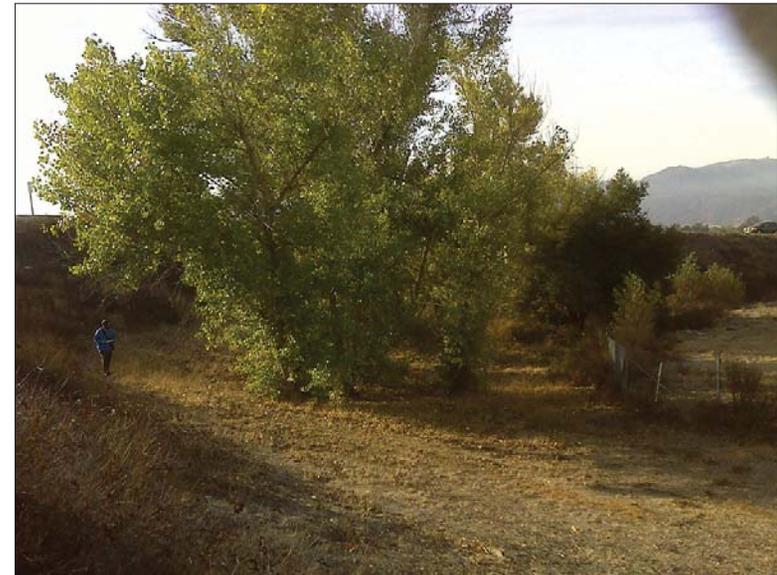
Photograph 4: Photograph of Southern Riparian Scrub located within the southeastern portion of the project site.

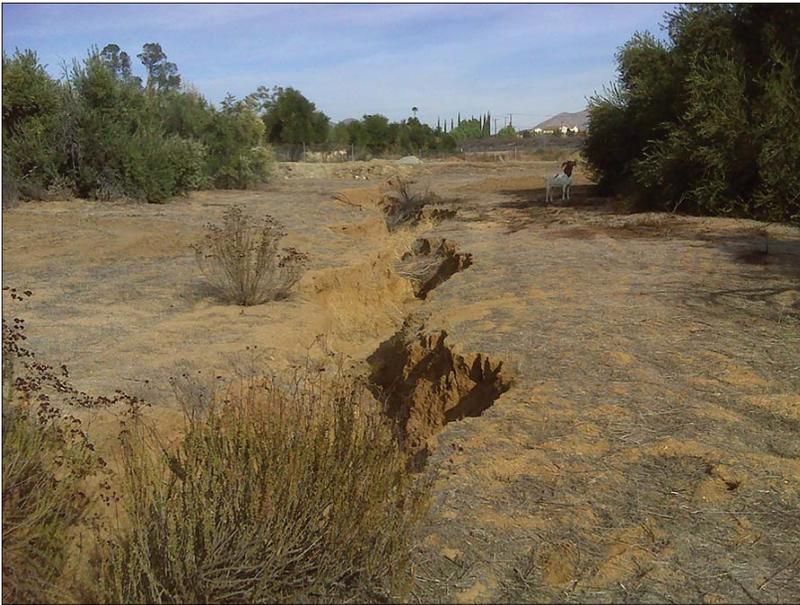
Photograph 1: Drainage A erosional feature looking upstream/north near northern project boundary.

One on-site drainage feature, Drainage A, was observed in the western portion of the Project site, traversing the site in a northeast to southwest direction. Two additional jurisdictional drainage features were identified off-site, namely Drainages B and C. No USGS blue line streams are mapped within the Project site or off-site areas. Drainages B and C are considered MSHCP Riverine/Riparian Areas, respectively. Non-jurisdictional areas were also observed on the Project site, including an historic tributary to Drainage A and topographic low points. Representative photographs of the drainages and non-jurisdictional areas are included in **Figure 6a, Figure 6b, and Figure 6c, Drainage Photographs**.

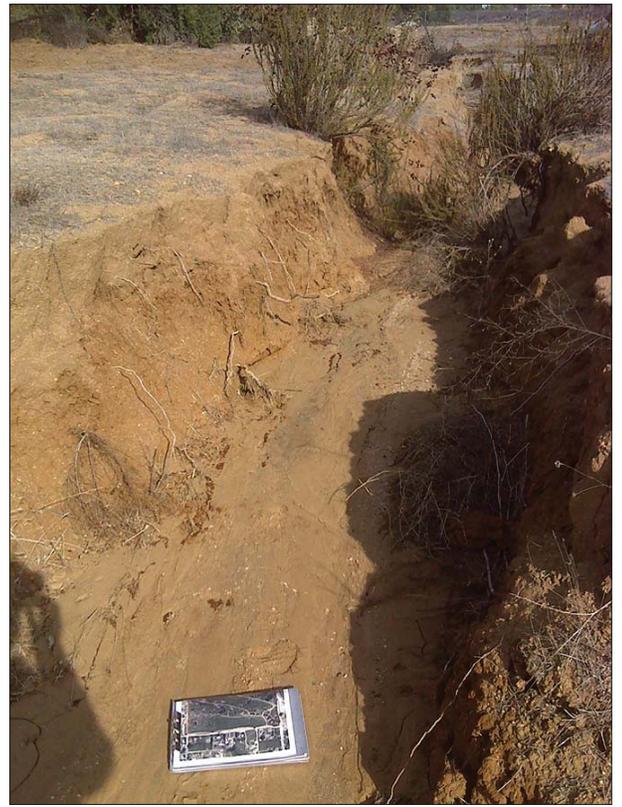
Photograph 2: View within incised portion of Drainage A erosional feature looking upstream/north. Note exposed roots along vertical banks suggesting recent high velocity flows consistent with anthropogenic discharge given lack of upstream watershed.

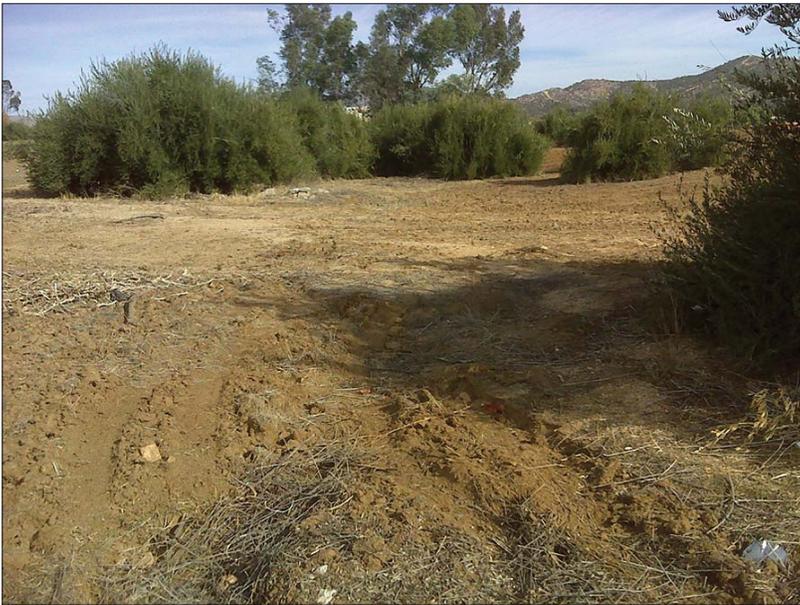
Photograph 3: Drainage A near central portion of site where streambed terminates and indicators of flow become indiscernible.

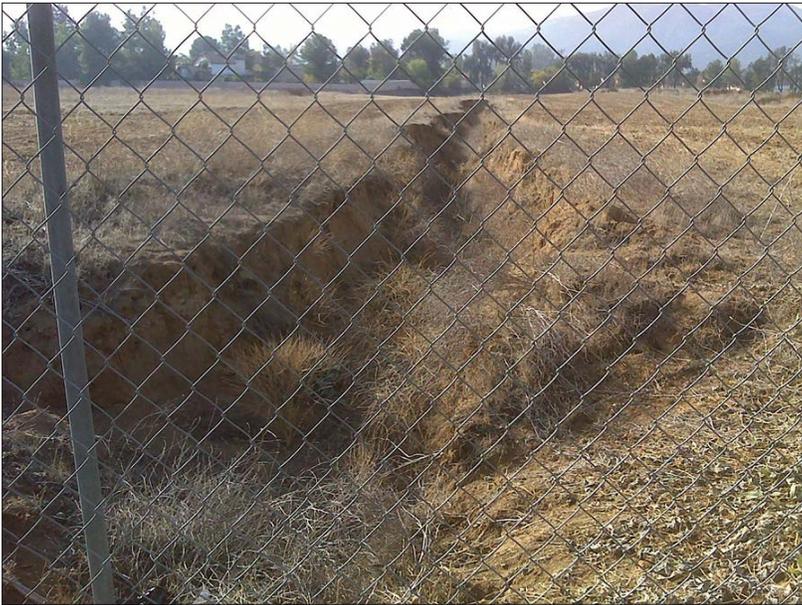
Photograph 4: Off-site Drainage B looking south/downstream from shoulder of Baxter Road.

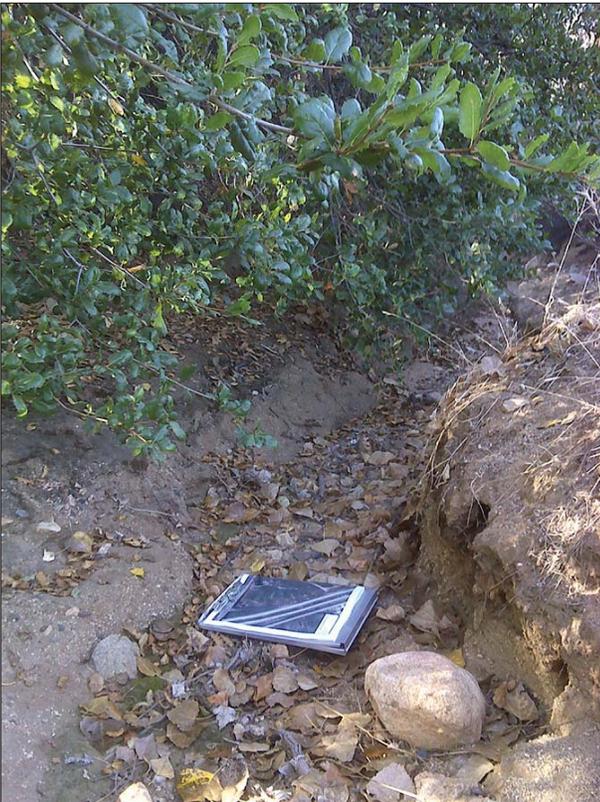
Photograph 5: Off-site Drainage C looking southwest/downstream within streambed near culvert beneath Baxter Road.

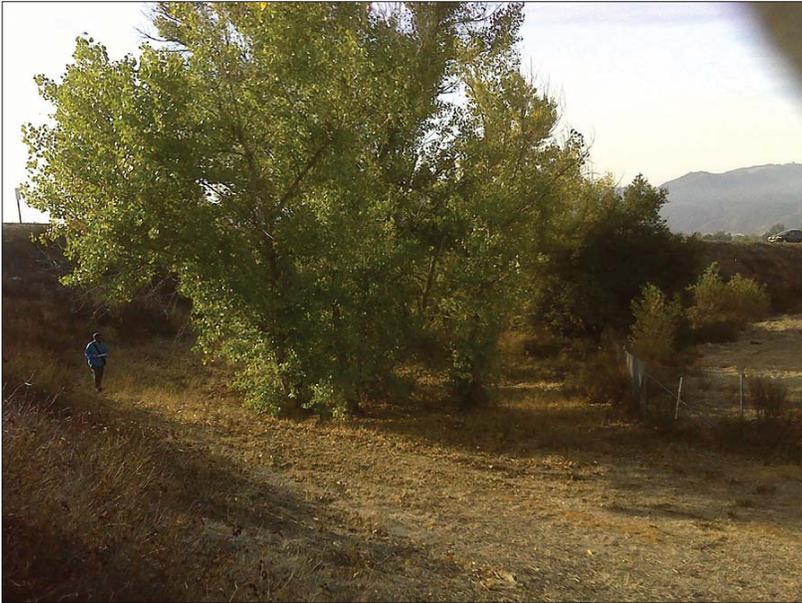
Photograph 6: Upstream Drainage C (off-site) looking south at cottonwood trees located directly downstream of culvert beneath the I-15 Baxter Road (Southbound) off-ramp.

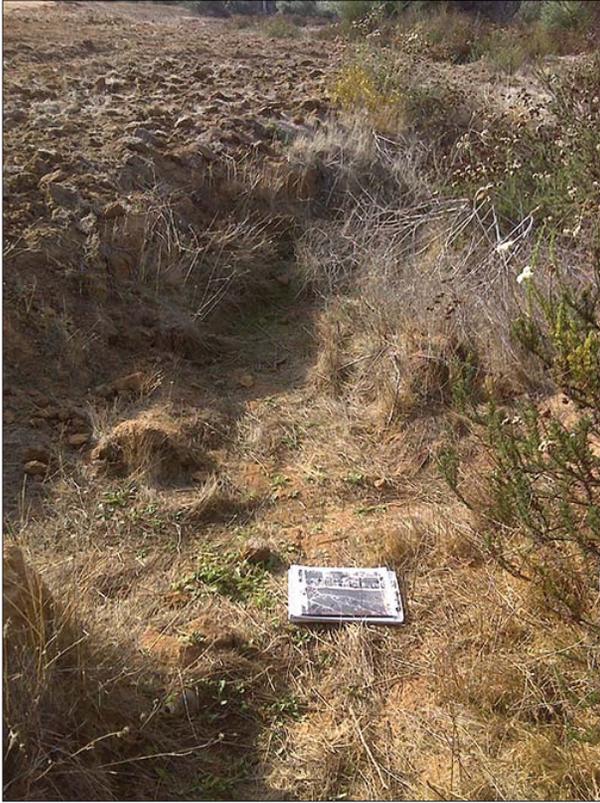
Photograph 7: Photo looking southwest within non-jurisdictional remnant drainage feature approximately 80 linear feet south of northern project boundary.

One historic tributary to Drainage A was observed, which initiates at the northern property boundary approximately 160 feet east of Drainage A. However, the feature was determined to be non-jurisdictional due to a lack of any discernible evidence of flow such as an OHWM or other field indicators indicative of jurisdictional features. The feature was also determined not to support jurisdiction due to the dominance of upland vegetation such as buckwheat and ruderal grasses within the historic feature, and the lack of any streambed indicators directly upstream of the site where rural disturbance appears to have prevented the reestablishment of a drainage feature or erosion of a new channel. All of these observations support the conclusion that the feature is remnant in nature and no longer conveys the hydrology necessary to constitute a functional streambed subject to regulation by the resource agencies. A photograph of the non-jurisdictional feature is provided in **Figures 6c, Drainage Photographs** (see photo 7). Areas of lower

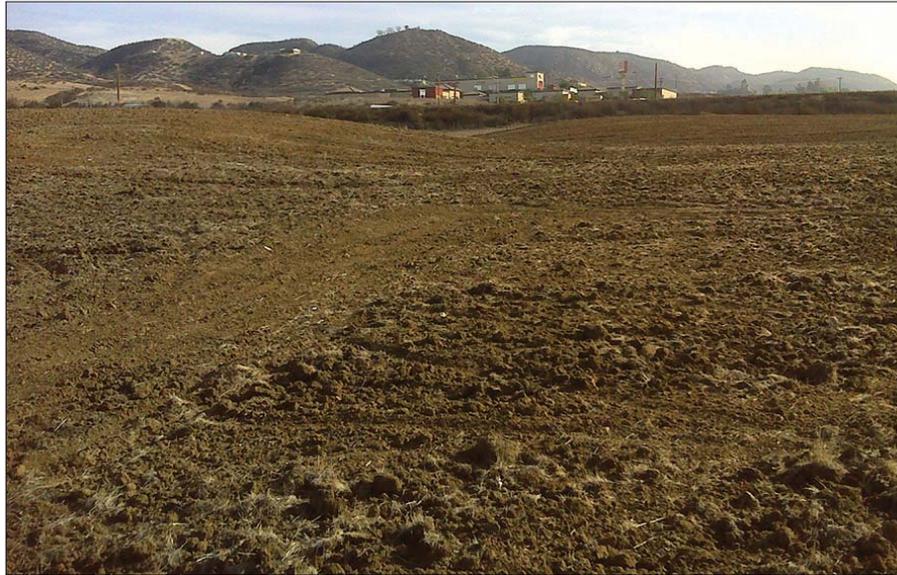
Photograph 8: Photo looking east from within topographic low-point of rolling hill contours occurring near southeast corner of site. Note lack of discernible streambed.

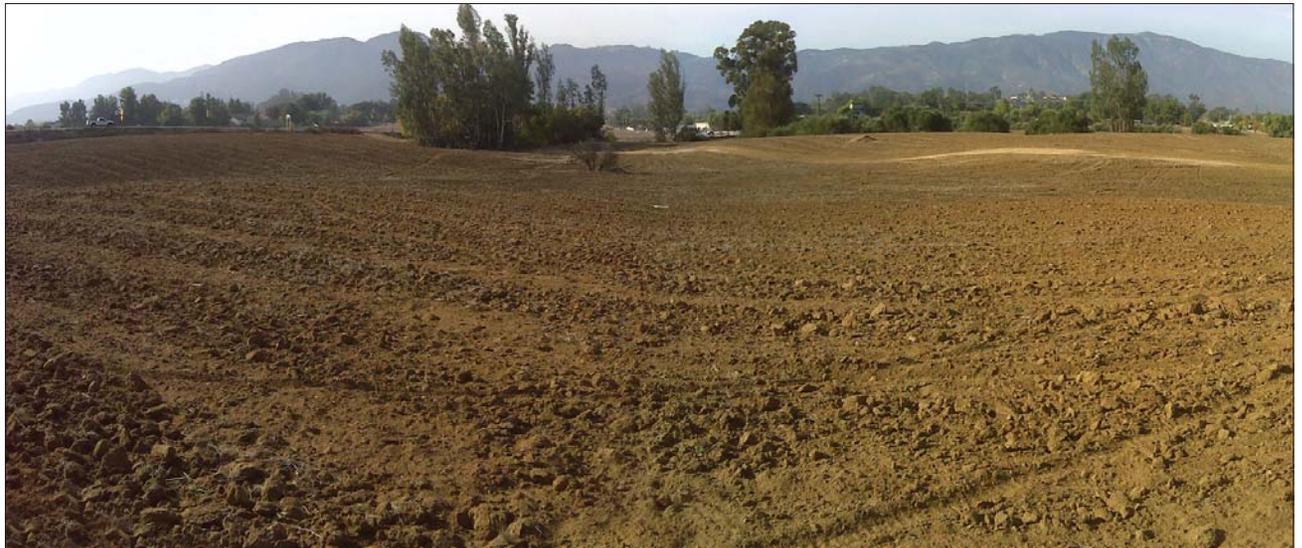
Photograph 9: Photo looking southwest with topographic low-point in foreground lacking a discernible streambed or indicators of jurisdiction. Note 0.36 acre southern willow scrub/eucalyptus woodland in distance.

In addition, an approximately 0.33 acre on-site area and contiguous 0.03 acre off-site area determined to support disturbed southern willow scrub/eucalyptus woodland vegetation occurs adjacent to the central portion of the southern project boundary. This area appears to support remnant habitat that existed on the site prior to the historic diversion of much of the upstream watershed due to the construction of I-15, and was not observed to support jurisdictional field indicators associated with a streambed such as the presence of an OHWM or a defined bed and bank. As a result, the approximately 0.33 acre on-site and 0.03 acre off-site southern willow scrub/eucalyptus woodland area does not support jurisdictional waters regulated by the USACE, RWQCB, or CDFW. A photograph of the vegetation area is provided in **Figure 6c** (see photo 9).

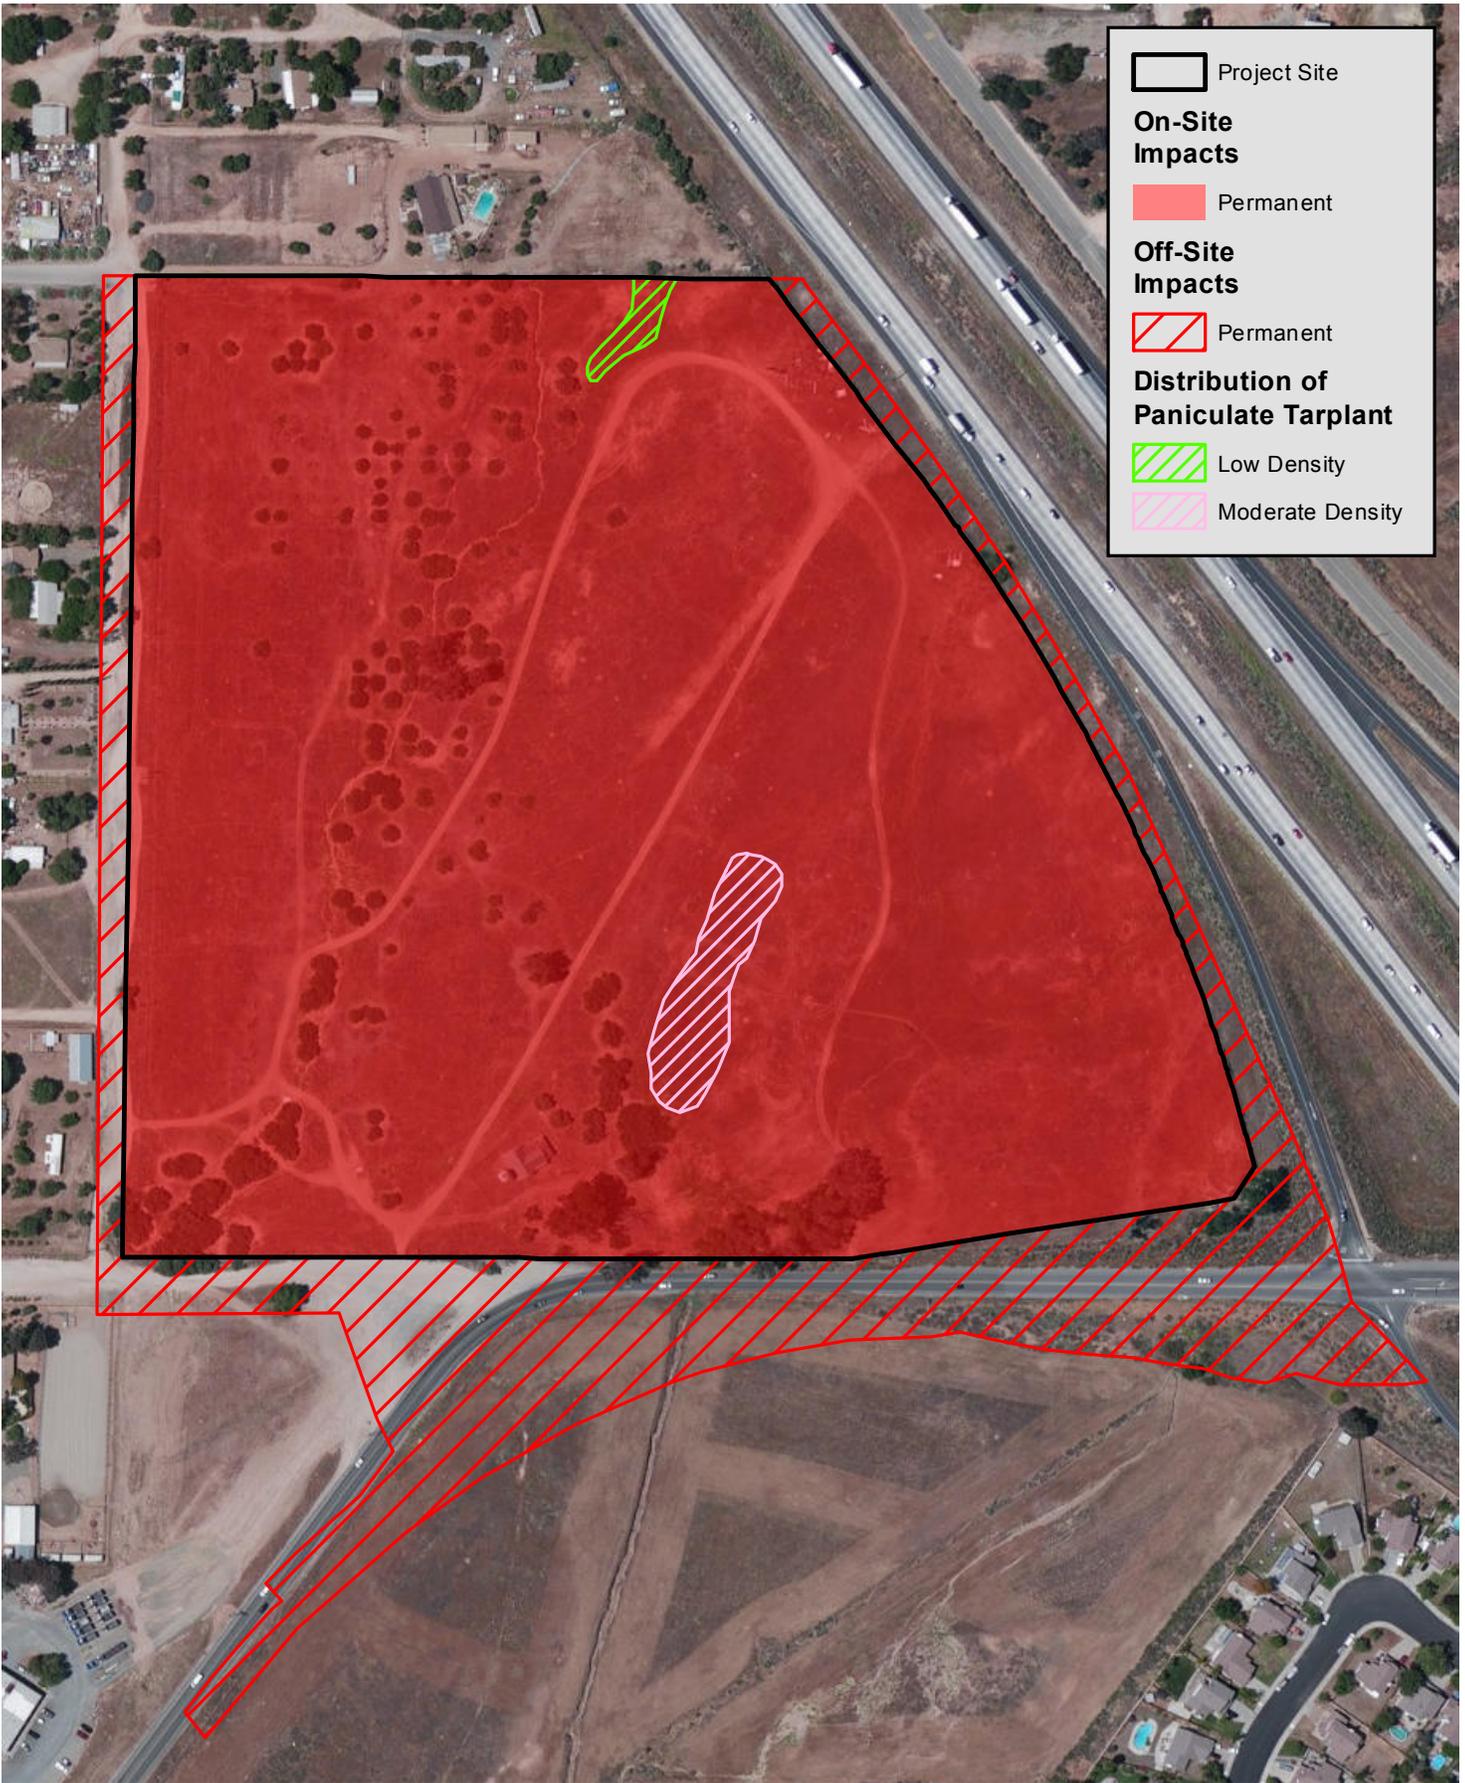
Project Site
On-Site Impacts
 Permanent
Off-Site Impacts
 Permanent
Distribution of Paniculate Tarplant
 Low Density
 Moderate Density

Sensitive plants include those listed by the USFWS, CDFW, and CNPS (particularly lists 1A, 1B, and 2). One potentially sensitive plant species was observed on the Project site, paniculate tarplant (*Deinandra paniculata*). This species is a CNPS List 4, which is classified as 'Plants of limited distribution – a watch list'. The paniculate tarplant was found in two locations on-site totaling 0.74 acre, including a moderate density area within a low lying location in the southeastern portion of the Project site (0.60 acre) and a low density area in the northeastern portion of the Project site (0.14 acre). The southeastern location consisted of several hundred individuals in a moderately dense cluster, and solitary individuals were scattered for a distance of approximately 50 yards. The species was flowering at the time of the survey.

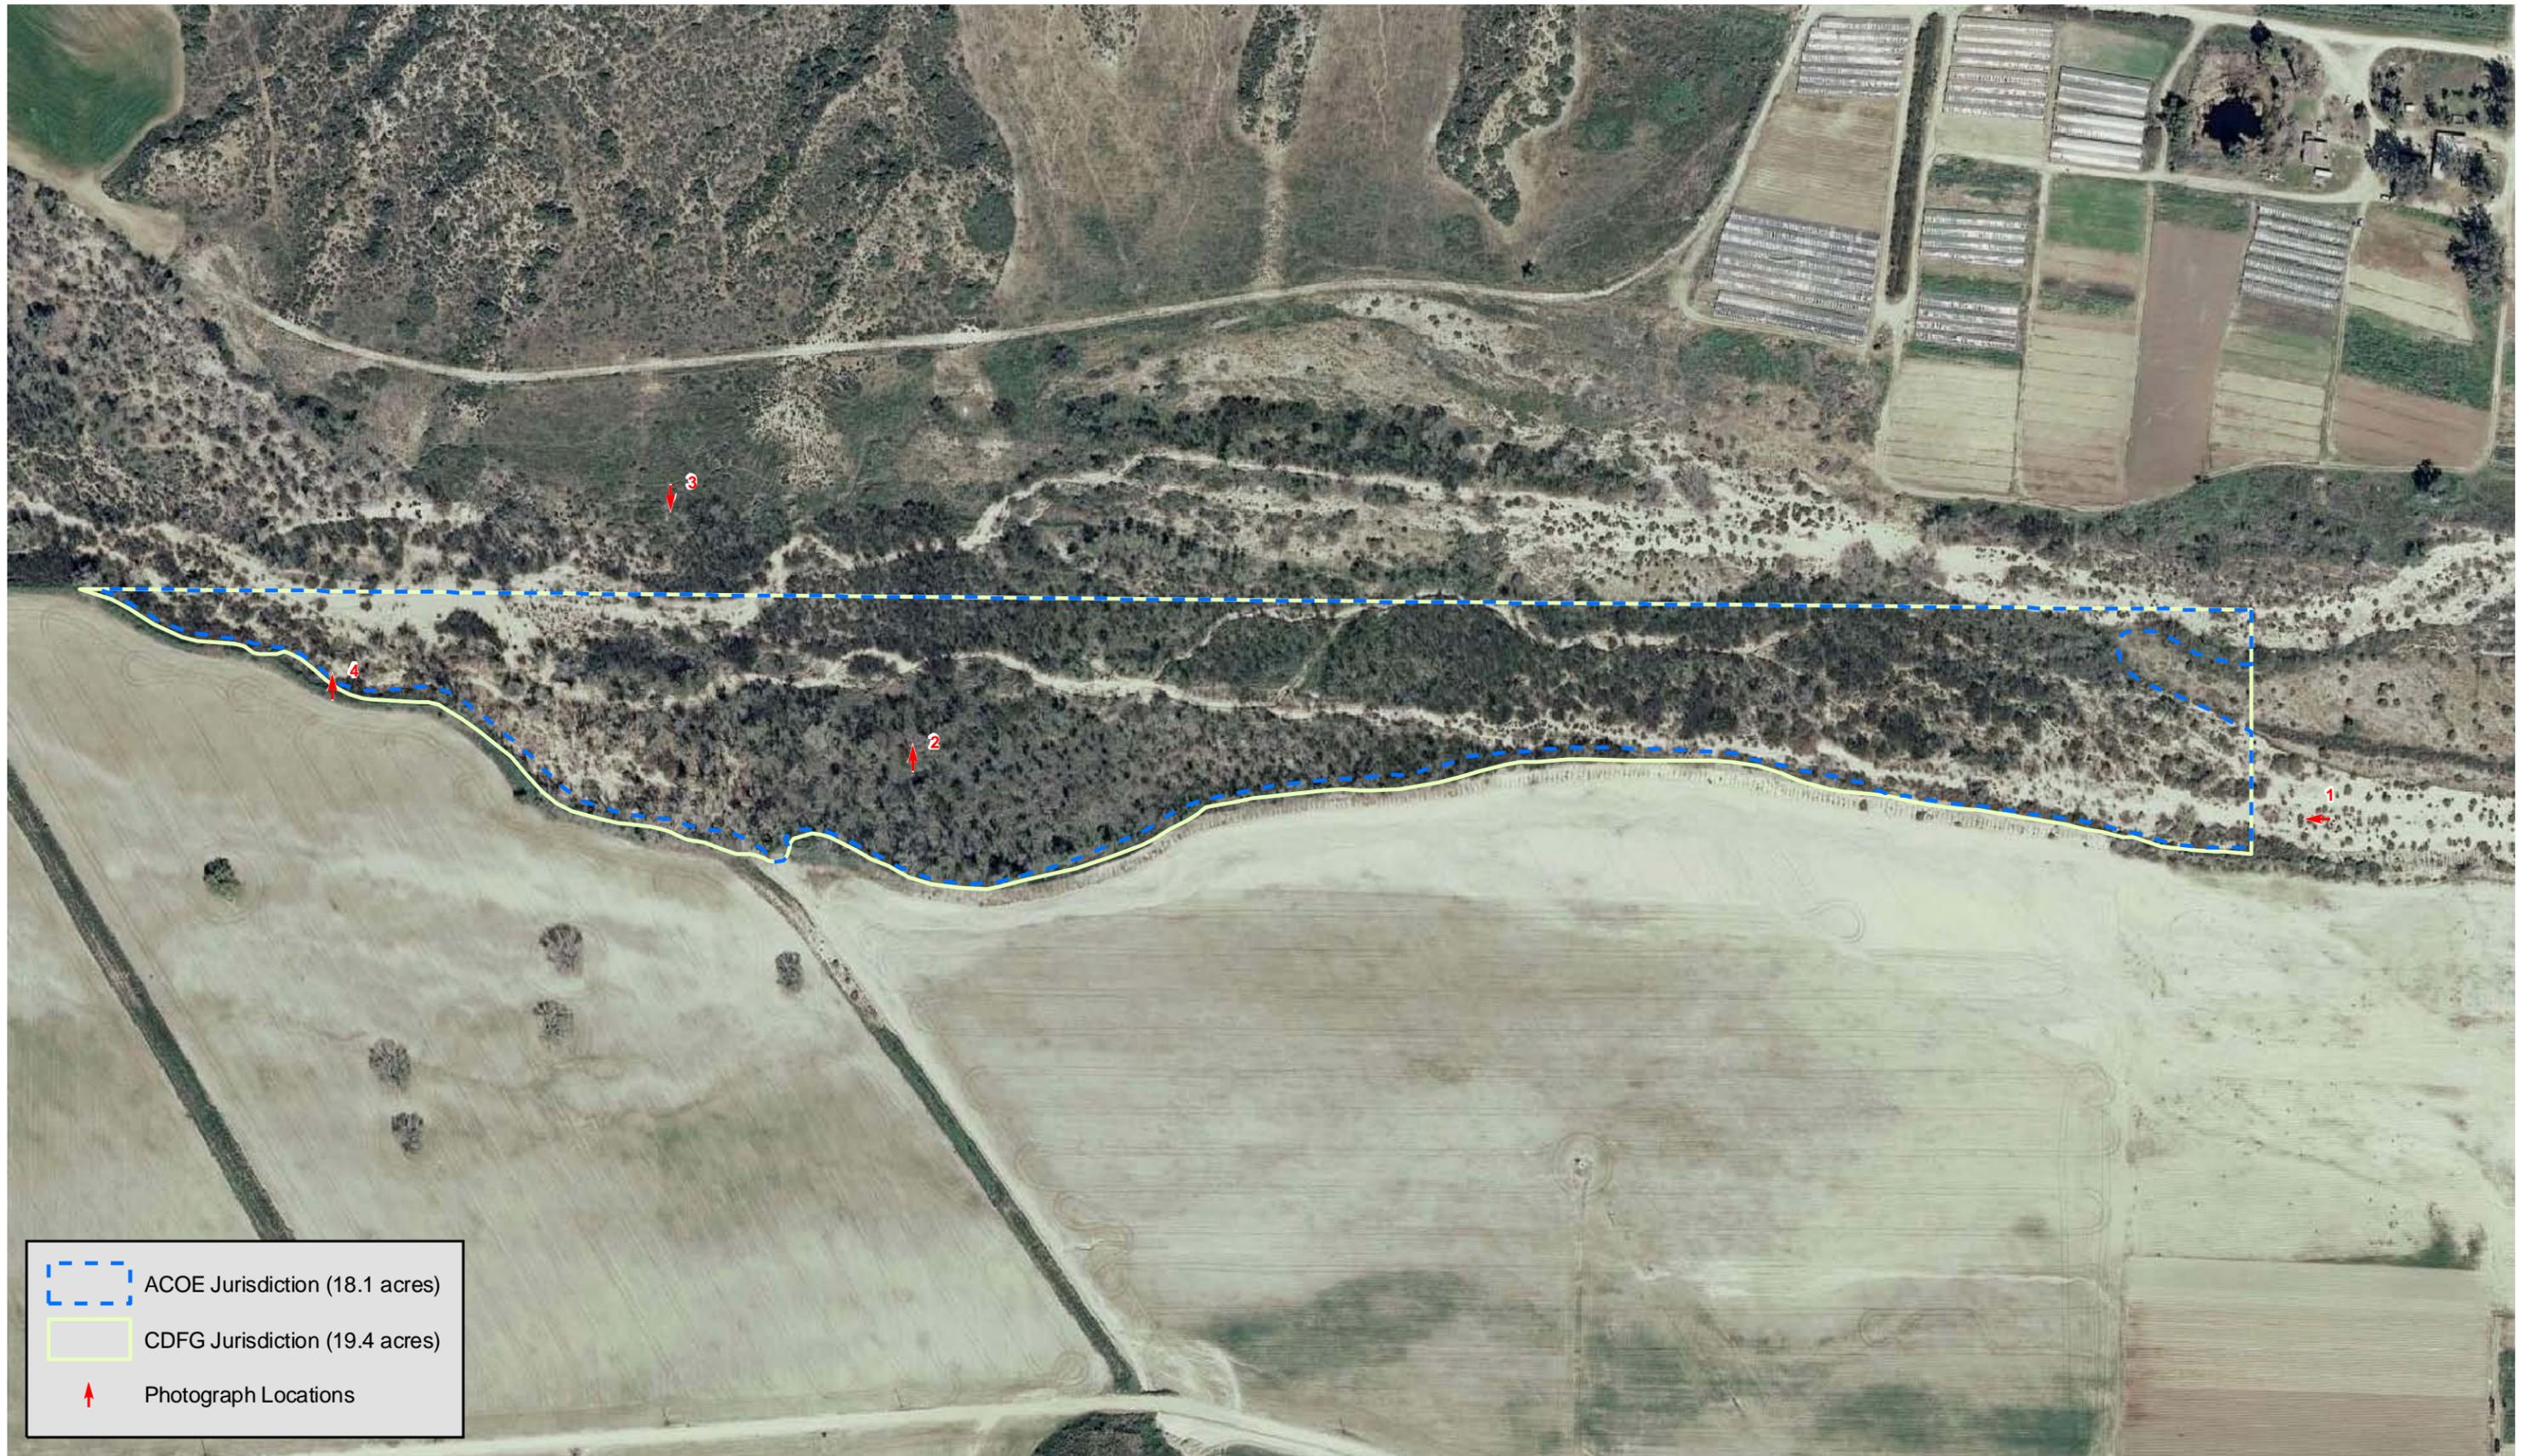
ACOE Jurisdiction (18.1 acres)

Photograph Locations

Wilson Creek is an intermittent drainage feature and riparian corridor that is subject to CDFG regulatory jurisdiction. The streambed area and the active floodplain between the northern and southern embankments are also considered Waters of the U.S. and thus subject to ACOE and RWQCB jurisdiction (**Figure 4, Jurisdictional Limits and Photo Locations**).
