GEOTECHNICAL FEASIBILITY STUDY

Cornerstone Community Church – Parking Lot and Ball Fields

Project Number: T3477-GFS

March 8, 2006

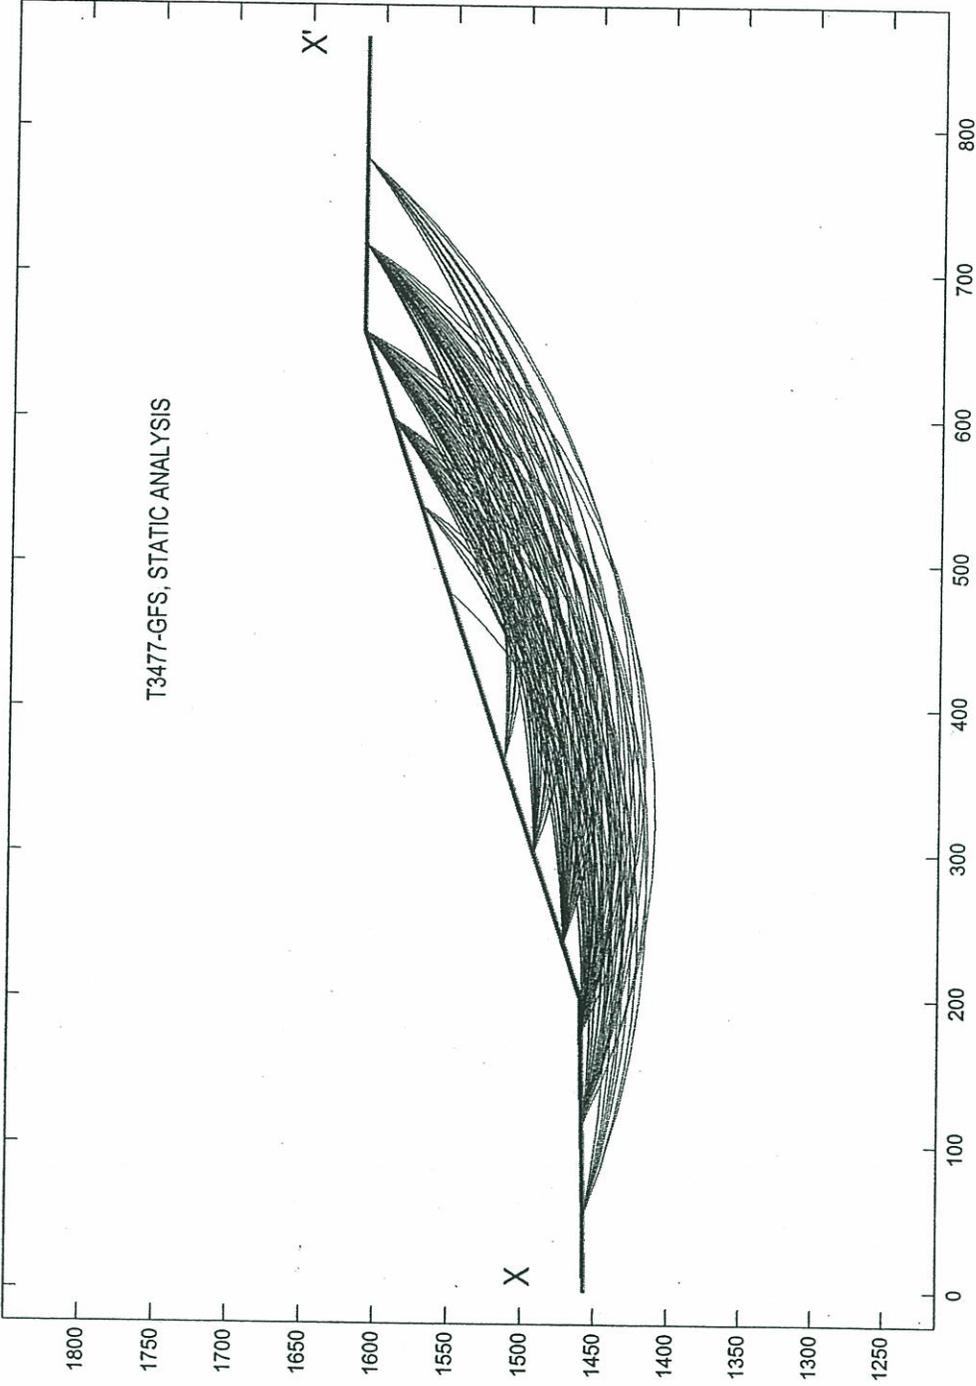
SLOPE STABILITY CALCULATIONS

Bishop Simplified Method of Analysis - Circular Failure Surface

Factor of Safety for initial failure circle approximation: 3.45
